BEFORE THE TENNESSEE REGULATORY AUTHORITY NASHVILLE, TENNESSEE

IN RE:)		
)		
PETITION OF BERRY'S CHAPEL)		
UTILITY, INC. TO RECOVER COSTS)		
TO REPAIR FLOOD DAMAGE AND TO)		
REFUND CUSTOMER SERVICE FEES)	DOCKET NO.	11-00180

PETITION TO RECOVER COSTS TO REPAIR FLOOD DAMAGE AND TO REFUND CUSTOMER SERVICE FEES

Flood Damage Inspection GAM Project No. 10-054

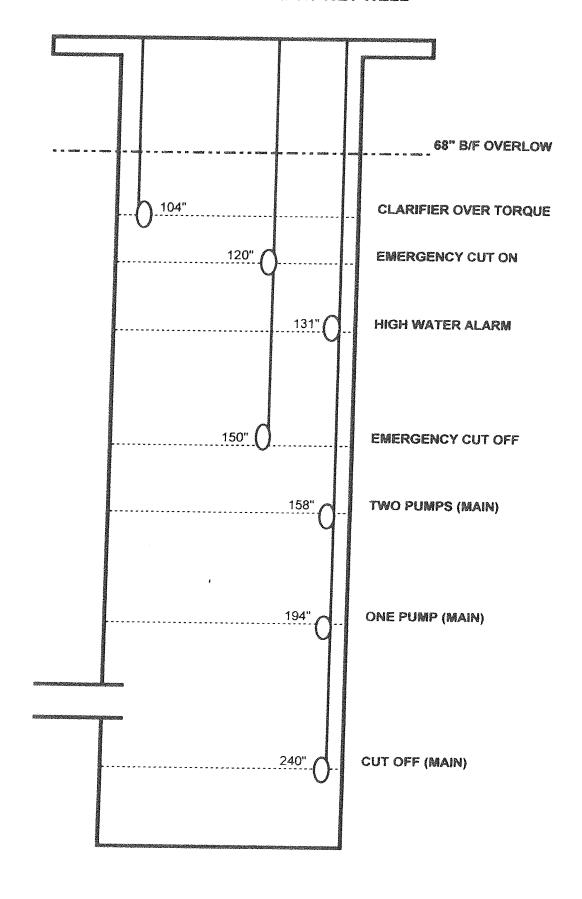
FLOAT DIAGRAM AT PLANT WET WELL

DESCRIPTION		A	MOUNT
Repaired, cleaned, and adjusted float telemetry system.			3,450.00
(Cleaned and repaired entire pump station wet well (30 ft. deep), alarm system, and float system. Repair and cleaning of 35' can station (includes dry out of pumps, motor, electrical panels, sump pumping, dehumidifier, and climate control.)			0,400.00
See attached diagram			
			as de contracto de
	TOTAL	\$	3,450.00
