REPORT OF NATURAL GAS SAFETY INSPECTION REPORT #11-211

OPERATOR: Knoxville Utilities Board – Knoxville, Tennessee

SYNOPSIS

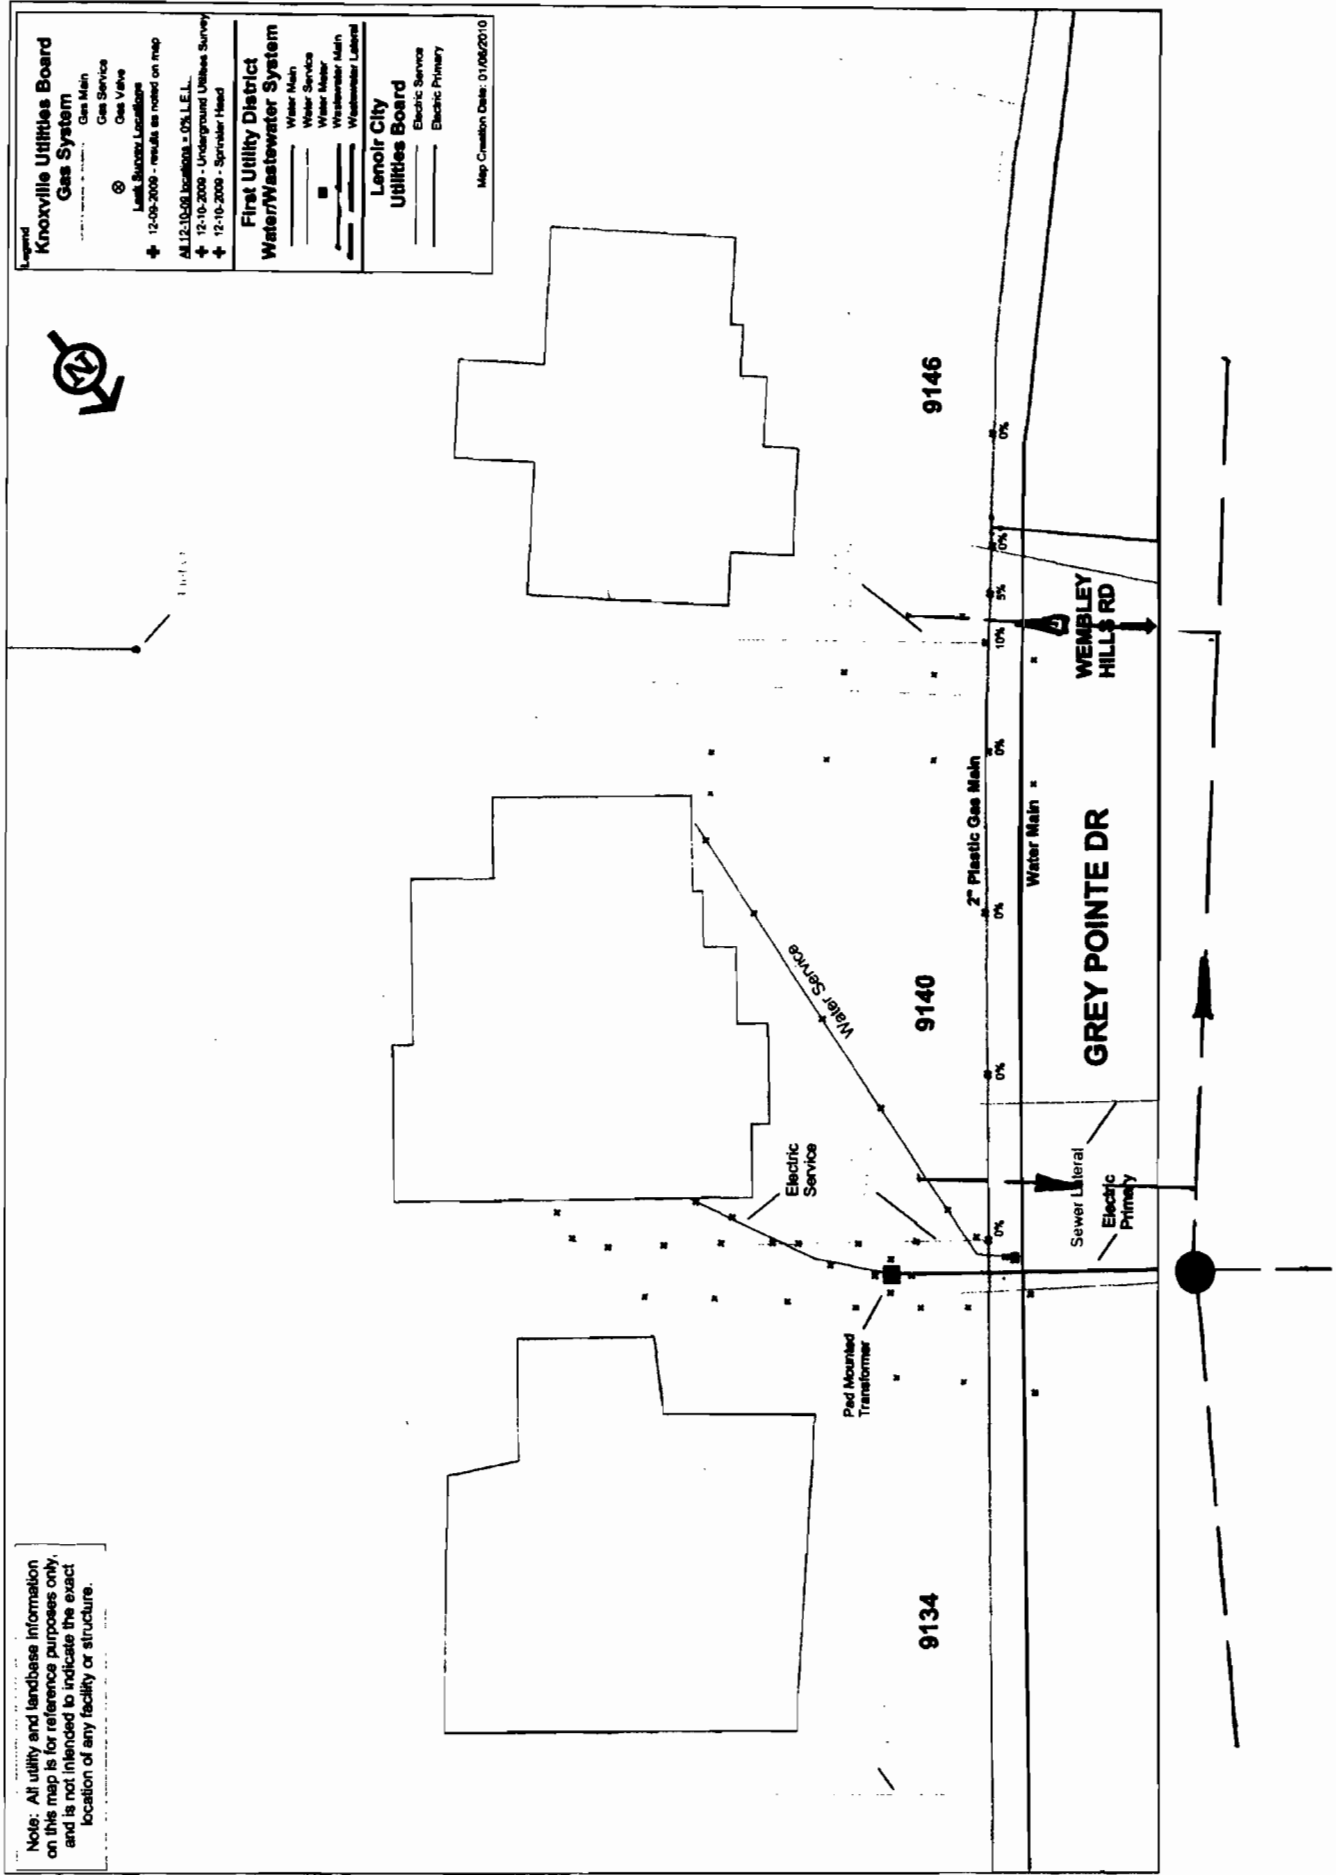
Attachment 5

The surveys detected a reading of 10% of the LEL at the gas main in front of address 9146 and of 5% at the next location, just southwest and at a greater distance from address 9140 (*See Attachment 5*). All other readings at locations northeast and southwest of these two were 0% of the LEL. It might appear, therefore, that there was a leak on either the main line or the service line in the immediate area where the residuals were found.

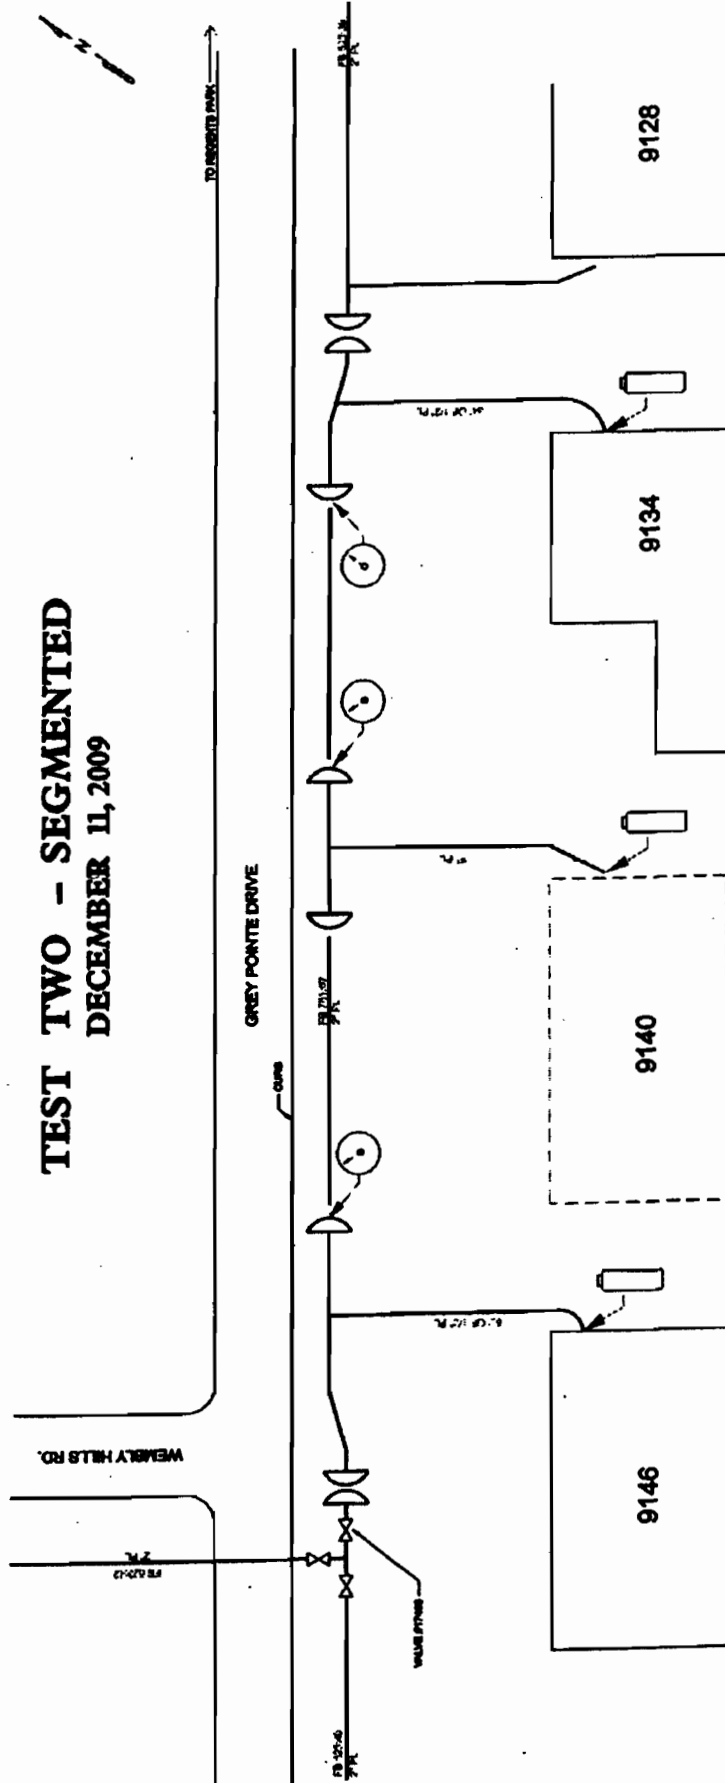
TEST TWO - SEGMENTED DECEMBER 11, 2009

The two neighboring sections passed the pressure tests, but the section of main and service line that had served address 9140 did not. It was observed that air from the pressure test was being released between the upper half of the service tee fitting and the top of the natural gas main. Further examination revealed that two of the four nylon bolts clamping the tee to the main were broken, although KUB could not determine whether the bolts broke before or because of the explosion. KUB preserved this section of main for further testing (See Attachment 3, pg. 3 and Attachments 7 and 8).

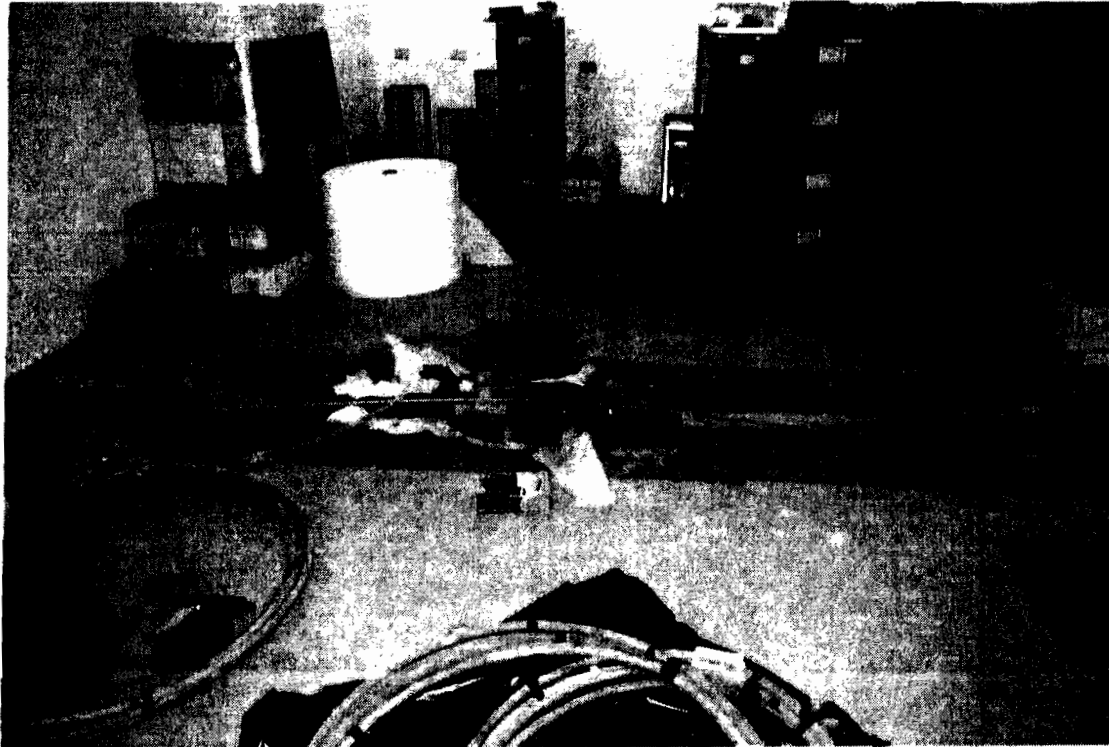
Photograph 1: Pipe and tapping tee assembly after removal from site.

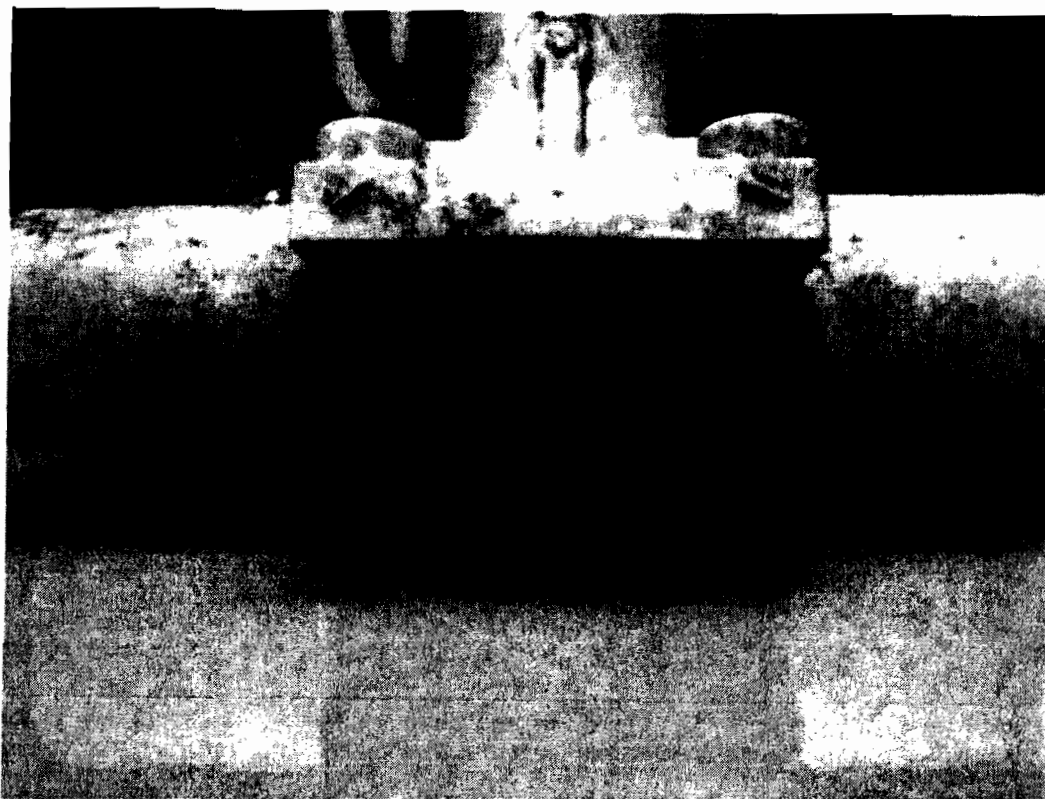
KUB sent the removed section of main, including the service tee, to Engineering Systems, Inc. (ESI) for examination. X-rays of the service tee taken by ESI showed the cutter assembly was not penetrating the main. The materials noted consisted of one-half inch PE 2406 Plexico polyethylene pipe, two inch PE 2406 Plexico polyethylene pipe, and a Perfection Permalock Tee, Tapping Medium Density Polyethylene Pipe (MDPE) two inches by one-half inch IPS Mechanical. ESI's report, dated May 25, 2010, states that "it is not possible to determine whether the broken bolts on the back side of the Perfection Corp. Permalock® tapping tee were broken prior to the explosion of December 9, 2009 or as a result of that event" (*See Attachment 11, pg. 4*). Additional testing by Test America determined that air space samples taken at the accident site on January 14, 2010 by APR Consultants showed no presence of the components of natural or sewer gas (*See Attachment 12*).

Photograph 4: Position of hole in main and gasket found after cleaning.
