**BEFORE THE TENNESSEE REGULATORY AUTHORITY
NASHVILLE, TENNESSEE**

**FORMAL NOTICE OF VIOLATIONS,
KNOXVILLE UTILITIES BOARD INCIDENT,
12/09/09, REPORT OF NATURAL GAS SAFETY
INSPECTION #11-211**

**DOCKET NO.
12-00111**

**ORDER ACCEPTING PROPOSED CIVIL PENALTY
AND CORRECTIVE ACTIONS**

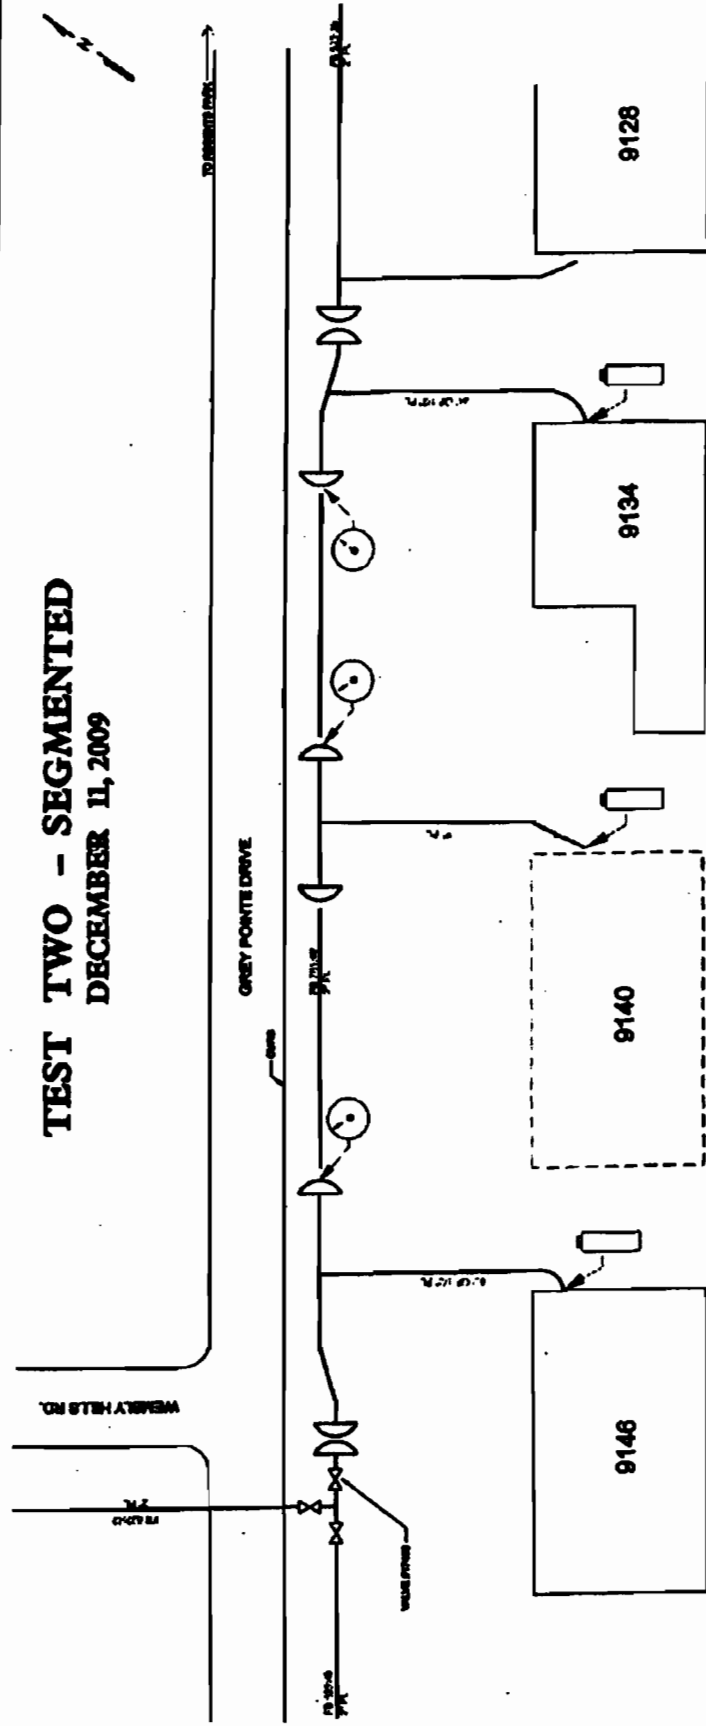
ATTACHMENT 7

The two neighboring sections passed the pressure tests, but the section of main and service line that had served address 9140 did not. It was observed that air from the pressure test was being released between the upper half of the service tee fitting and the top of the natural gas main. Further examination revealed that two of the four nylon bolts clamping the tee to the main were broken, although KUB could not determine whether the bolts broke before or because of the explosion. KUB preserved this section of main for further testing (See Attachment 3, pg. 3 and Attachments 7 and 8).

TEST TWO - SEGMENTED DECEMBER 11, 2009

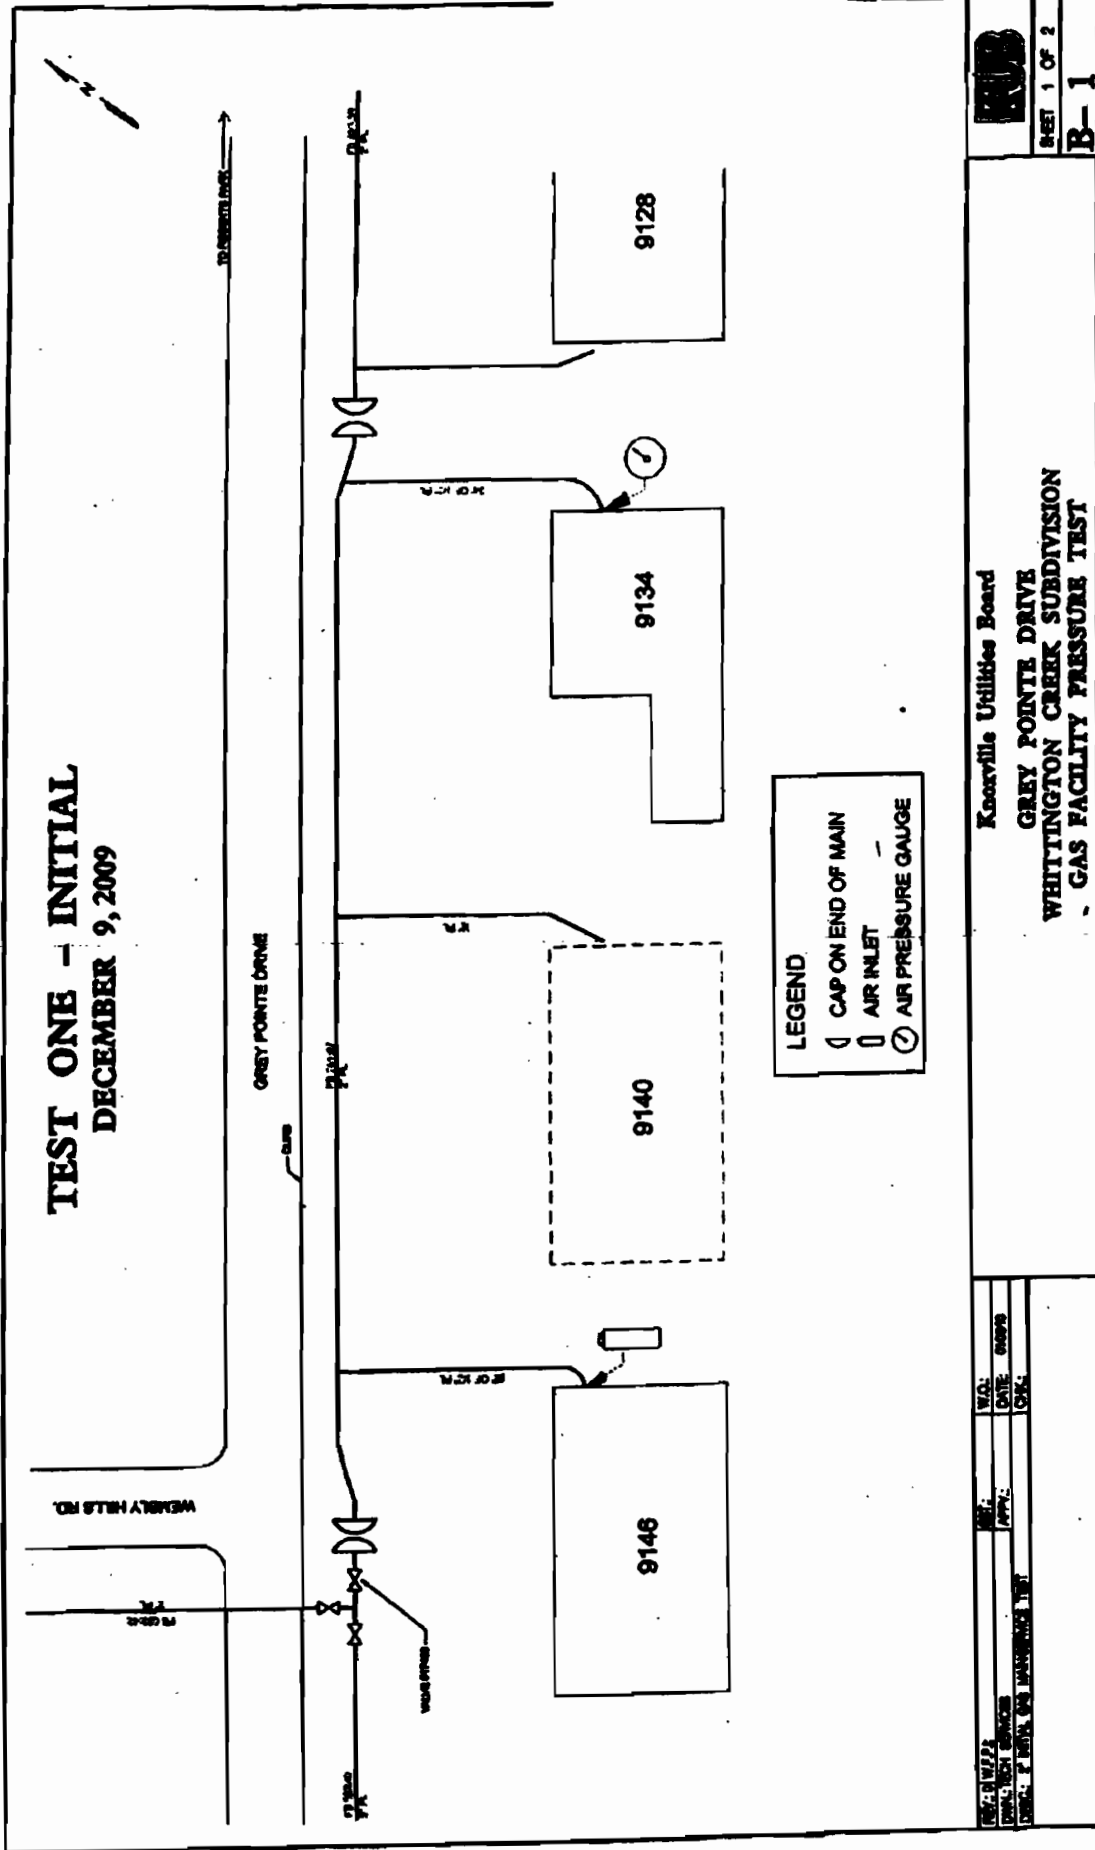
ATTACHMENT 8

TEST ONE - INITIAL DECEMBER 9, 2009
