Docket  
14-0000000000

Monthly Update  
31-Aug-15

August 19, 2015

RE: Compliance Inspections 7/20/2015  
 SOP-05033 Smoky Village Subdivision, Sevier County  
 SOP-00019 Starr Crest Resort, Sevier County  
 SOP-01033 Starr Crest II Resorts, Sevier County  
 SOP-98033 Swan Harbour Subdivision, Roane County  
 SOP-99024 Tall Oak Subdivision, Blount County  
 SOP-99016 Townsend Town Square, Blount County

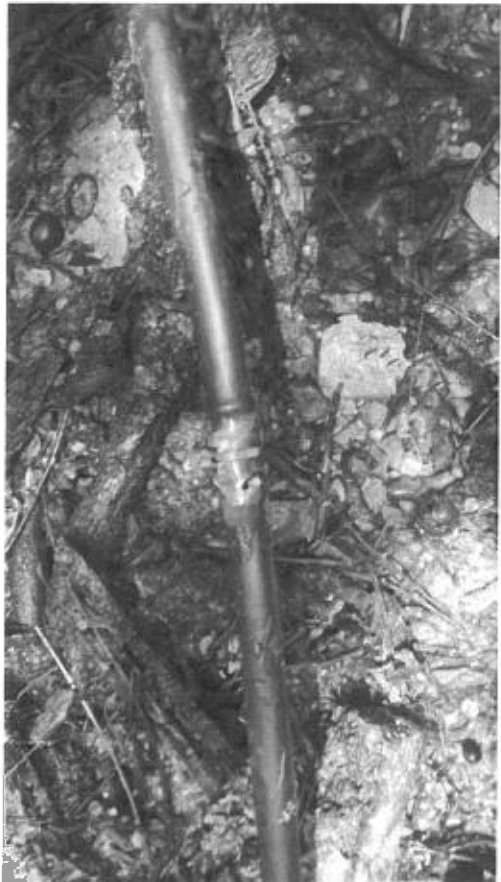
Photo #1

*On 7/20/15 a site inspection was conducted to determine if the system has been brought into compliance. There was evidence that the system had overflowed from the tanks as previously noted, however on the day of the inspection, no overflow from the tanks were observed. Broken /chewed pipes were noted causing effluent to flow into a drain. It is common for drip tubes that are laying on the surface or in the duff layer of heavily forested areas of this region to be broken due to falling trees and to be chewed on by small animals and black bears. Thus, the discovery and repair of these damaged tubes are an ongoing maintenance item and are normally inspected during the monthly site visits with repairs performed soon afterwards. The broken pipe referenced in the photo accompanying your report has been repaired. Technicians also found two more small chewed sections and repaired those also. Please see photos #1, #2 and #3 for documentation.*

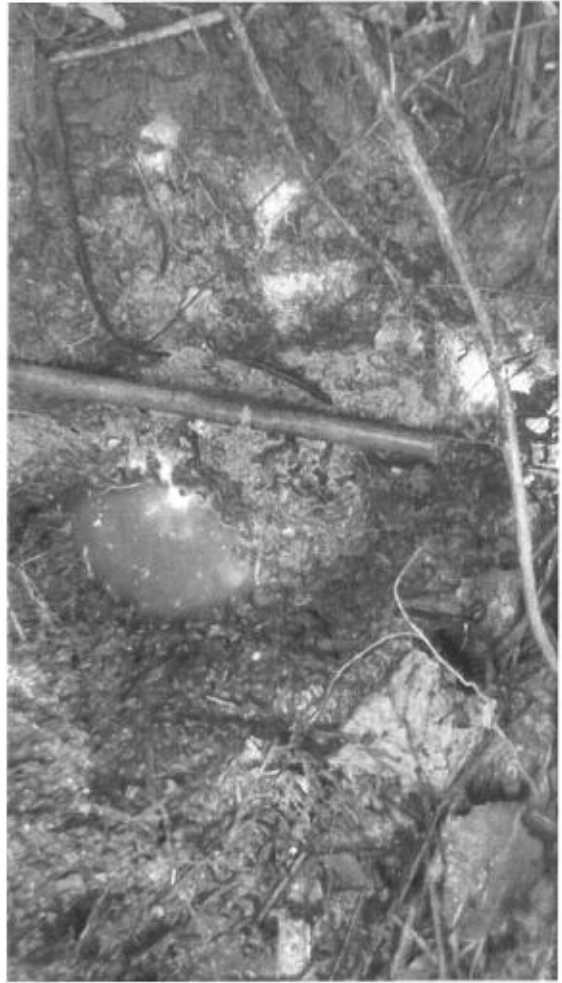
Photo #8

*An area of ponding was observed on the lower portion of the drip field located at 35°48'18.4/-83°50'00.00". Ponding was previously observed on the February 28, 2014 inspection conducted by KFFO staff and & August 15, 2014 as well.*

The several areas of ponding that were noted on last year's inspection were addressed by making repairs to leaking drip tubing. While we do not believe this ponding is due to last year's leak, but rather due to a new leak, this new ponding was evaluated and the broken drip tubing that was contributing to it was repaired on August 4, 2015 (see photo #8).
