**Tennessee Wastewater Systems, Inc.  
Docket 15-00025  
April 2021 Report Overview**

**RE:    Notice of Violation**  
Tennessee Wastewater Systems, Inc.  
Sunnybrook Farms Treatment System, SOP-03015  
Robertson County, Tennessee

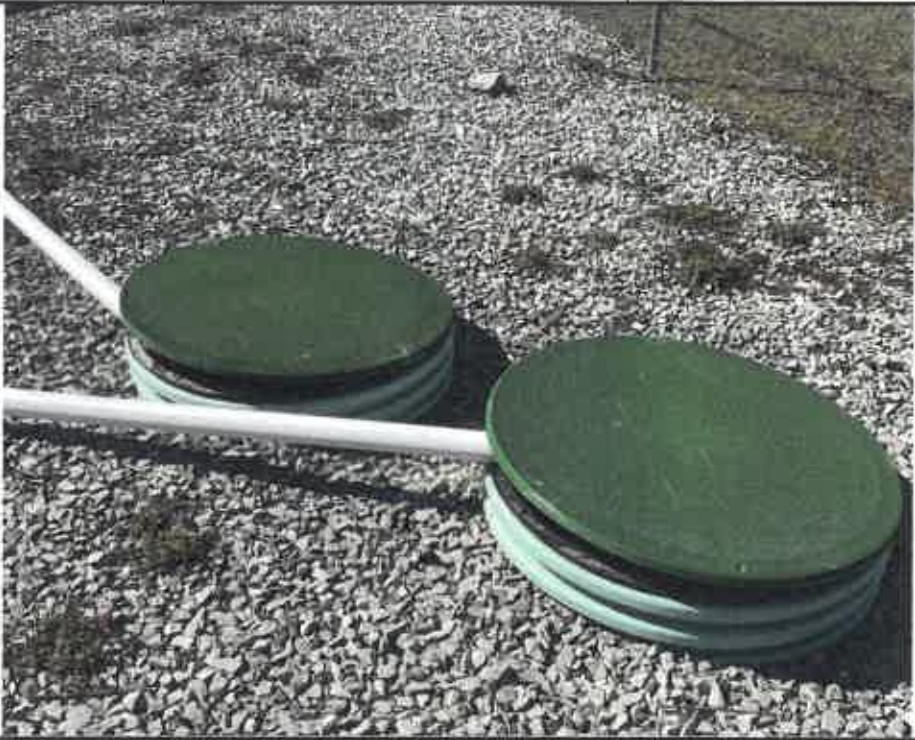
<b>Photo No.</b> 1	<b>Date</b> 3-3-2021

<p><b>Description</b> View of PVC piping emerging from two open manholes located towards the northwest corner of the fenced in recirculating sandfilter area.</p> <p>Photo taken by Jenny Strobel using state issued iPhone.</p>

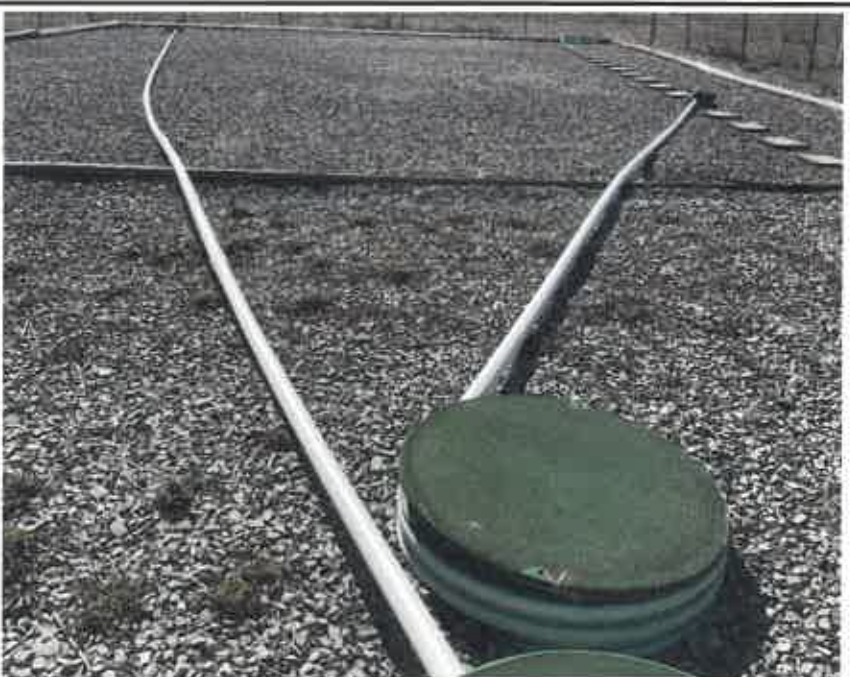
<b>Photo No.</b> 2	<b>Date</b> 3-3-2021

<p><b>Description</b> View of the PVC piping extending from the open manholes, bypassing the clogged areas of the sandfilters, and rerouted to other areas of the sandfilter system. Facing the southeast corner.</p> <p>Photo taken by Jenny Strobel using state issued iPhone.</p>

Tennessee Wastewater Systems (TWS) must develop and submit a corrective action plan (CAP) detailing steps that will be taken to remedy the issues with the sand filter that require rerouting flow around portions of the system. The CAP should also address how TWS will dispose of effluent from the sand filter. The CAP should detail how TWS will determine the repair or rehabilitation requirements and methods for the sand filter. Additionally, a method of controlling the distribution of wastewater to the zones of the sand filter should be developed that does not require having the tank and well lids open.

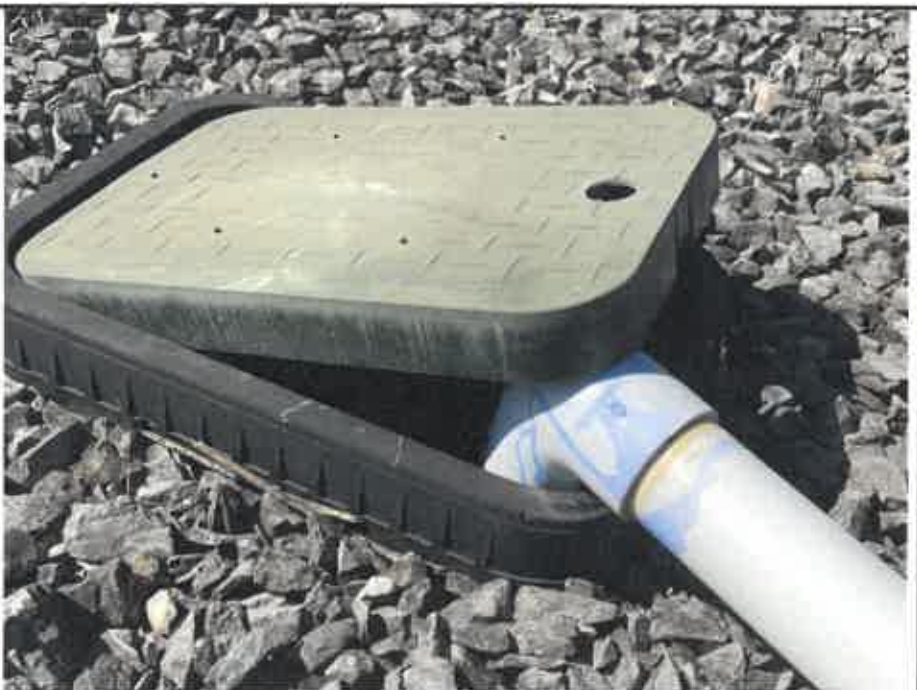
<b>Photo No.</b>	<b>Date</b>

4	3-3-2021	
<b>Description</b> View of the PVC pipe after being rerouted, located along the western boundary of the fenced in sandfilter area.  Photo taken by Jenny Strobel using state issued iPhone.

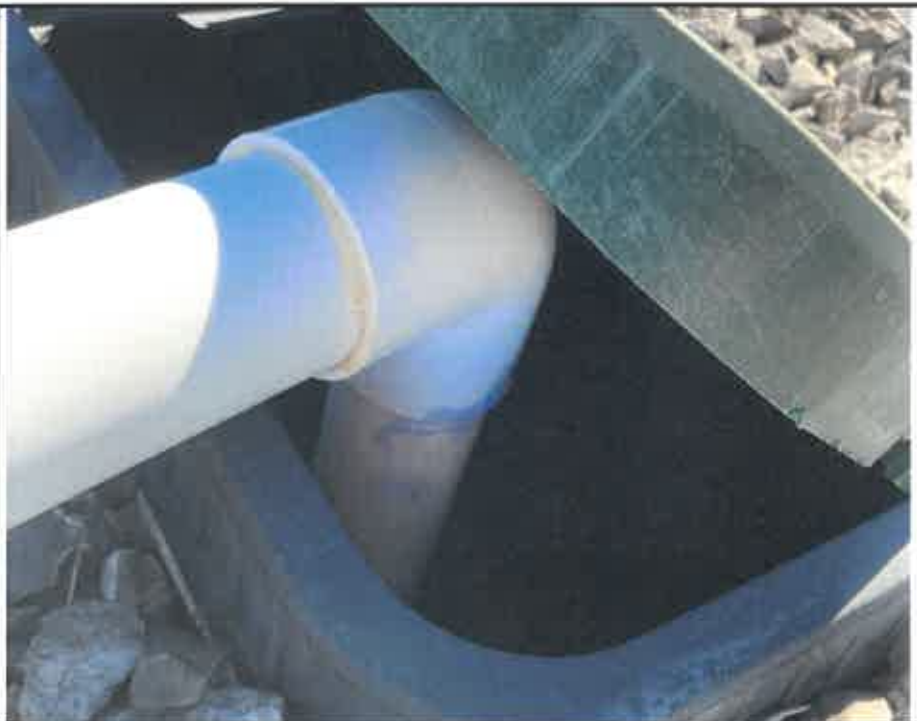
<b>Photo No.</b>	<b>Date</b>

6	3-3-2021	
<b>Description</b> Additional view of the PVC pipe after being rerouted, located along the southern boundary of the fenced in sandfilter area.  Photo taken by Jenny Strobel using state issued iPhone.

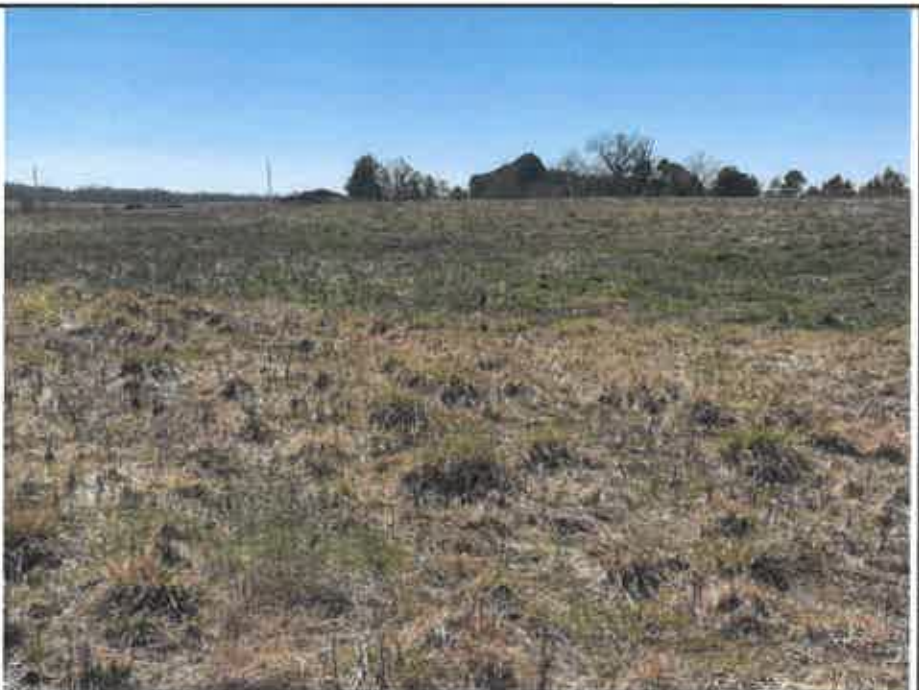
<b>Photo No.</b>	<b>Date</b>

In addition, Ms. Strobel and Mr. Fey walked through the drip field during the site reconnaissance and noted areas of saturation and pooling. Throughout the entire drip field area, black and green algae was observed indicating saturation for an extended period of time. While it had recently rained before the site reconnaissance, the drip field, which is located on higher ground was saturated and had pools of water, while the lower ground around the drip field was dry.

14	3-3-2021	
<b>Description</b> Photo taken from the southern boundary of the fenced in sandfilter area. During the site reconnaissance, the higher ground was saturated while the lower ground was dry.  Photo taken by Jenny Strobel using state issued iPhone.

The cause of the clogged sandfilters must be addressed to maintain correct operation of the system. The ponding in the drip field must be investigated immediately and any sources of effluent on the surface must be repaired as soon as possible.
