Re: Petition of Cartwright Creek, LLC to Increase Tap Fees to Address
Environmental Issues Raised by the Tennessee Department of Environment and
Conservation
Docket No. 19- 00034

Cartwright Creek, Collections System Review Inflo Design Group

Collections System Review

JUNE, 2018

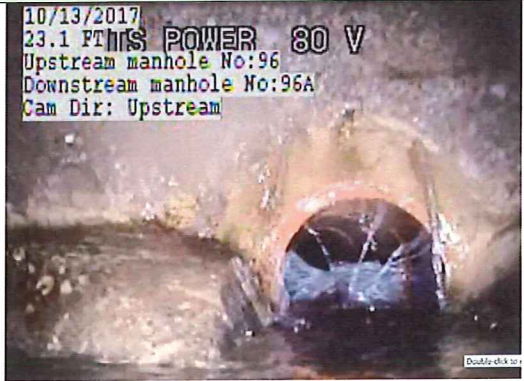
<p>MANHOLE 96A, NEAR THE CREEK IN FRONT OF GRASSLAND MIDDLE SCHOOL, HAS A HIGH DEGREE OF INFILTRATION. GIVEN THAT THIS CCTV WORK WAS PERFORMED DURING A RELATIVELY DRY MID-OCTOBER, IT IS LIKELY THAT THE INFILTRATION IS MUCH WORSE IN WETTER TIMES OF THE YEAR.</p>
KEY OBSERVATIONS	<ol style="list-style-type: none"> 1. The area near Grassland Middle School is particularly prone to Infiltration. 2. Several manholes are potential sources of Inflow & Infiltration into the system and warrant further inspection. 	
RECOMMENDED IMPROVEMENTS	<ol style="list-style-type: none"> 1. Perform comprehensive rehabilitation on a portion of the system just to the west of Grassland Middle School. 2. Perform point repairs on a service line behind Pet Vet on Hillsboro road and at two manholes near Sonic in the Grassland commercial area.

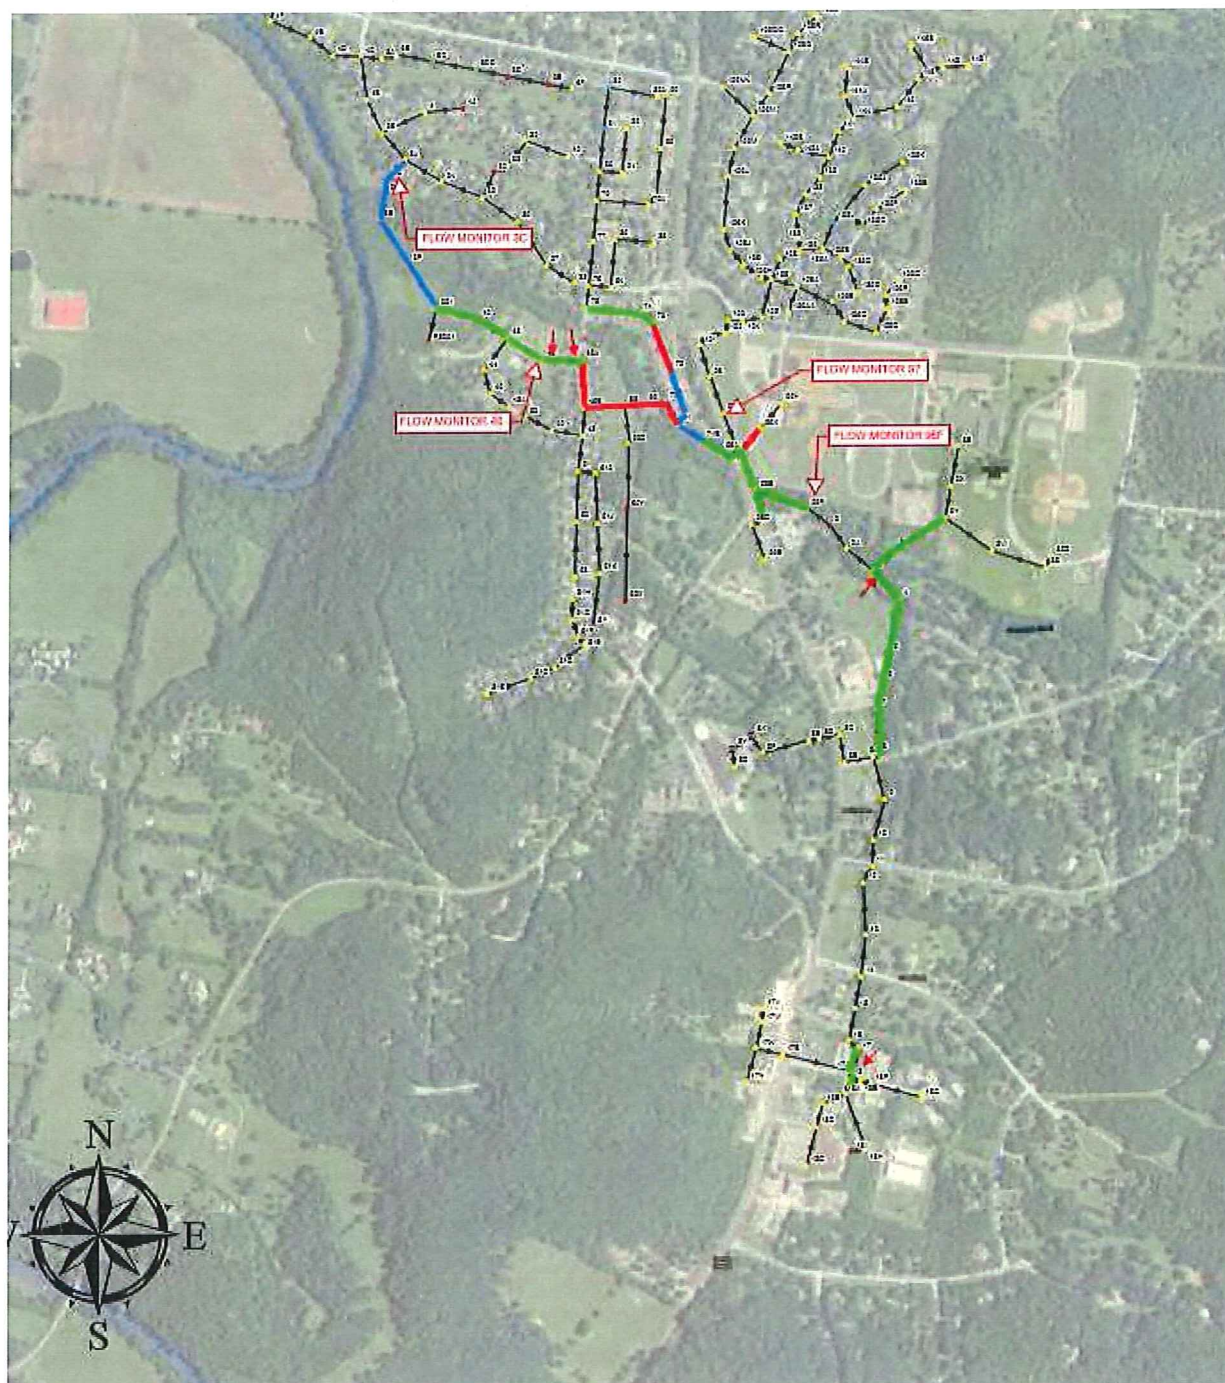
Following the **GREEN = GOOD**, **BLUE = MARGINAL**, and **RED = BAD** convention in the table, a graphical representation of the CCTV review is shown on the following page. Here, it is evident that major issues are concentrated in a relatively specific area.

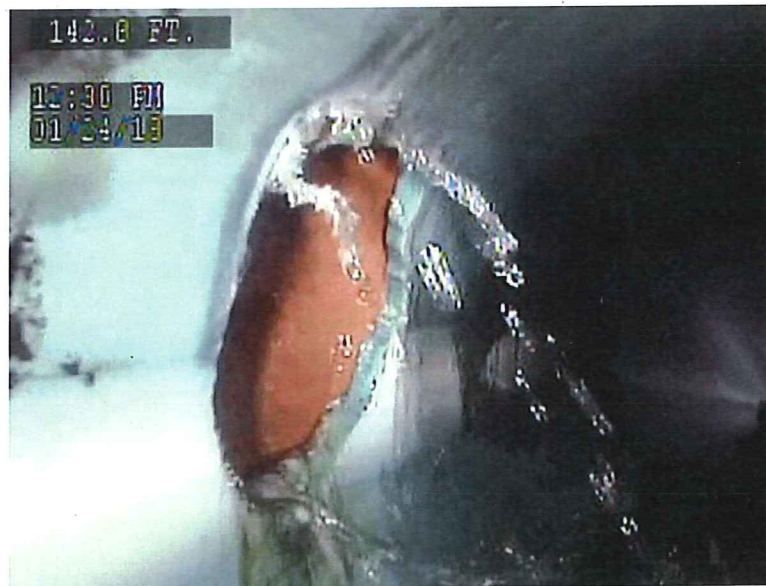
1. ***Previous rehabilitation efforts appear to have been somewhat effective.*** Segment 46A to 46 was previously lined and in much better condition than the adjacent segment 46B to 46A which had not been lined. However, the two services on segment 46A-46 were only reinstated and not sealed, and both of them were leaking as can be seen in the figure below.

IDG recommends that any services on lines that are rehabilitated receive at least a “cut and buff / lateral seal” treatment

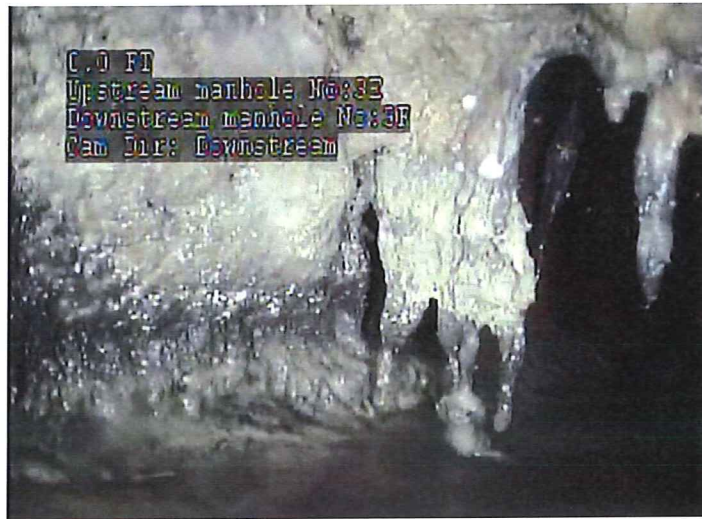
2. ***Grease is collecting in the system in specific locations.*** A majority of the lines listed as “marginal” are 8” VCP segments coming from Boxwood Drive to the WWTP (manholes 3A to 3F). The true condition of these segments could not be determined because the lines were so full of grease, as shown below:

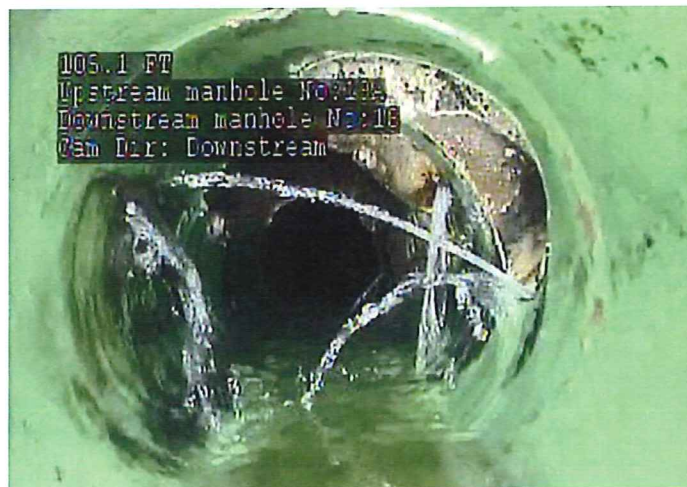
3. ***Manholes can be a major source of I/I, and in some cases may need to be replaced entirely.*** One or two manholes near Sonic in the Grassland Commercial Area are in need of repair or possible replacement, along with manholes in front of Grassland Middle School. Grouting and sealing with cementitious or epoxy coatings might work, but if the manholes are structurally deficient, replacing them altogether could be necessary.

Manholes appear to be a major contributor to the I/I problem in the system. Once a main is lined, there is an annular space between the liner and the main, and in some cases, between the main and the manhole itself, which allows infiltration to enter the system. We recommend that each manhole that is connected to a main that gets lined receive a cementitious coating to seal the manhole. There is some merit in considering a more robust (and more expensive) epoxy coating, but there does not appear to be a large amount of corrosion evident in the system, so a cementitious coating should suffice. As with the CIPP lining, there are qualified manhole rehabilitation contractors working nearby.

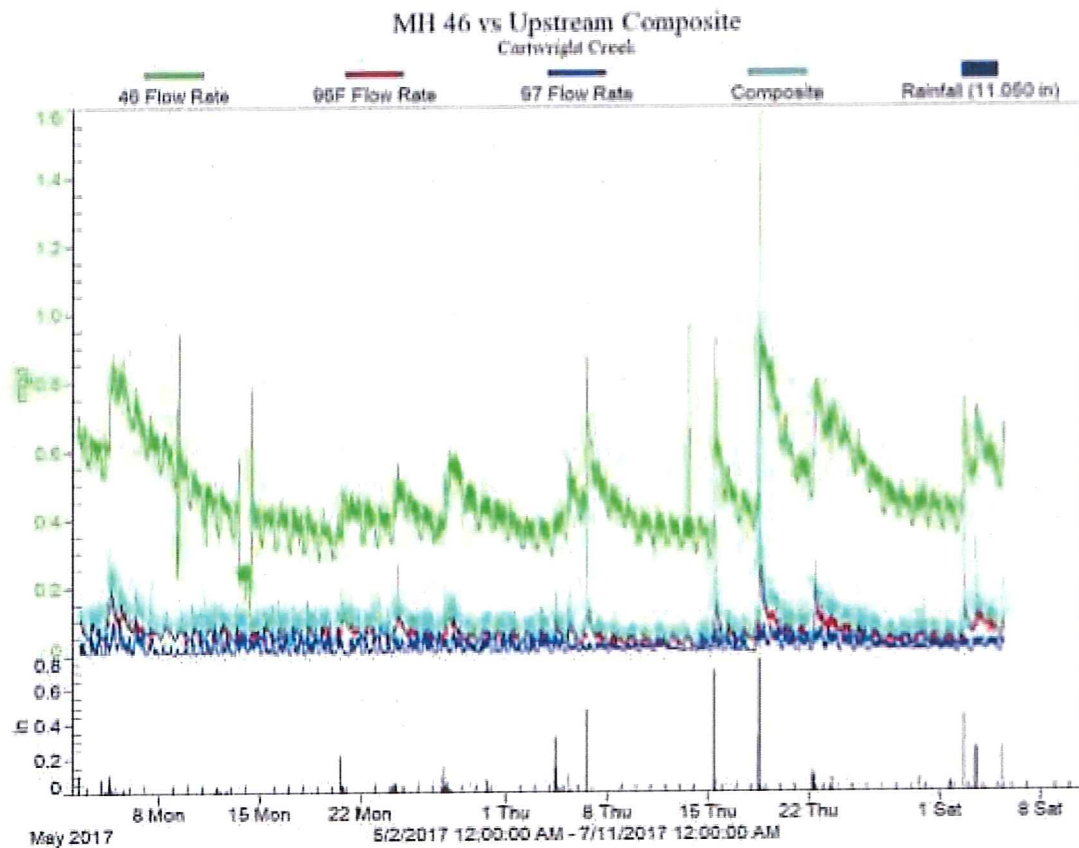
The flow monitoring information performed by Utility Technologies corroborates the findings in the CCTV review that the majority of the infiltration is originating in a relatively limited portion of the collection system. The most important conclusion from UTI's report is the graph that shows flow monitor 46 on the same axes as flow monitor 97 and 96F. Although there is some infiltration evident upstream of flow monitor 97, and perhaps more from 96F (a large proportion of which originates at two manholes near Sonic), the largest contributory basin is the area just upstream of Manhole 46.

From this graph, several things may be inferred when looking at the flows from Basin 46 (the green line):

1. After rain events, it can take close to a week for the flow to return back to normal.
2. Even at “normal” flows, the lowest readings are approximately 300,000 gallons per day. In a basin this small that is nearly 100% residential, the flow should approach a flow rate near 0 in the early-morning hours.
3. The distinct peaks nearing 1,000,000 gallons per day are indicative of direct inflow into the system, as if water is flowing directly into a manhole somewhere.

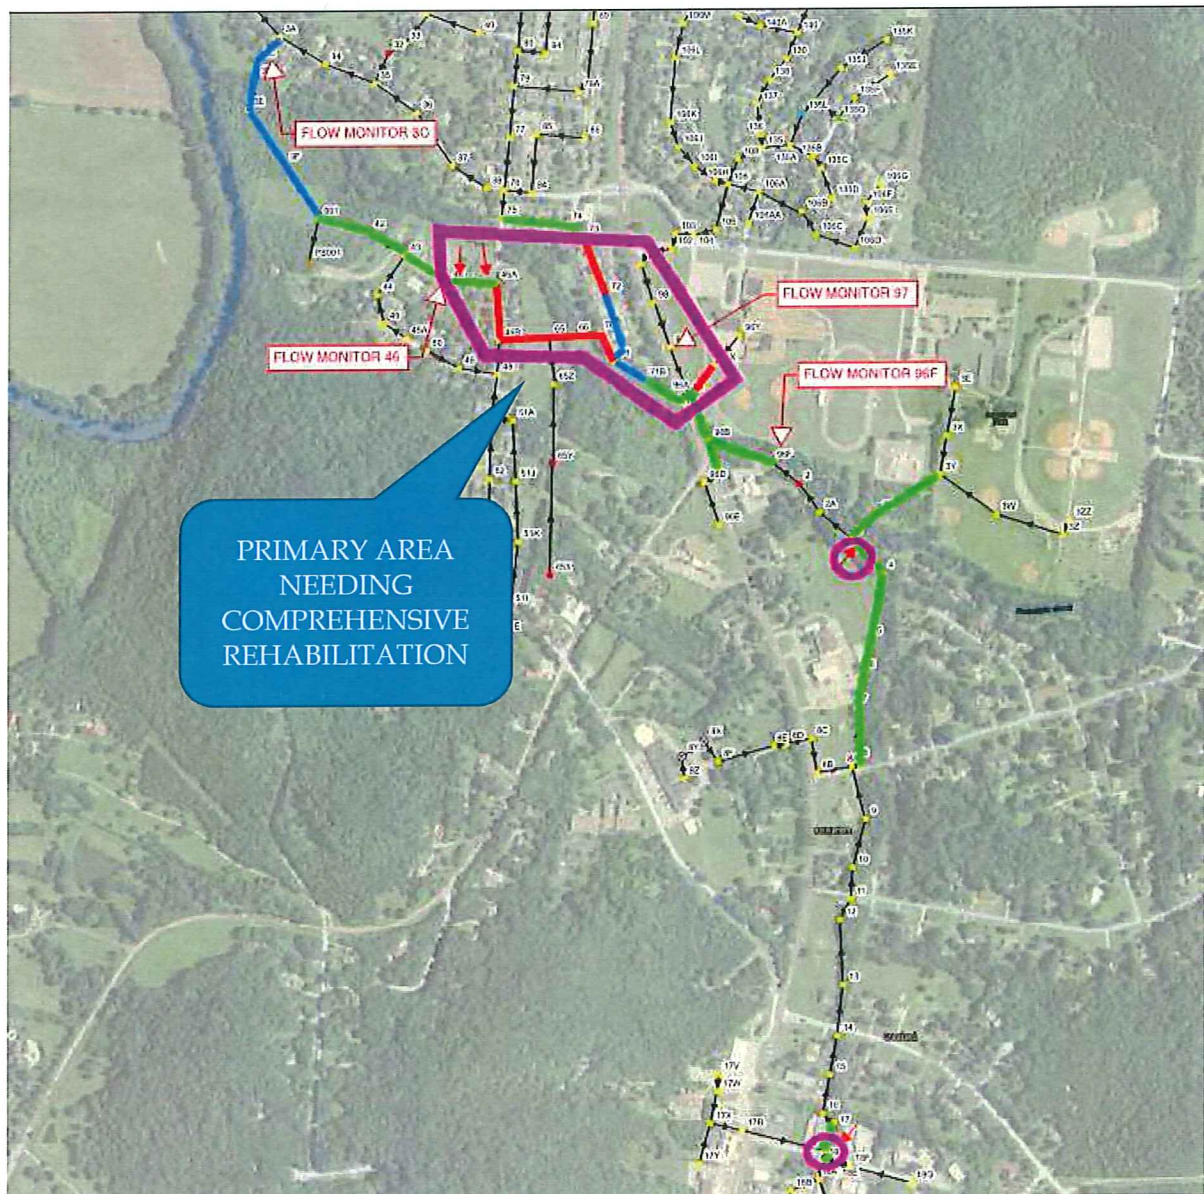
As stated previously, typical “find and fix” strategies often meet with limited success. IDG recommends a “Basin Approach” to comprehensively renew the collection system in the most problematic areas. In this instance, Basin 46 is the primary area of concern:

Two other smaller areas, involving a service line repair and manhole repairs, also need repairs, and they are circled in pink above.

For repair of the main lines, we recommend cured-in-place lining (CIPP), not unlike what has been completed before in the system. There are several qualified contractors currently working in Brentwood, Metro Nashville, and Dickson, so obtaining good pricing should be relatively straightforward. A summary table of the proposed work is included below:
