Re: Tennessee Public Utility Commission ("TPUC" or the "Commission"), Docket No. 24-00050, *Petition of Tennessee Wastewater Systems, Inc. to Amend Its Certificate of Convenience and Necessity to Include Star Creek and Hyde Park in Williamson County Tennessee*

## ATTACHMENT A

**RE: Compliance Evaluation Inspection and Notice of Violation**  
Tennessee Wastewater Systems, Inc.  
Permit #SOP-11014  
Montgomery County

**Report on the Performance of Wastewater Systems Utilizing Drip Dispersal in Tennessee**

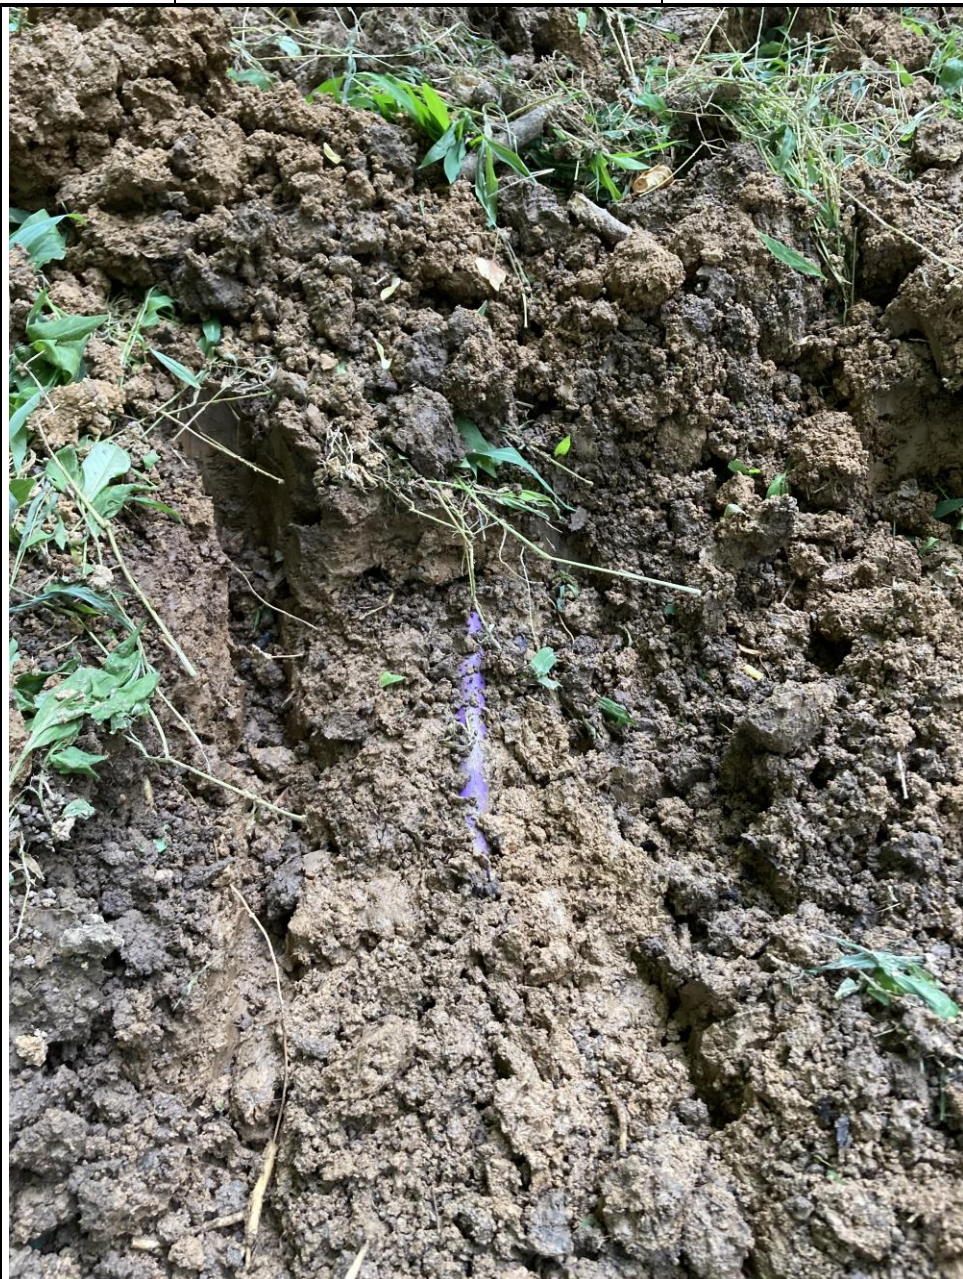
<b>Client or Facility Name:</b> Tennessee Wastewater Systems, Inc.		<b>Site Location:</b> Maple Green	<b>Permit No.:</b> SOP 01028
<b>Photo No.</b> 2	<b>Date</b> 7-3-2024

The drip field had numerous instances of ponding water, saturated soils, visible purple pipe, evidence of overland flow, and bare vegetation spots. The field is partially wooded. The wooded area was difficult to inspect due to woody briars and thorny vegetation. Numerous fallen trees are on drip lines, leaving large soil divots where the root balls had been pulled from the ground exposing purple pipe. Tree roots also have pushed the purple pipe up from the soil and pinched the lines. Numerous recently repaired areas were obvious and purple pipe was still visible in one of the repair areas which was pointed out to Mr. Nichols at the time of inspection.

<b>Description</b> Photo of visible purple pipe. Photo taken by Mrs. Christina Wingett with State issued iPhone.

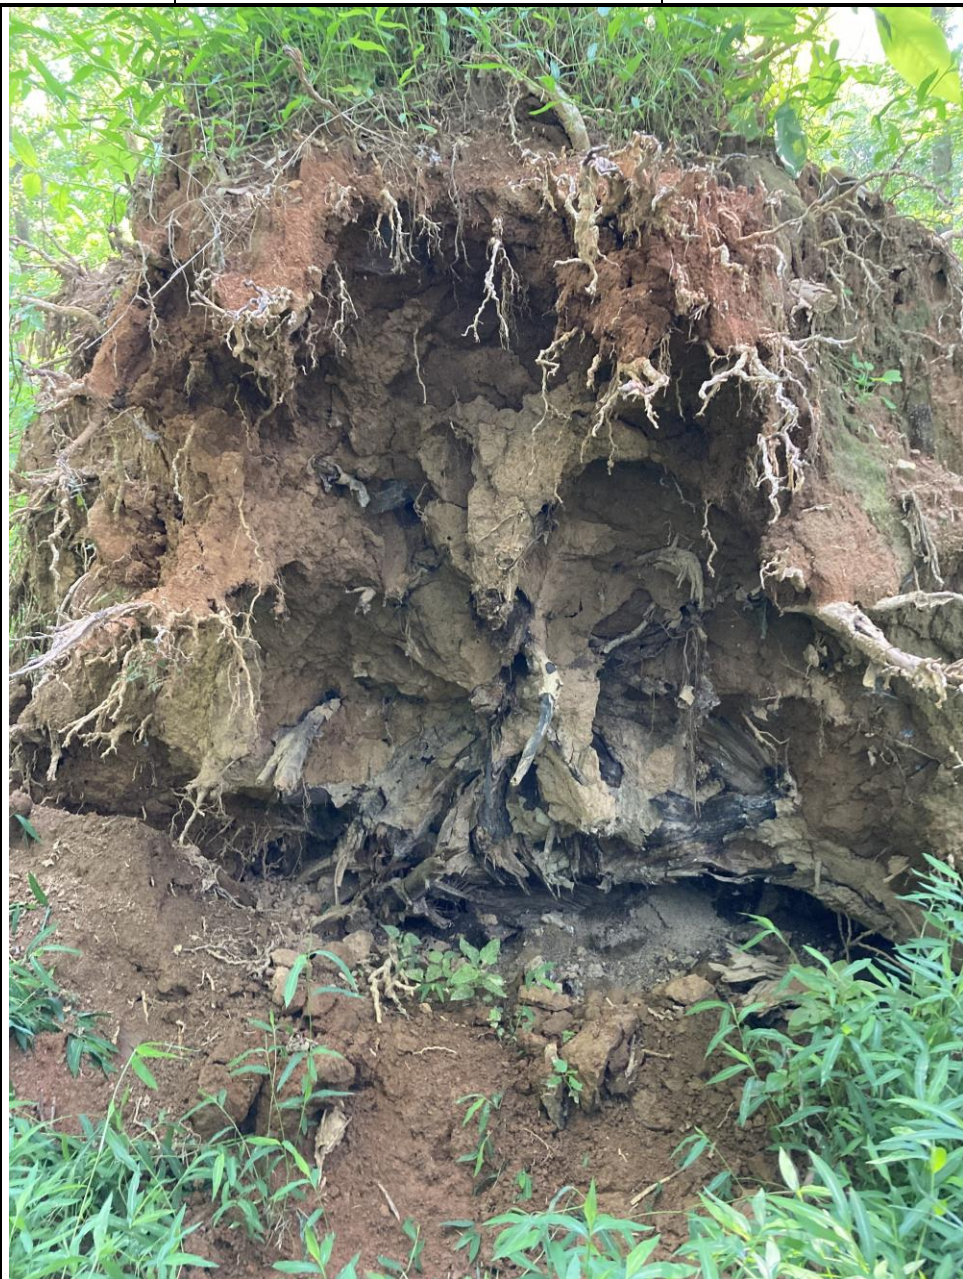
<b>Client or Facility Name:</b> Water/Wastewater Authority of Wilson County		<b>Site Location:</b> Sunset Harbor	<b>Permit No.:</b> SOP 05019
<b>Photo No.</b> 3	<b>Date</b> 7-3-2024

<b>Description</b> Photo of uprooted tree, purple pipe pulled from ground as shown in Photo 4. Photo taken by Mrs. Christina Wingett with State issued iPhone.

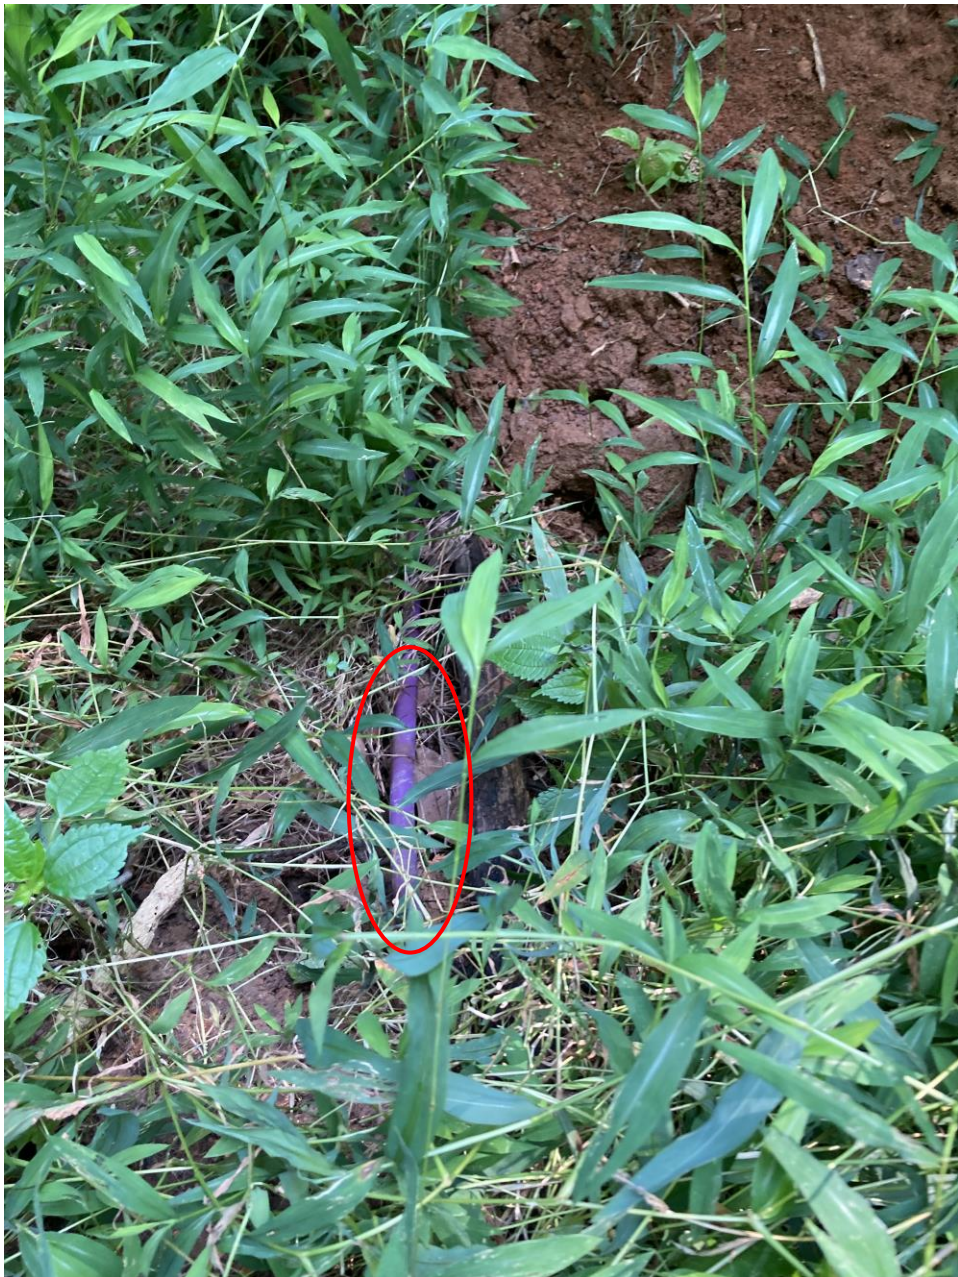
<b>Client or Facility Name:</b> Tennessee Wastewater Systems, Inc.		<b>Site Location:</b> Maple Green	<b>Permit No.:</b> SOP 01028
<b>Photo No.</b> 4	<b>Date</b> 7-3-2024

<b>Description</b> Photo of uprooted tree, purple pipe pulled from ground as shown in Photo 3. Photo taken by Mrs. Christina Wingett with State issued iPhone.

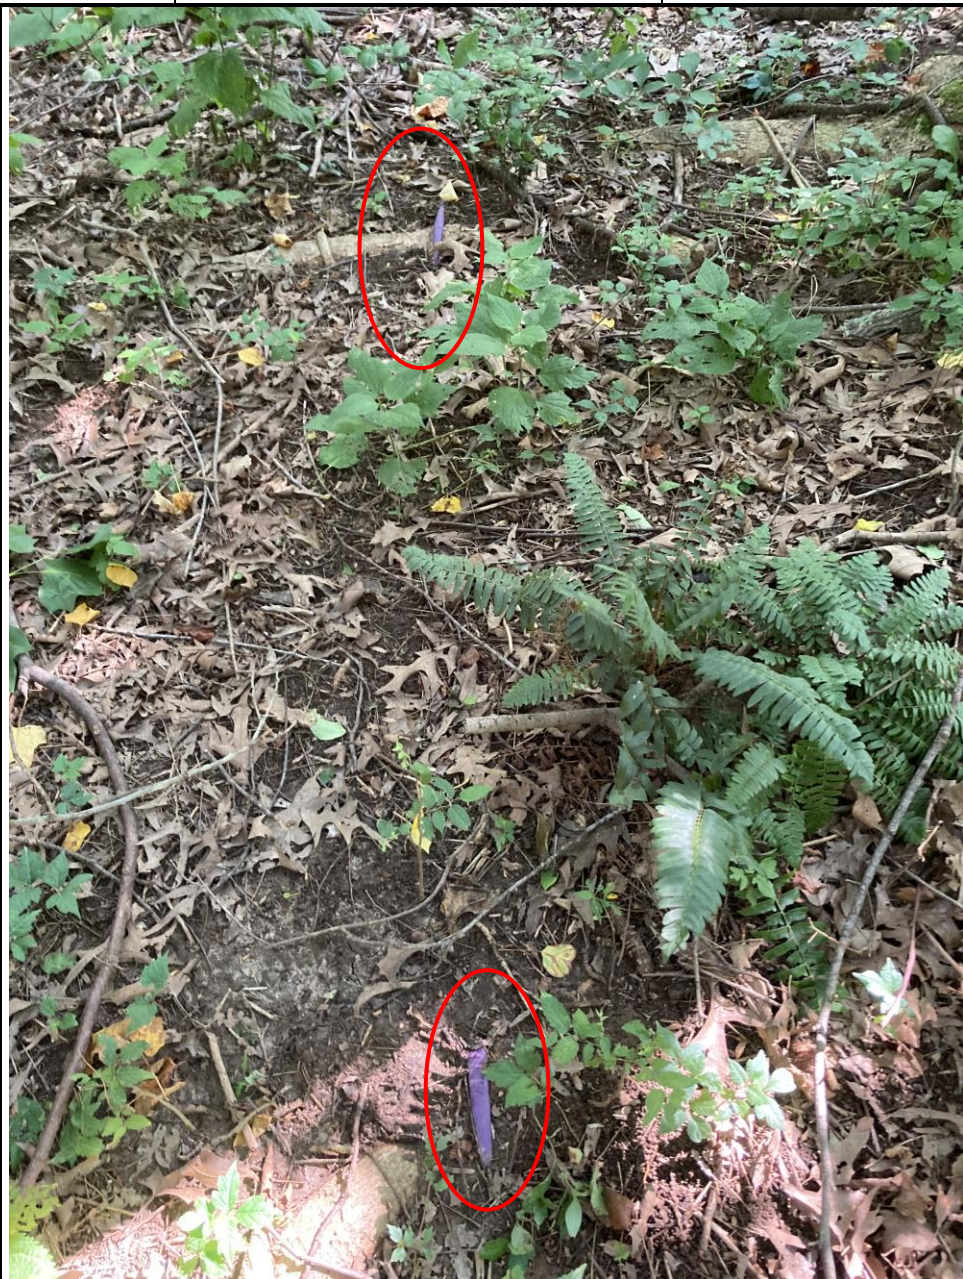
<b>Client or Facility Name:</b> Water/Wastewater Authority of Wilson County		<b>Site Location:</b> Sunset Harbor	<b>Permit No.:</b> SOP 05019
<b>Photo No.</b> 5	<b>Date</b> 7-3-2024

<b>Description</b> Photo of tree roots pushing up and restricting drip lines (purple pipe). Photo taken by Mrs. Christina Wingett with State issued iPhone.

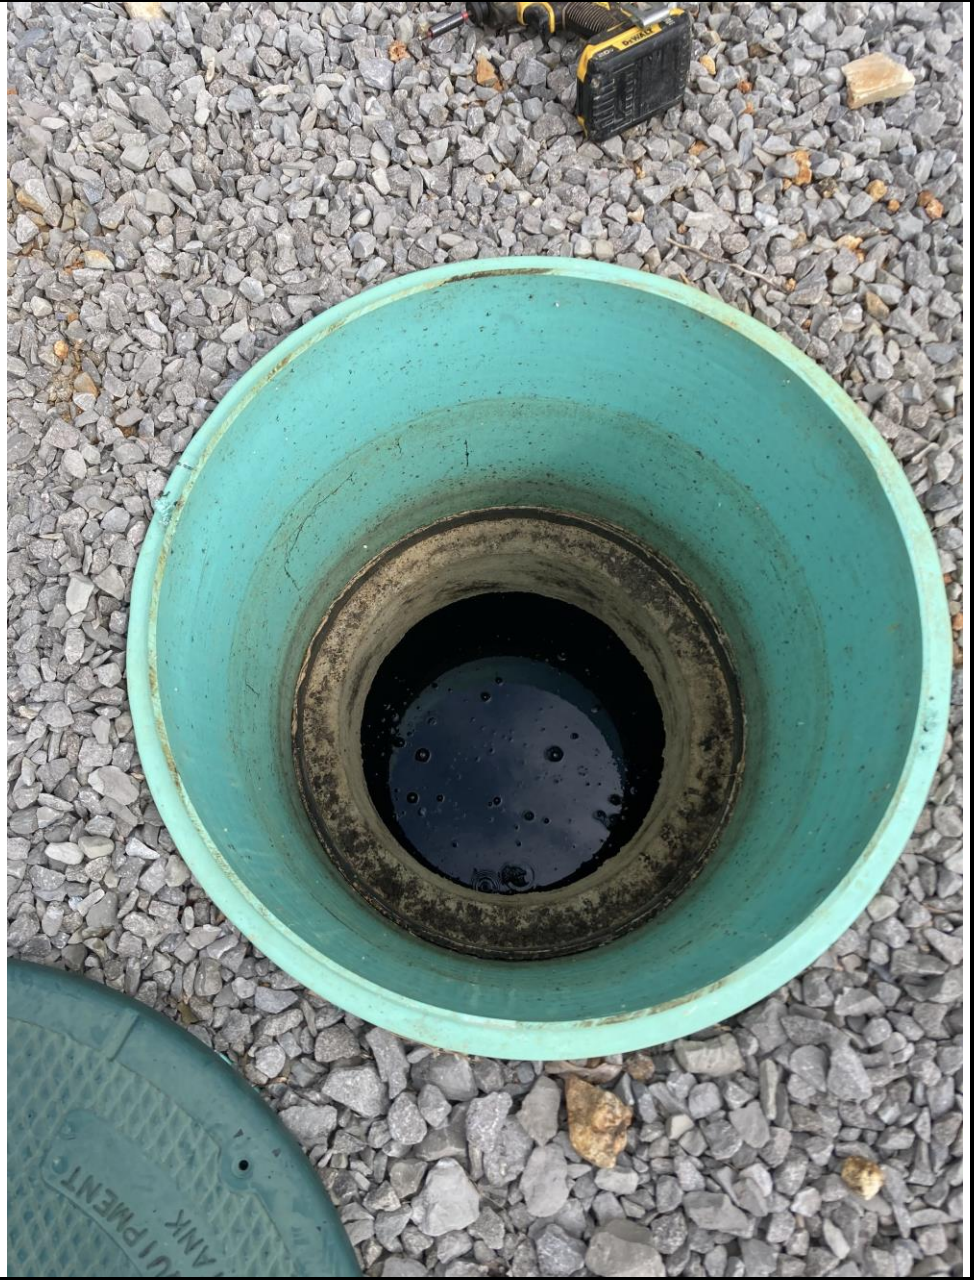
Client or Facility Name:		Site Location:	Permit No.:
Tennessee Wastewater Systems, Inc.		Maple Green	SOP 01028
Photo No.	Date

6	7-3-2024		
Description			
Oil sheen visible in effluent tank. Photo taken by Mrs. Christina Wingett with State issued iPhone.

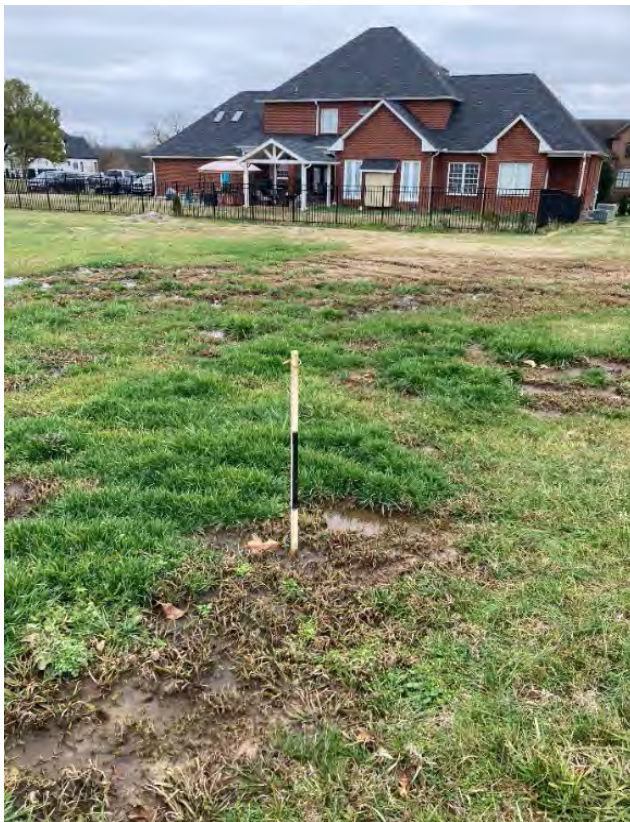
uniform striping in Photo 2 with uptake of nutrients through the grass as compared to Photo 1 with indistinct green areas along with areas where the vegetation is distressed or dead. These systems are in areas of the state with similar soil conditions, they both serve subdivisions, and they are a similar age (~18 years old). Yet, they demonstrate remarkably different performance. The system in Photo 2 reflects achievement of the design objective and does not indicate any evidence of permit noncompliance; whereas the system in Photo 1 does not comply with permit conditions and is not meeting the design objective. The Division, and others, are striving to understand the cause(s) of the disparity illustrated by this example.

Photo 1. Dysfunctional Land Application Area

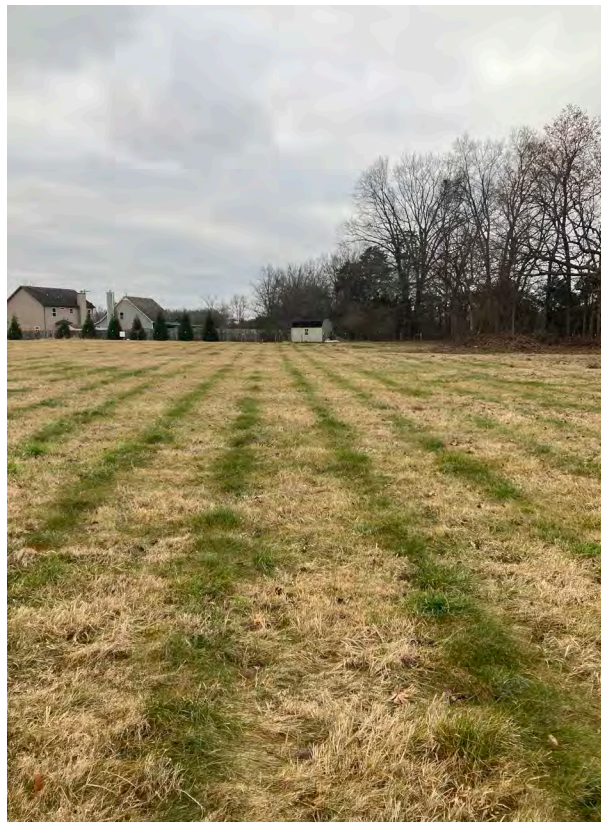
Photo 2. Functional Land Application Area

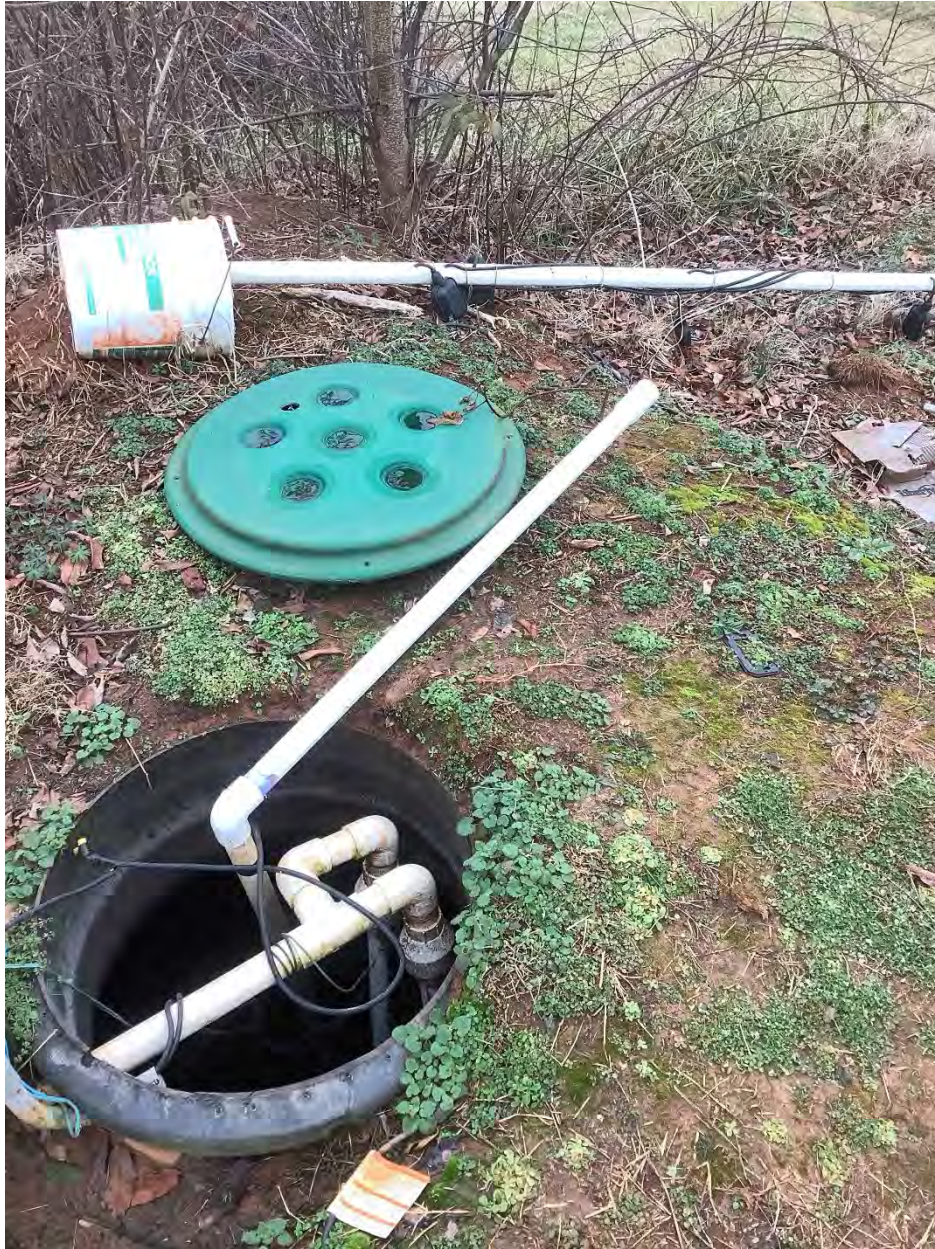
X2. Wastewater effluent being directed to adjacent ditch rather than the drip field.

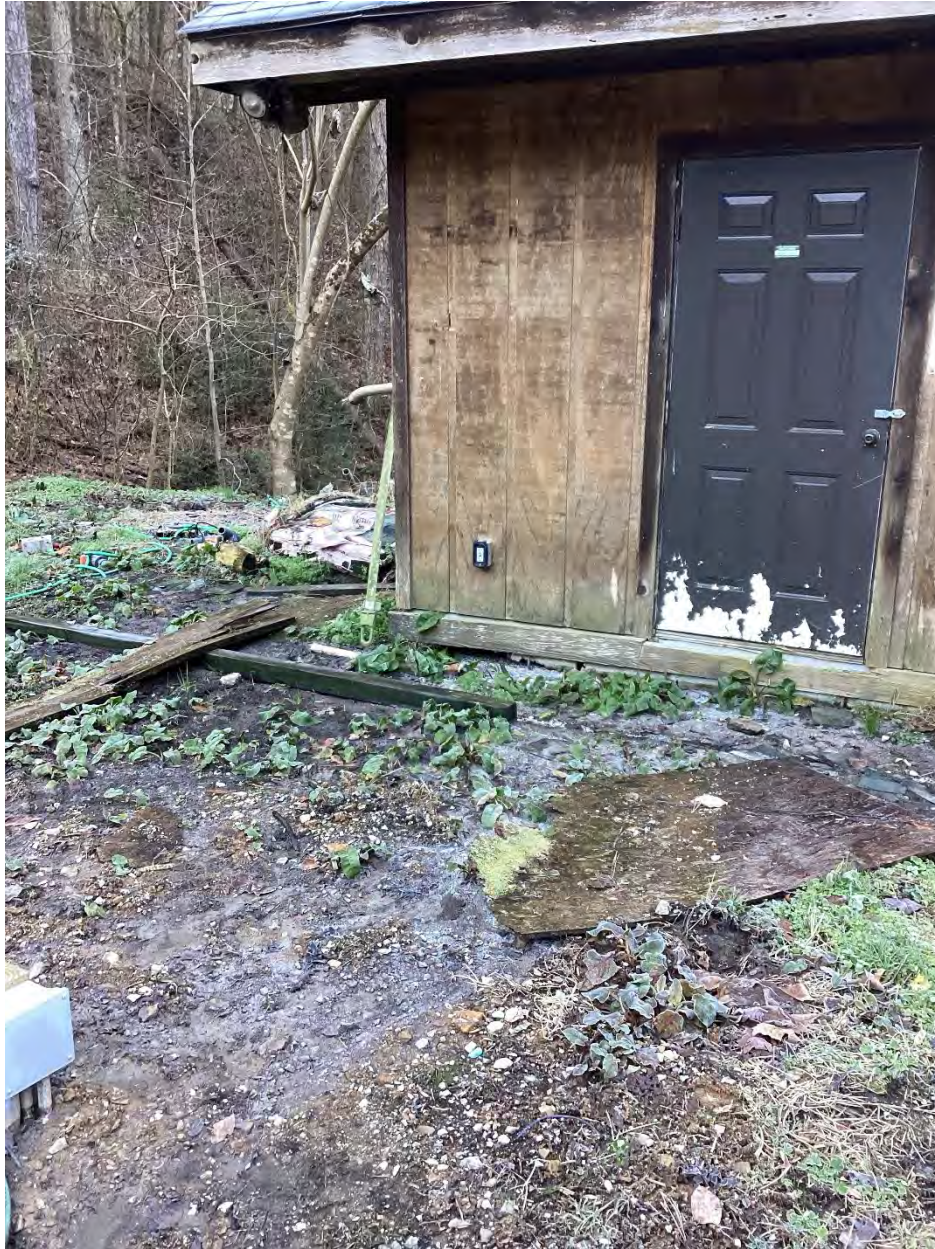
X2. Wastewater effluent being discharged from the control building rather than to the drip field.

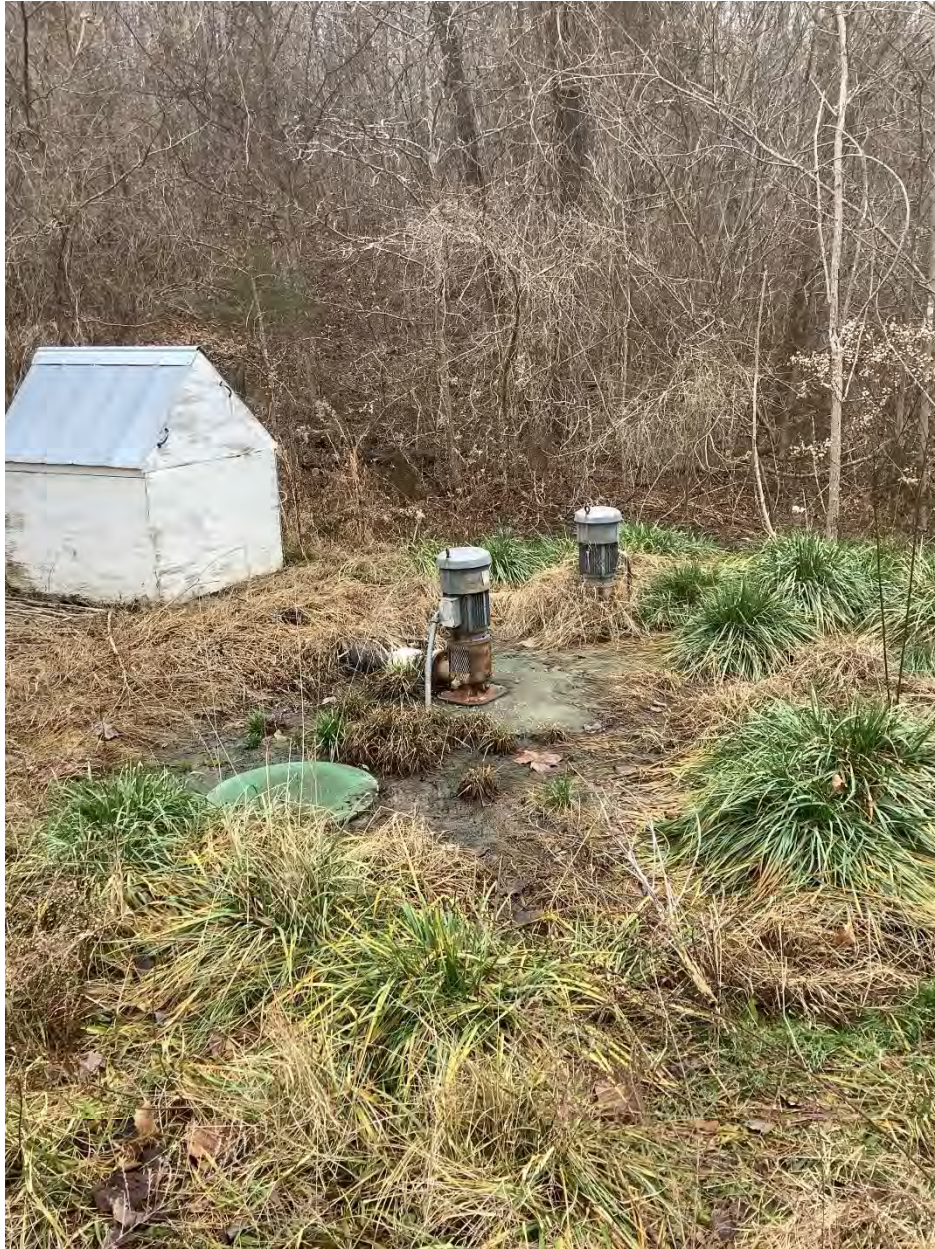
X2. Wastewater effluent being discharged from the pump vaults rather than to the drip field.

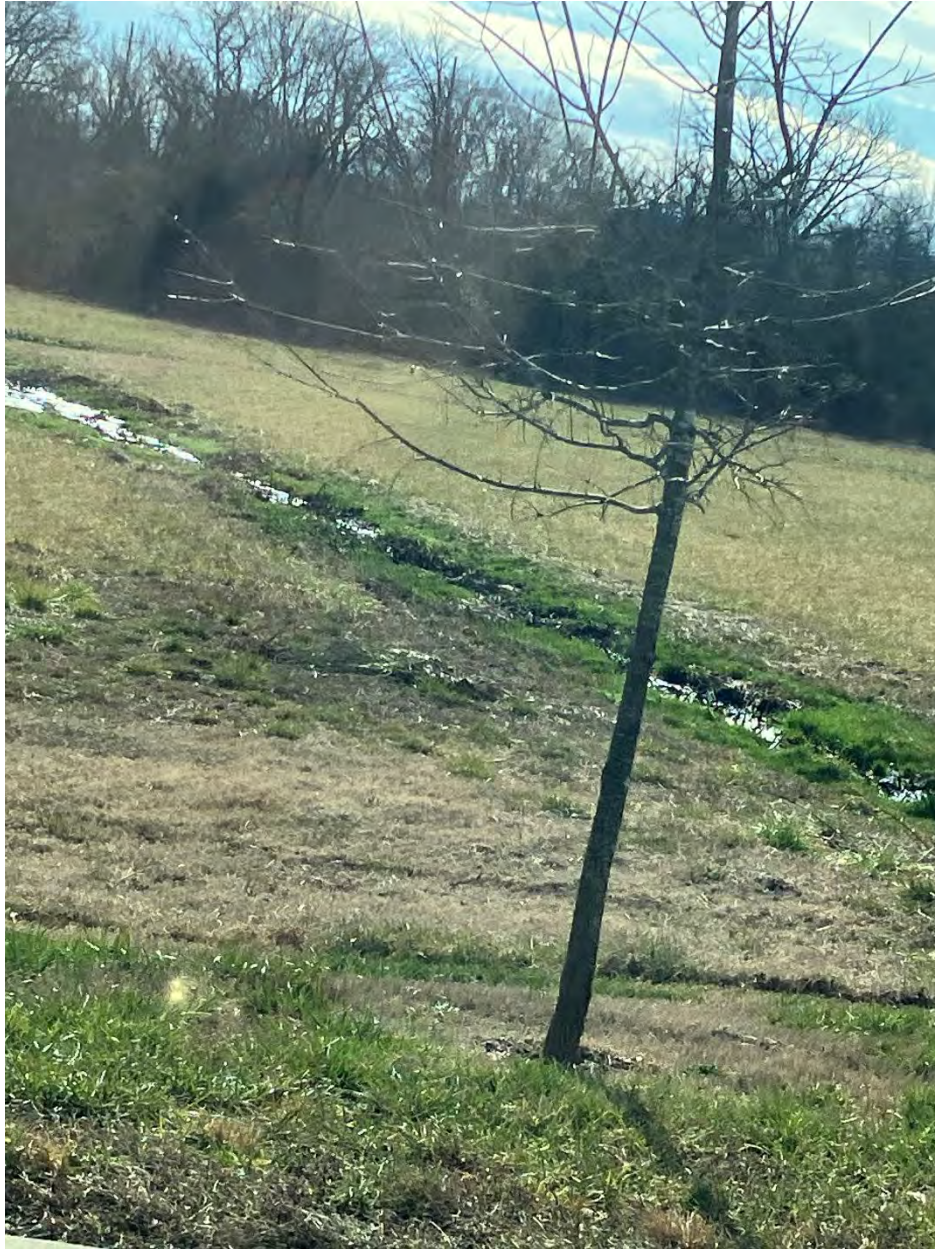
X2. Wastewater effluent being discharged from the sand filter rather than to the drip field.

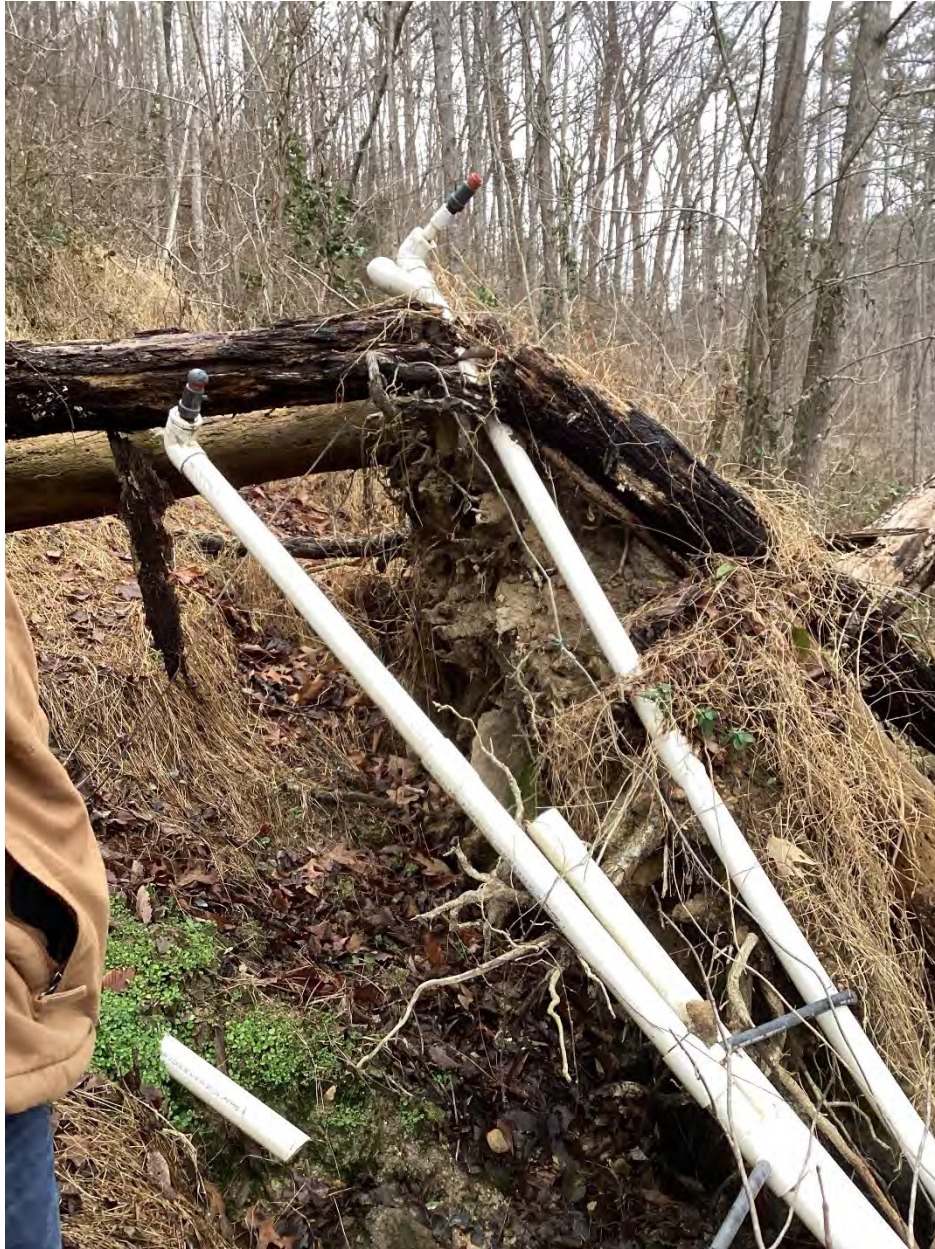
X3. Infrastructure piping unearthed and disconnected by uprooted tree.

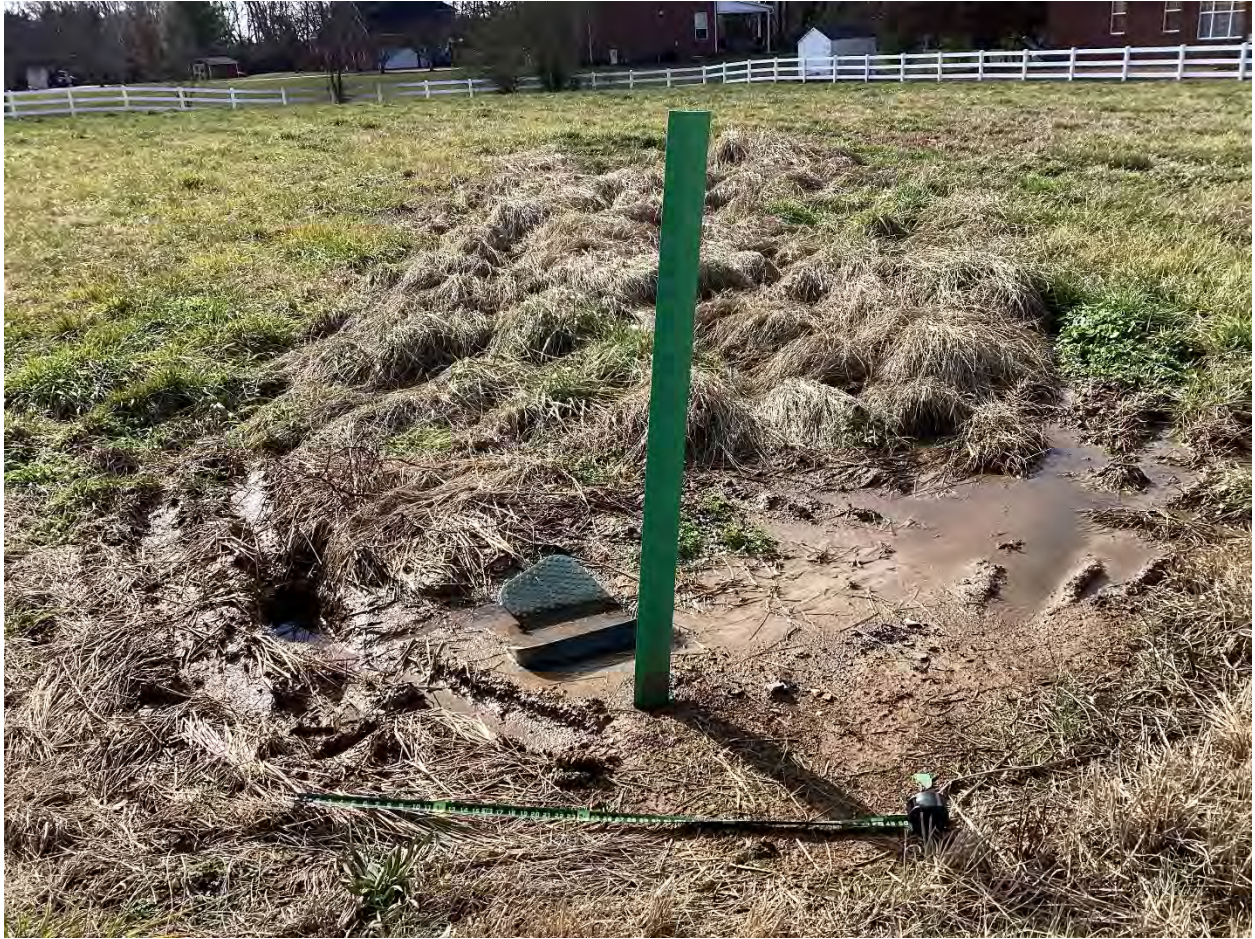
X3. Infrastructure piping failure allowing extensive effluent release.

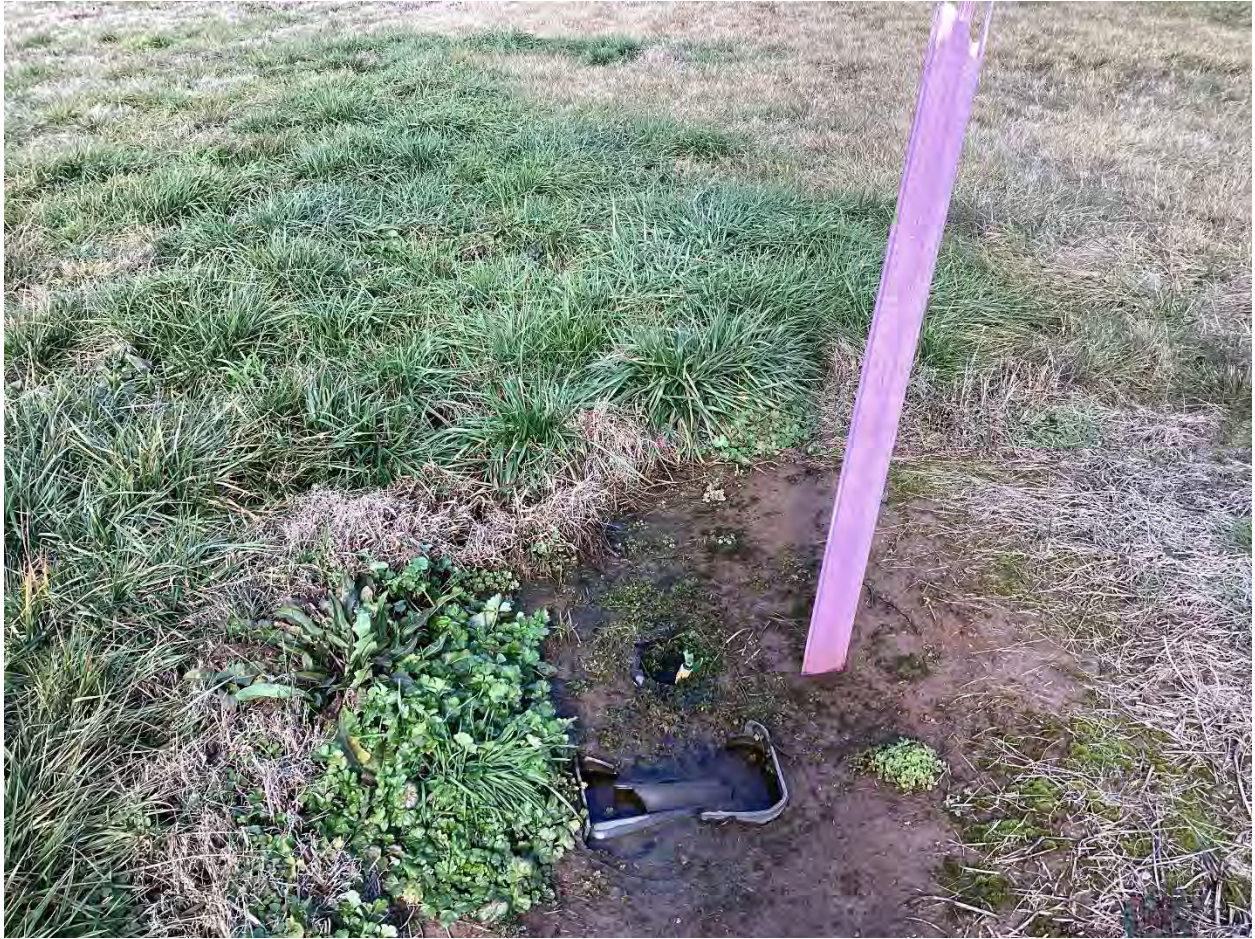
A2a. Localized saturation/ponding. Likely associated with a damaged valve.

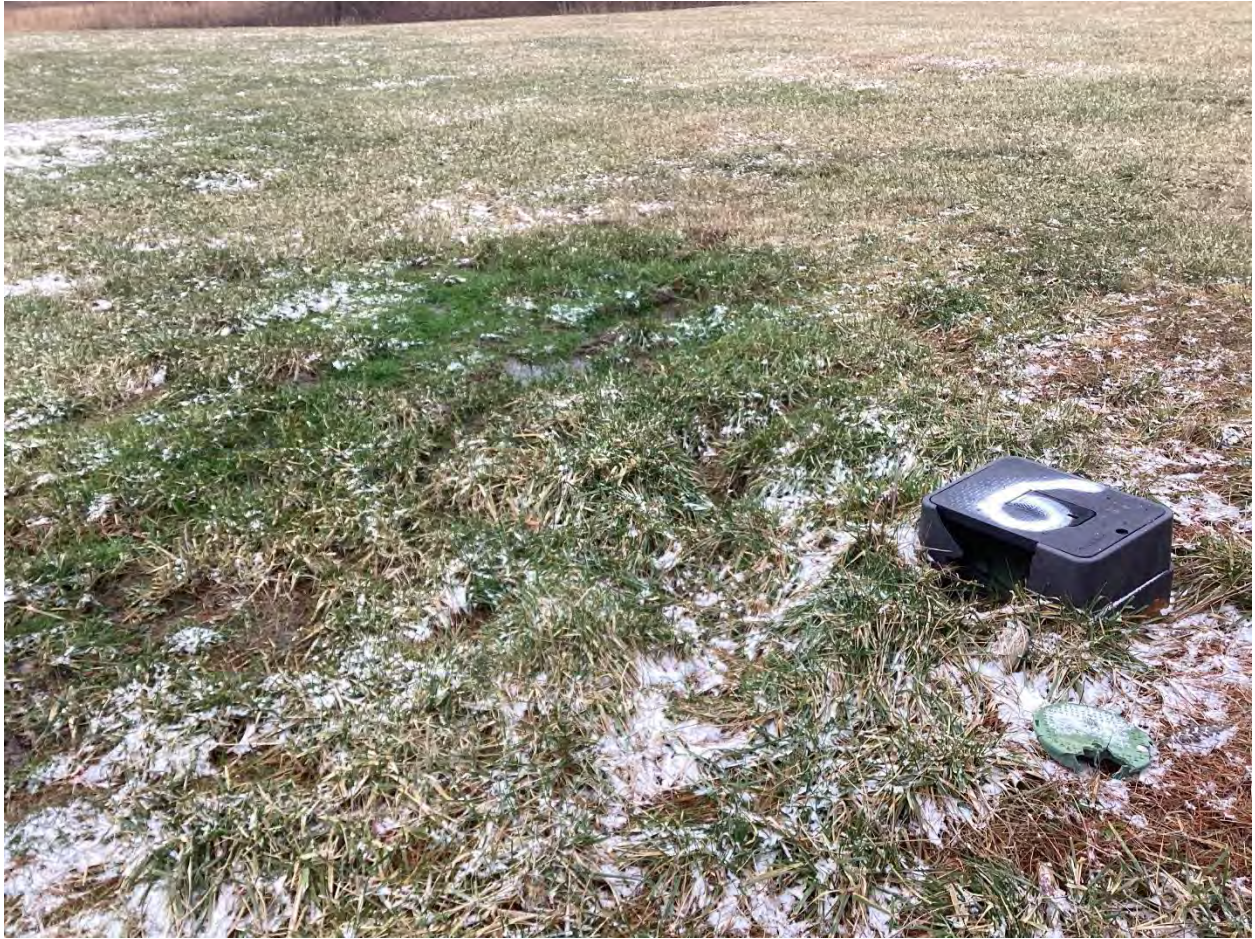
A2a. Localized saturation/ponding. Likely associated with a failed emitter.

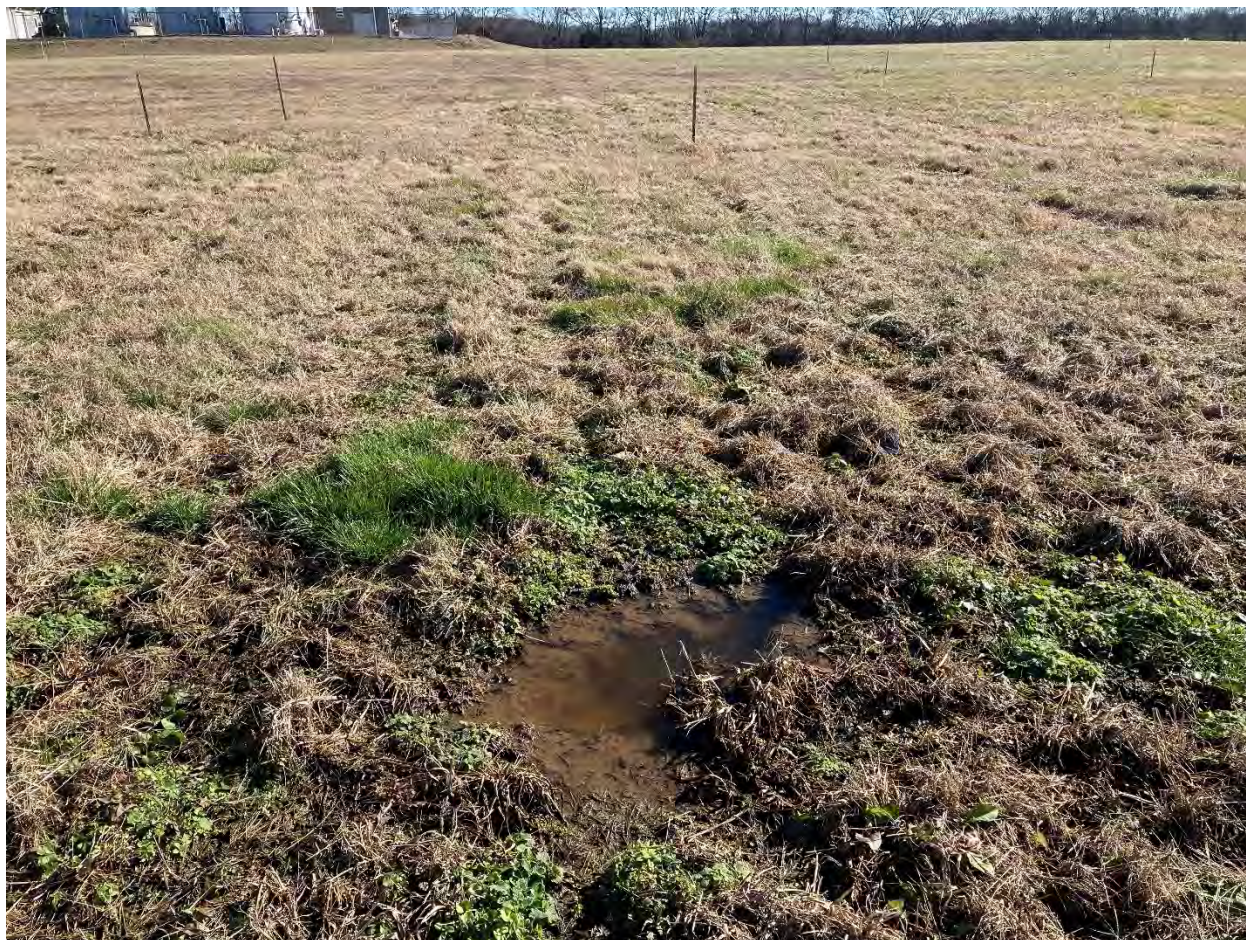
A2a. Localized saturation/ponding. Likely associated with a failed emitter or damaged line.

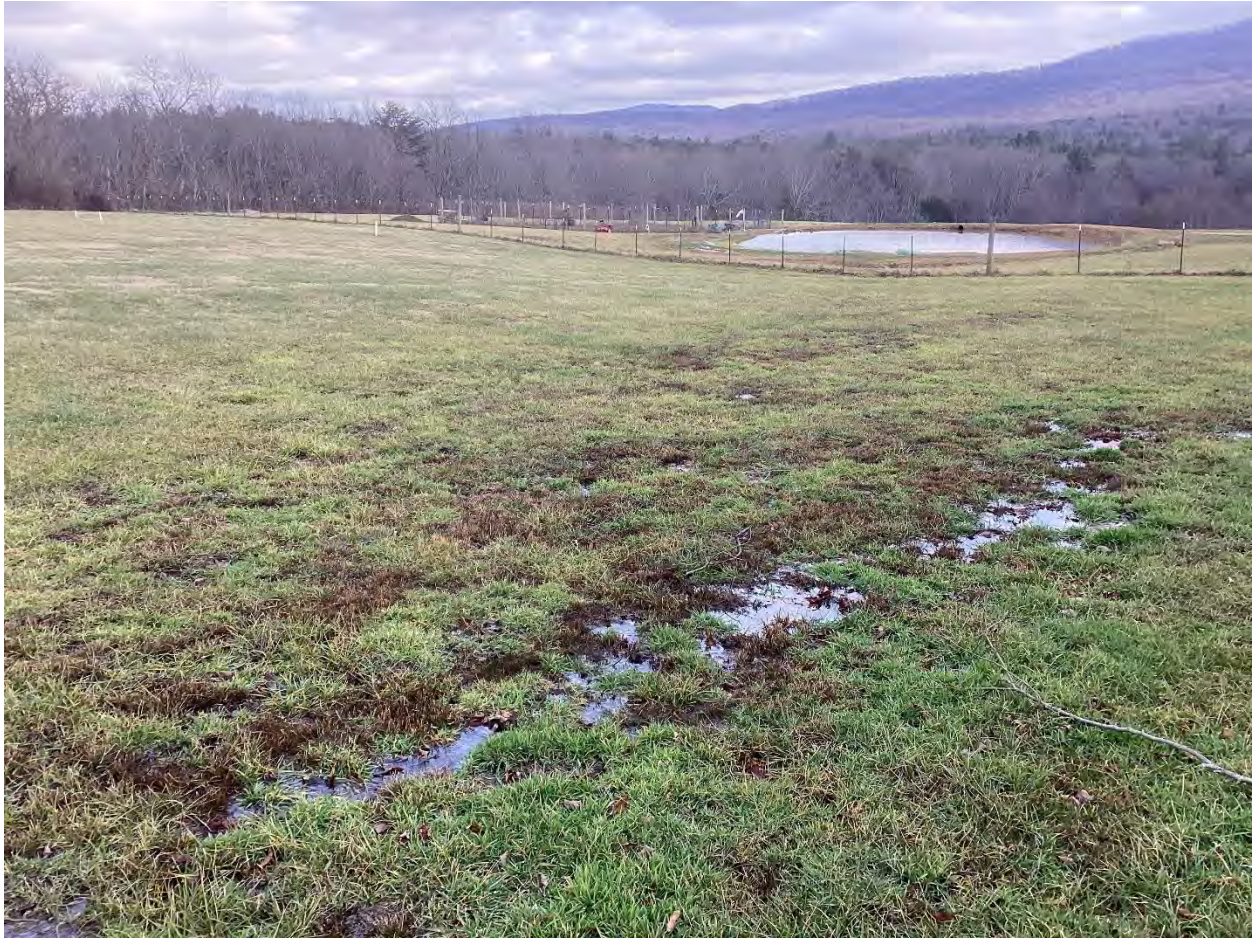
A2b. Extensive saturation/ponding.

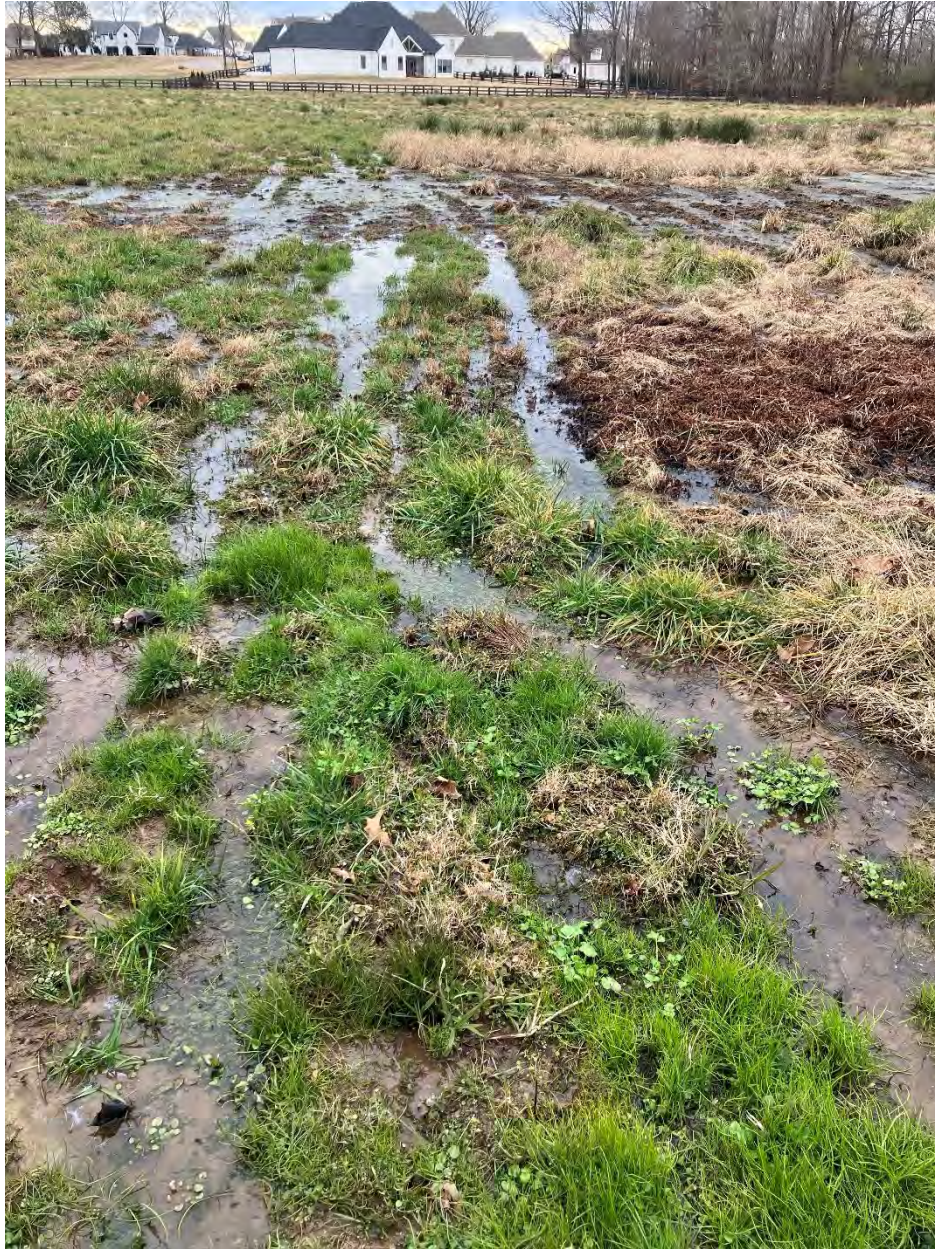
A2b. Extensive saturation/ponding.

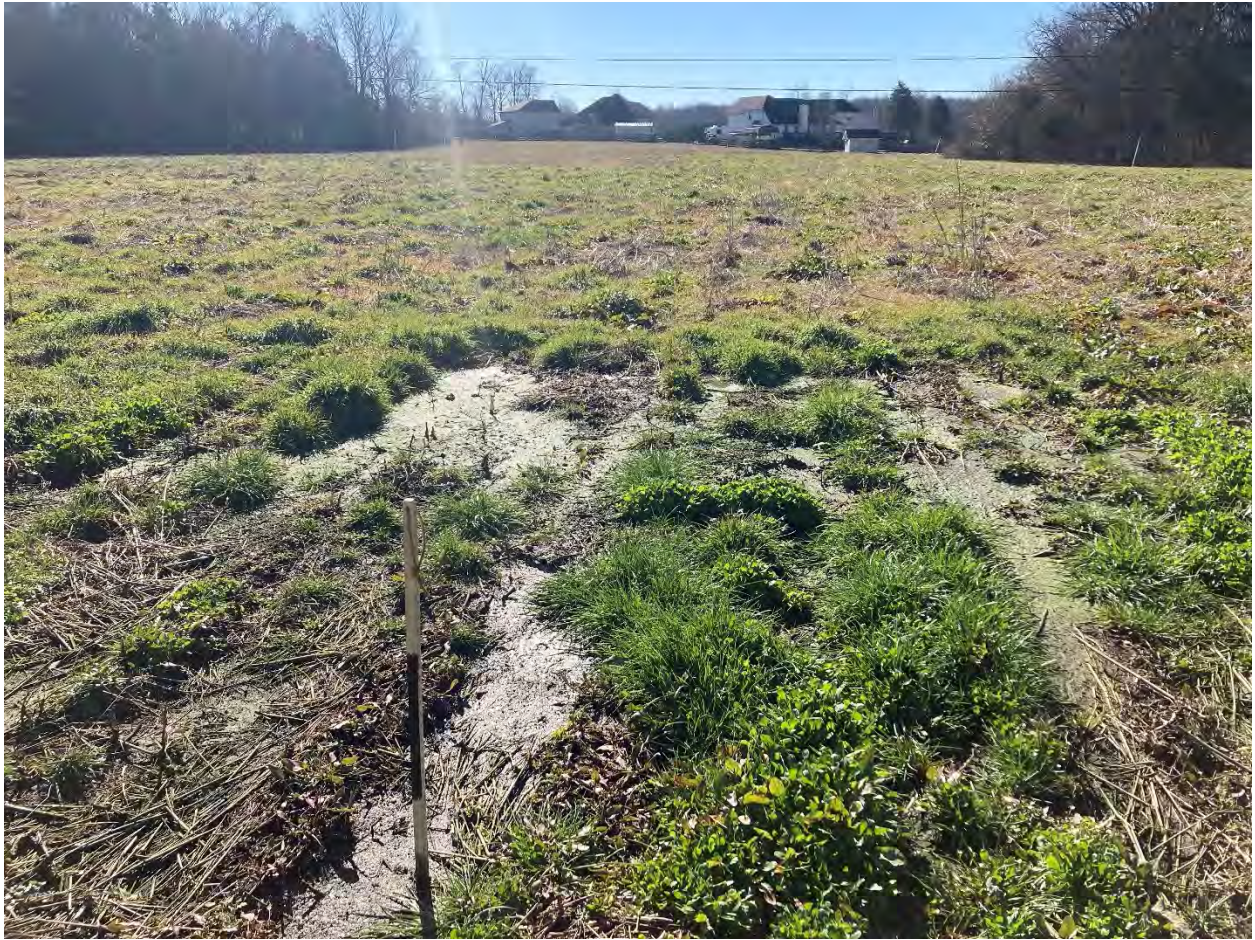
A2b. Extensive saturation/ponding.
