Re: Tennessee Public Utility Commission ("TPUC" or the "Commission"), Docket No. 24-00050, *Petition of Tennessee Wastewater Systems, Inc. to Amend Its Certificate of Convenience and Necessity to Include Star Creek and Hyde Park in Williamson County Tennessee*

## ATTACHMENT A

**RE: Compliance Evaluation Inspection and Notice of Violation**  
Tennessee Wastewater Systems, Inc.  
Permit #SOP-11014  
Montgomery County

**Report on the Performance of Wastewater Systems Utilizing Drip Dispersal in Tennessee**

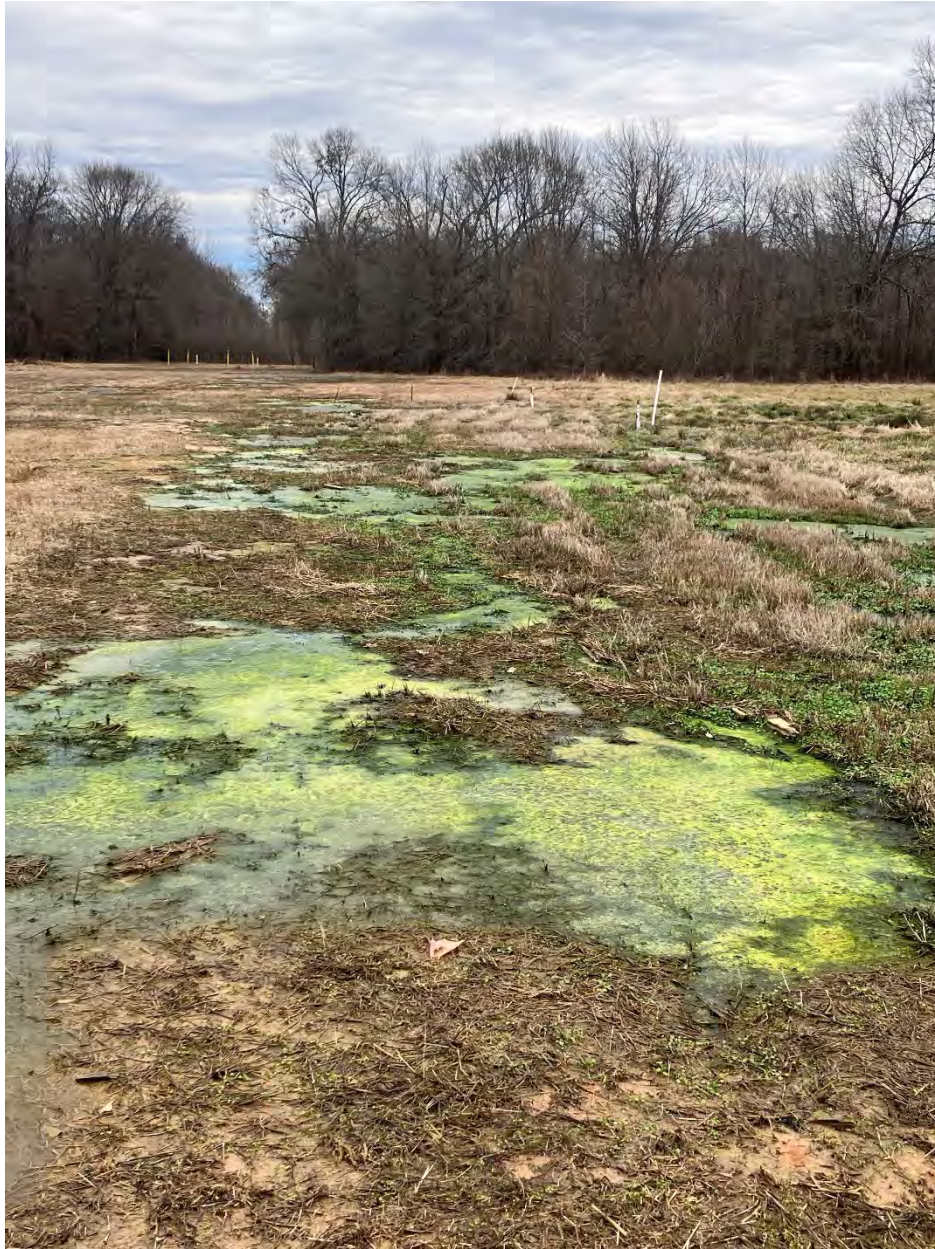
A2b. Extensive saturation/ponding.

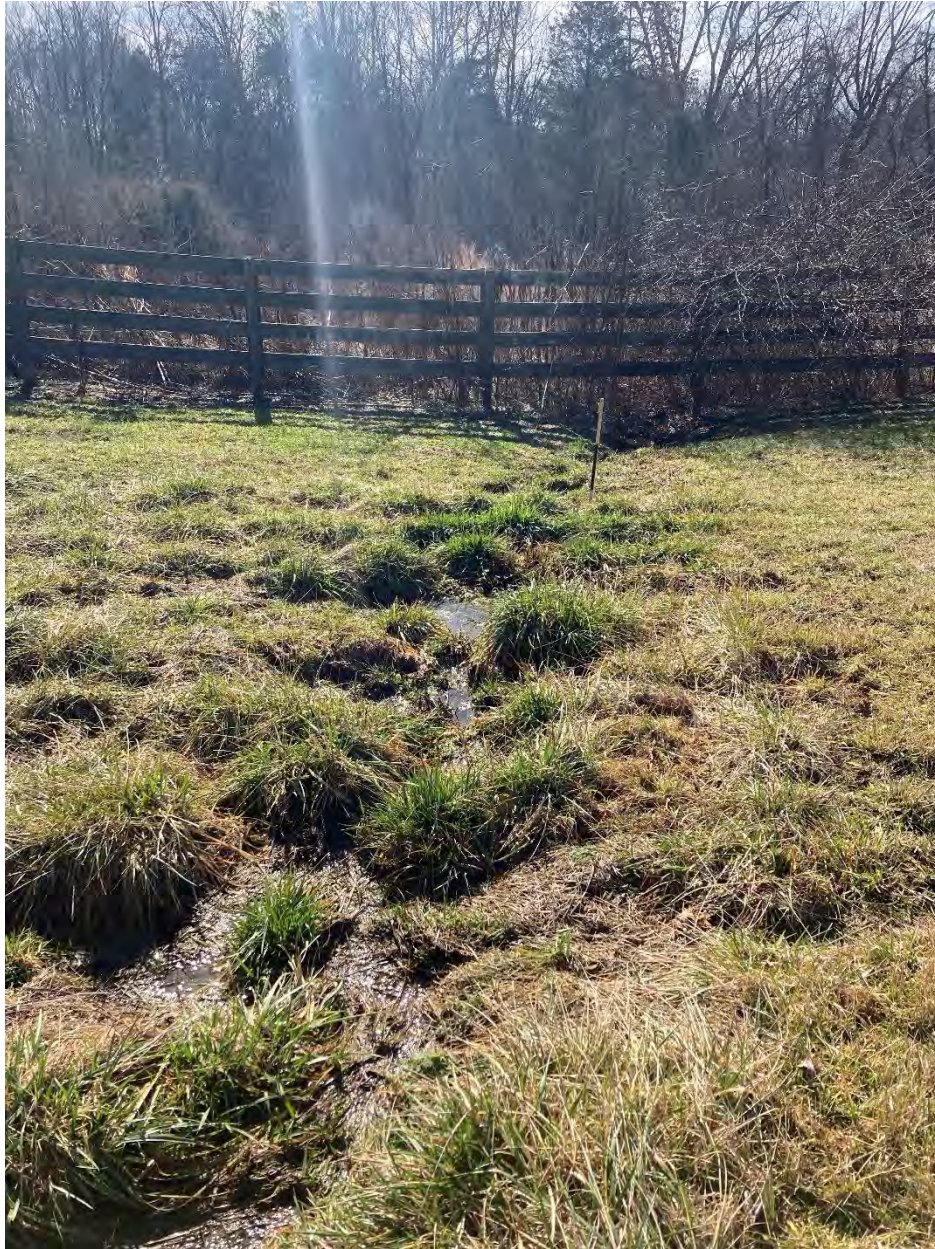
A2b. Extensive saturation/ponding including overland flow leaving the land application area.

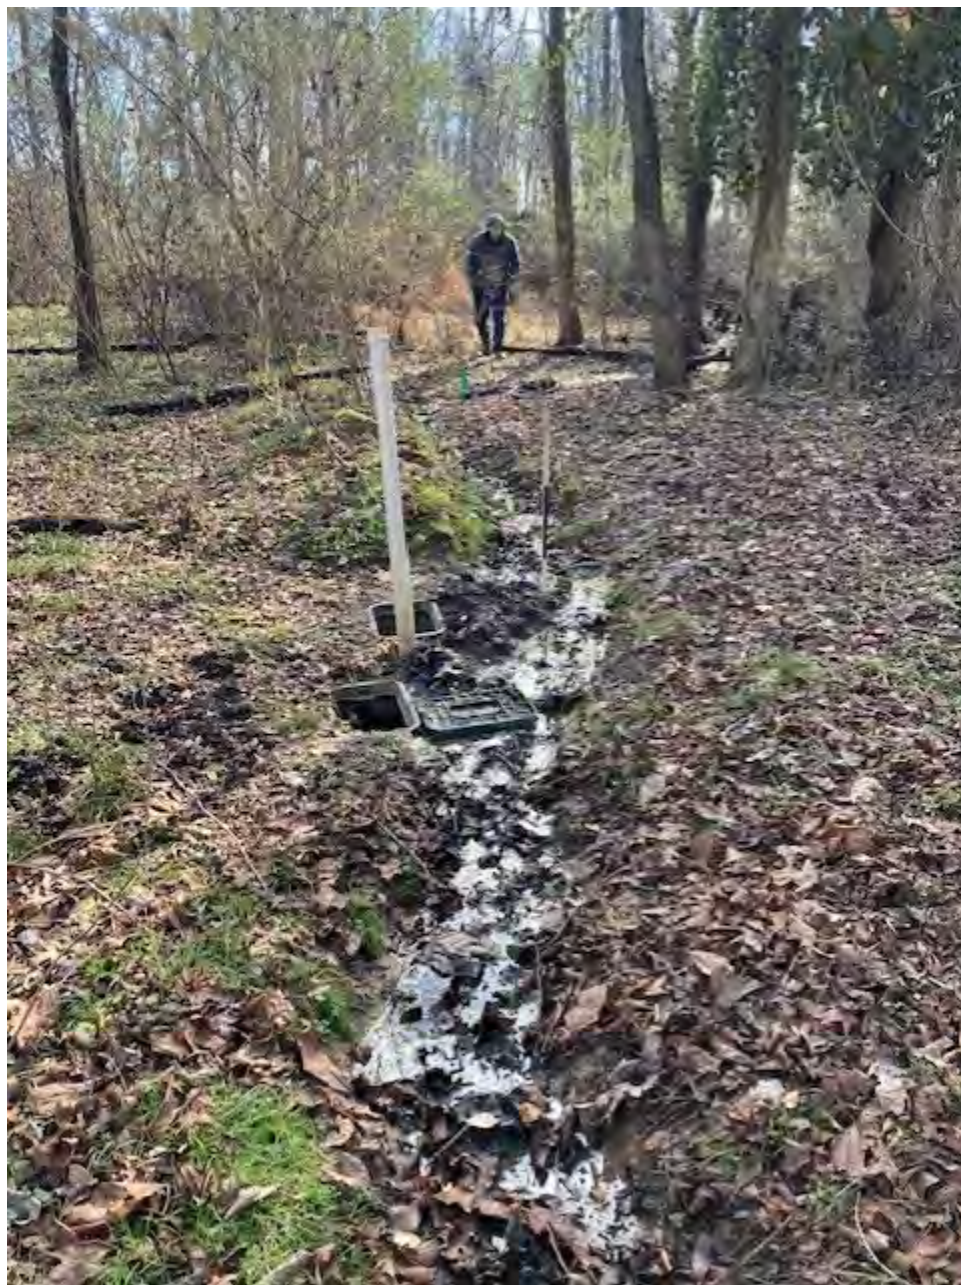
A2b. Extensive saturation/ponding including overland flow leaving the land application area.

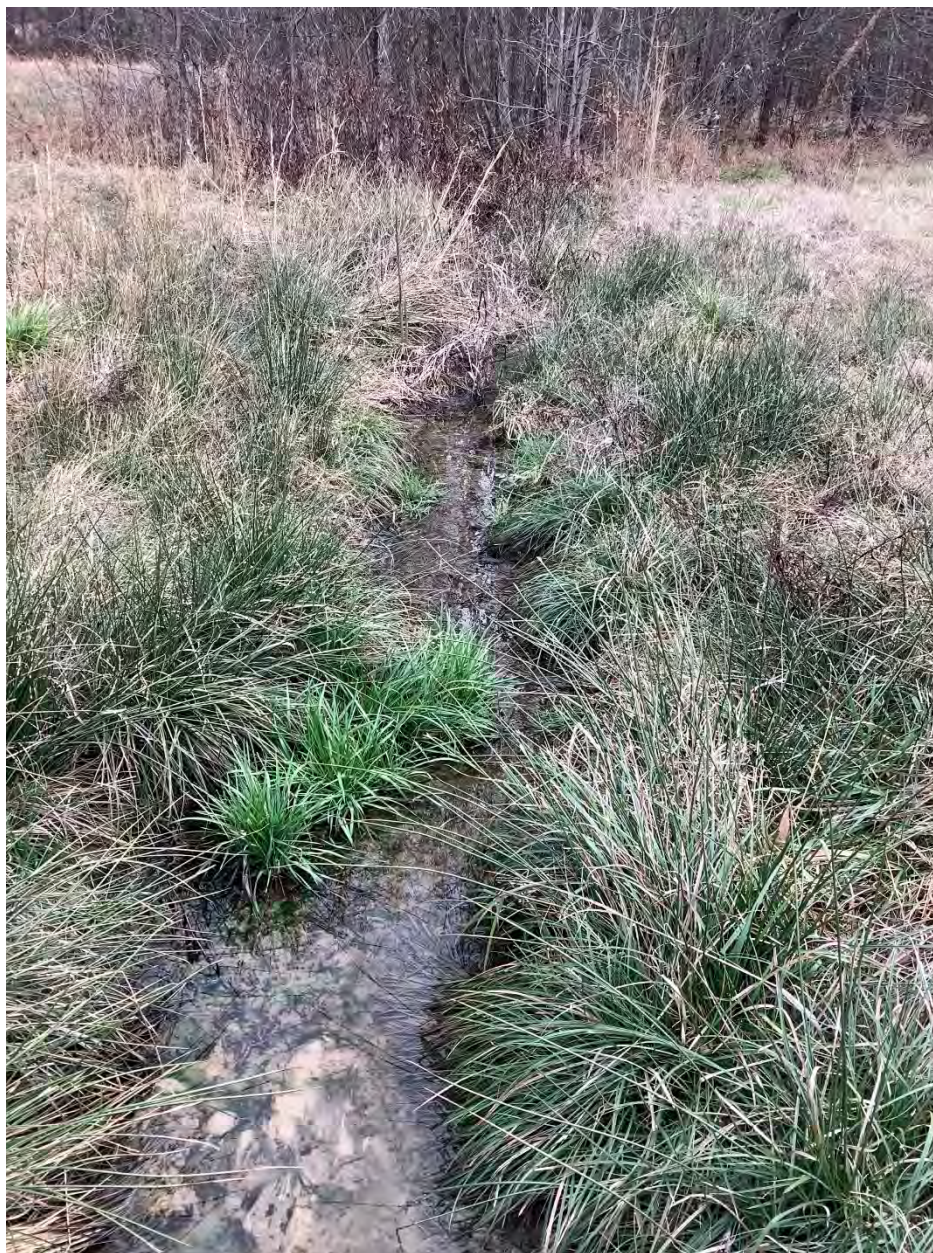
A2b. Extensive saturation/ponding including overland flow leaving the land application area and entering drainageways or surface water.

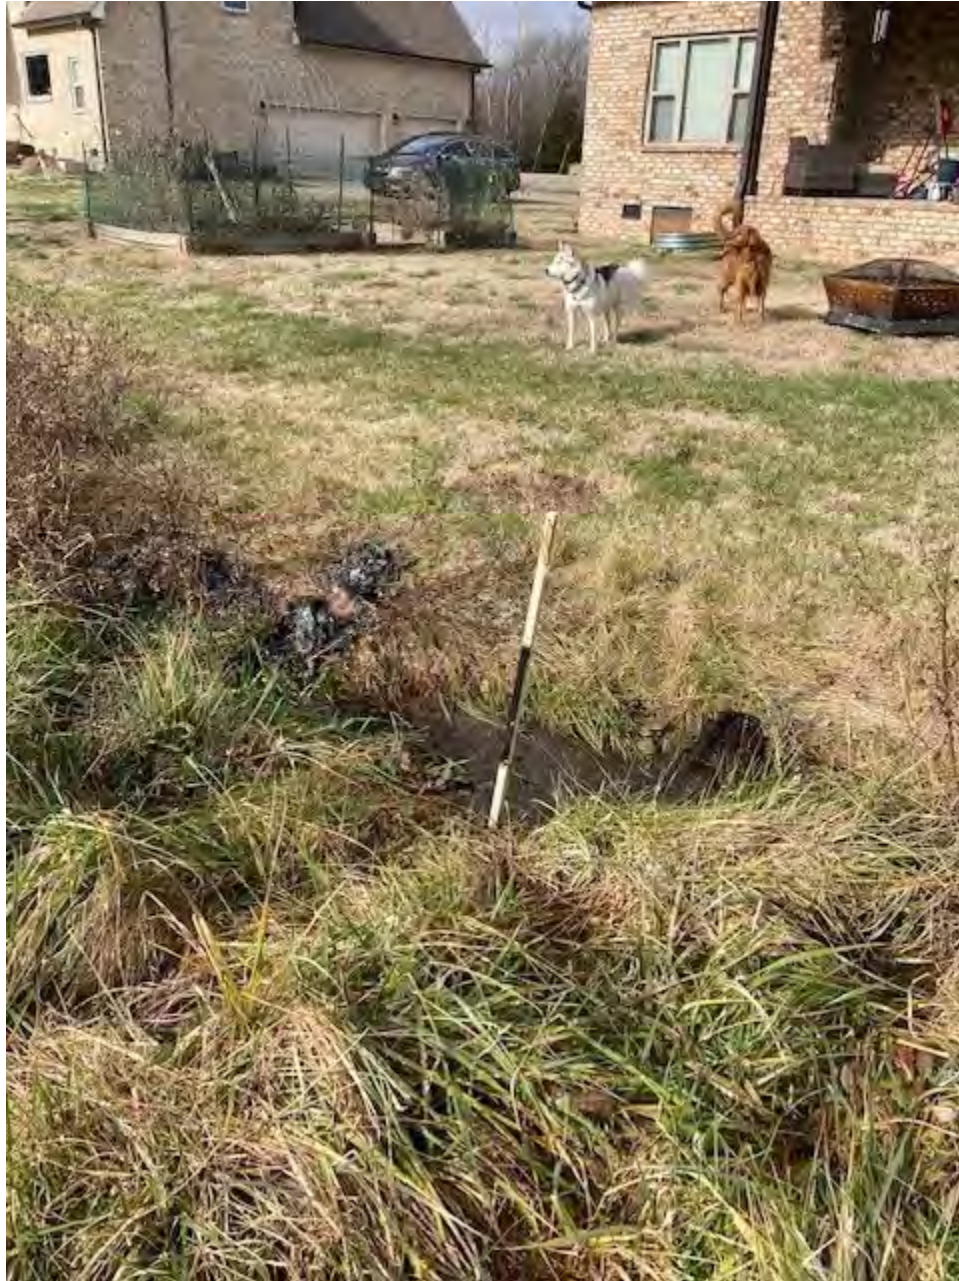
A2b. Extensive saturation/ponding including overland flow leaving the land application area and entering drainageways or surface water.

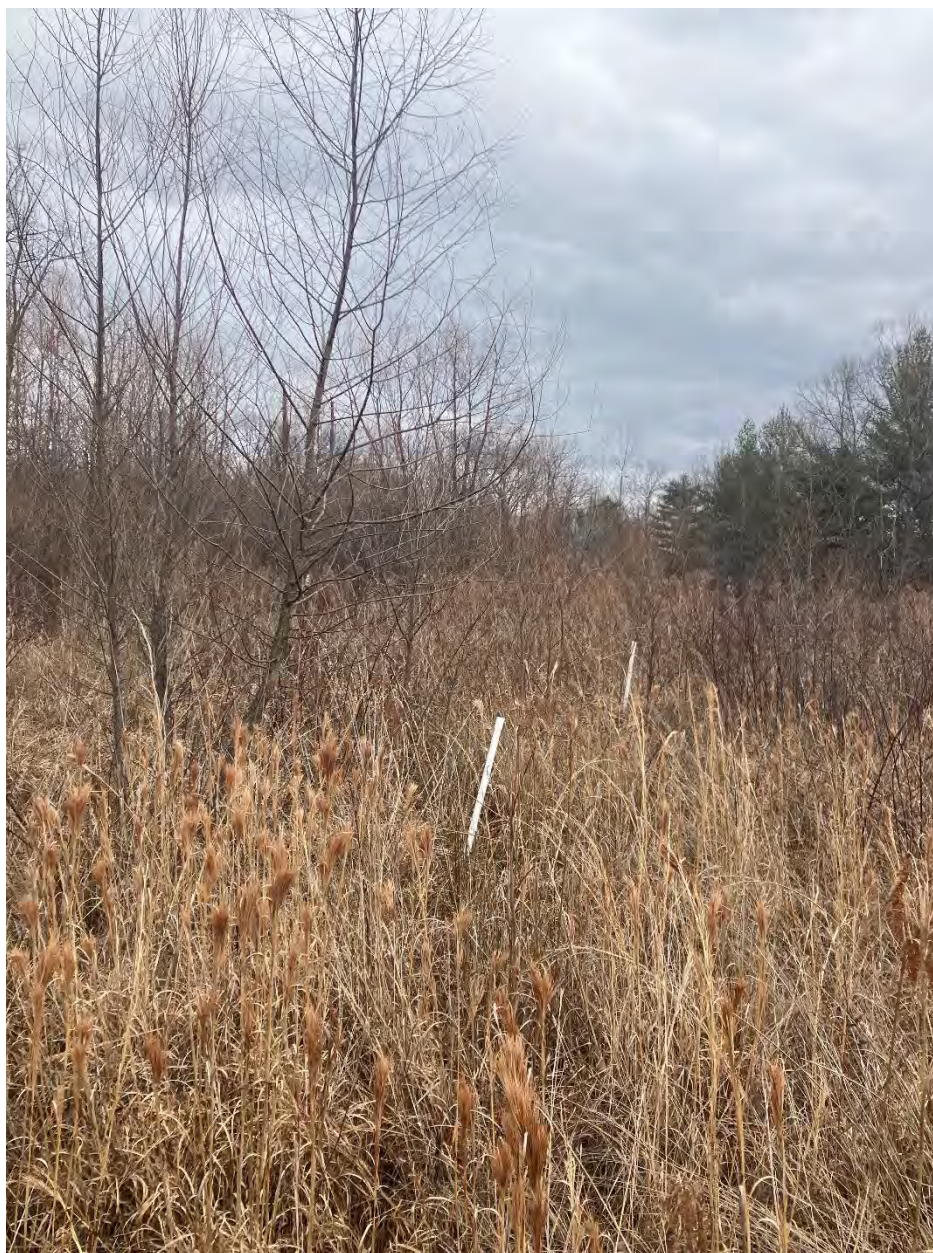
A3. Drip field covered in dense vegetation.

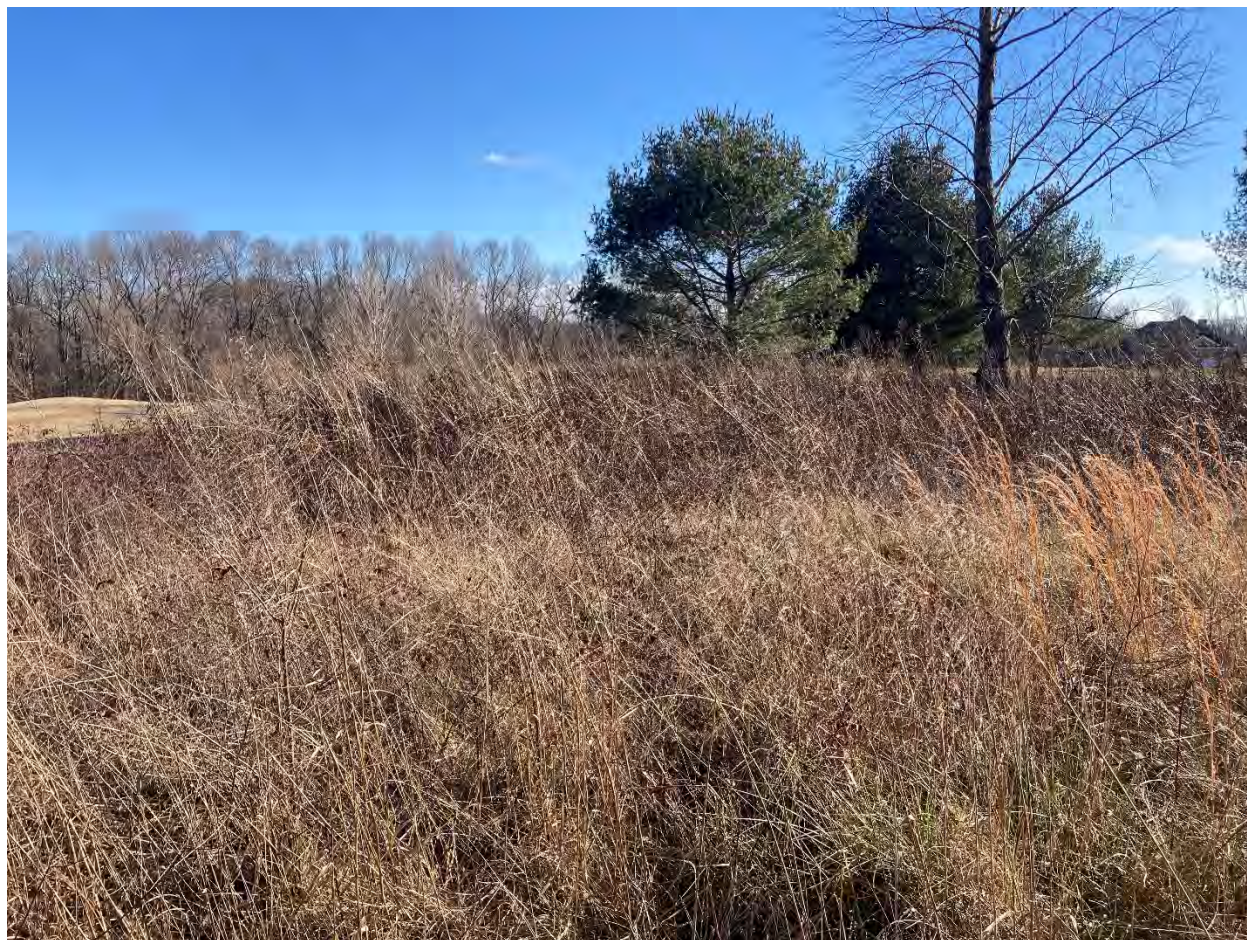
A3. Drip field covered in dense vegetation.

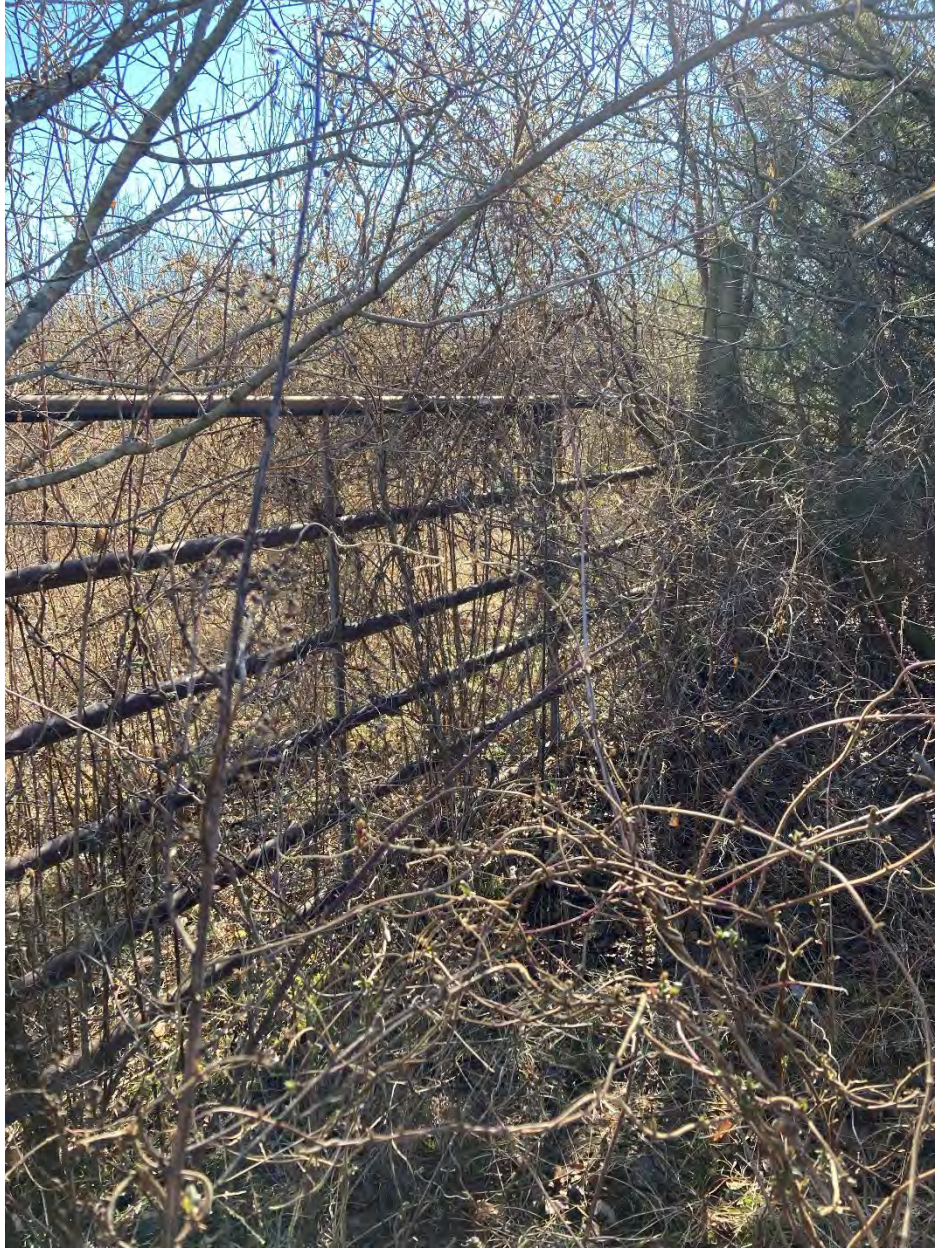
A3. Entrance to drip field. Entire area grown up in small trees and briars.
