Re: Tennessee Public Utility Commission ("TPUC" or the "Commission"), Docket No. 24-00050, *Petition of Tennessee Wastewater Systems, Inc. to Amend Its Certificate of Convenience and Necessity to Include Star Creek and Hyde Park in Williamson County Tennessee*

## ATTACHMENT A

**RE: Compliance Evaluation Inspection and Notice of Violation**  
Tennessee Wastewater Systems, Inc.  
Permit #SOP-11014  
Montgomery County

**Report on the Performance of Wastewater Systems Utilizing Drip Dispersal in Tennessee**

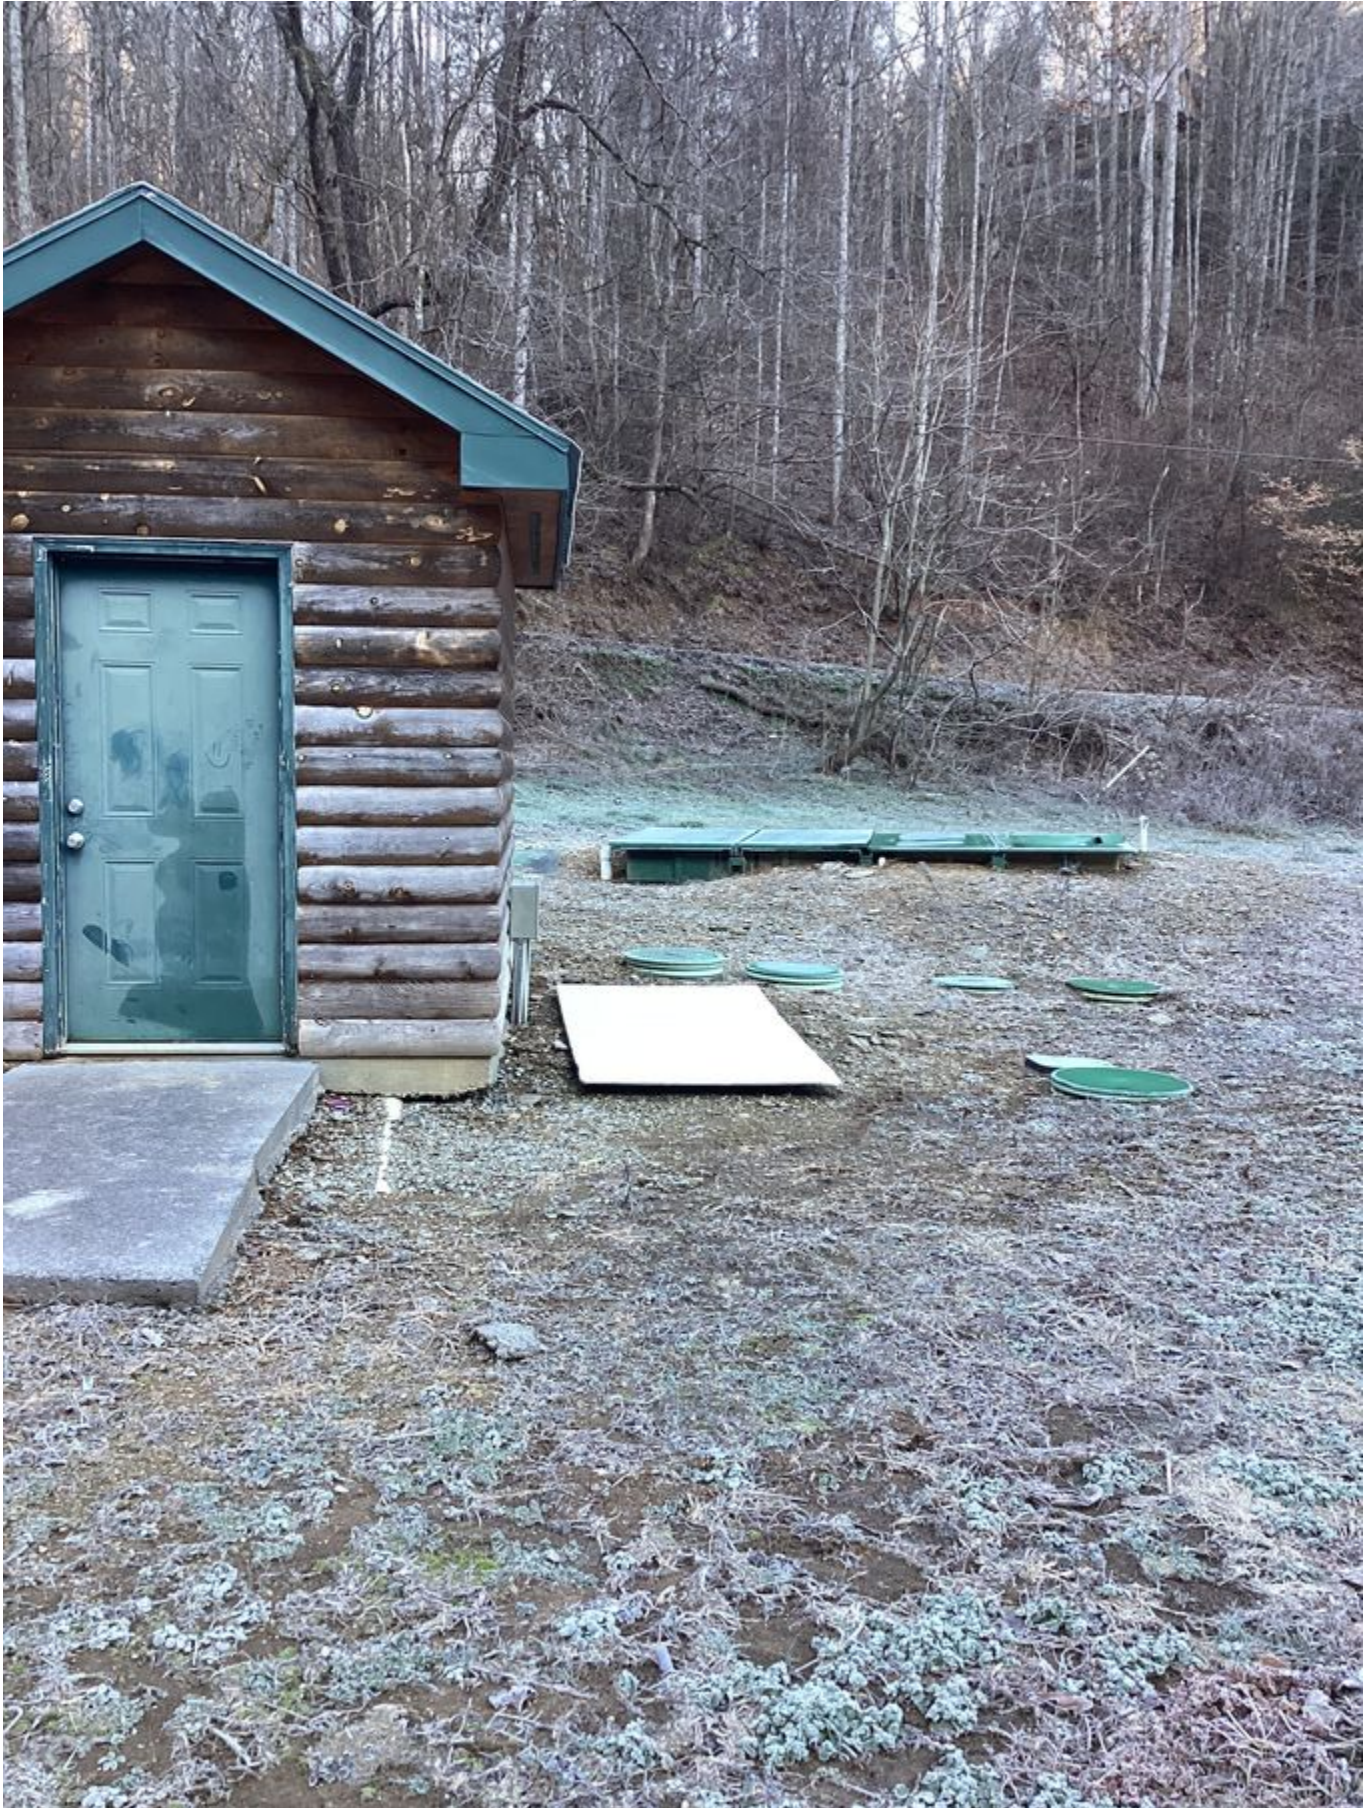
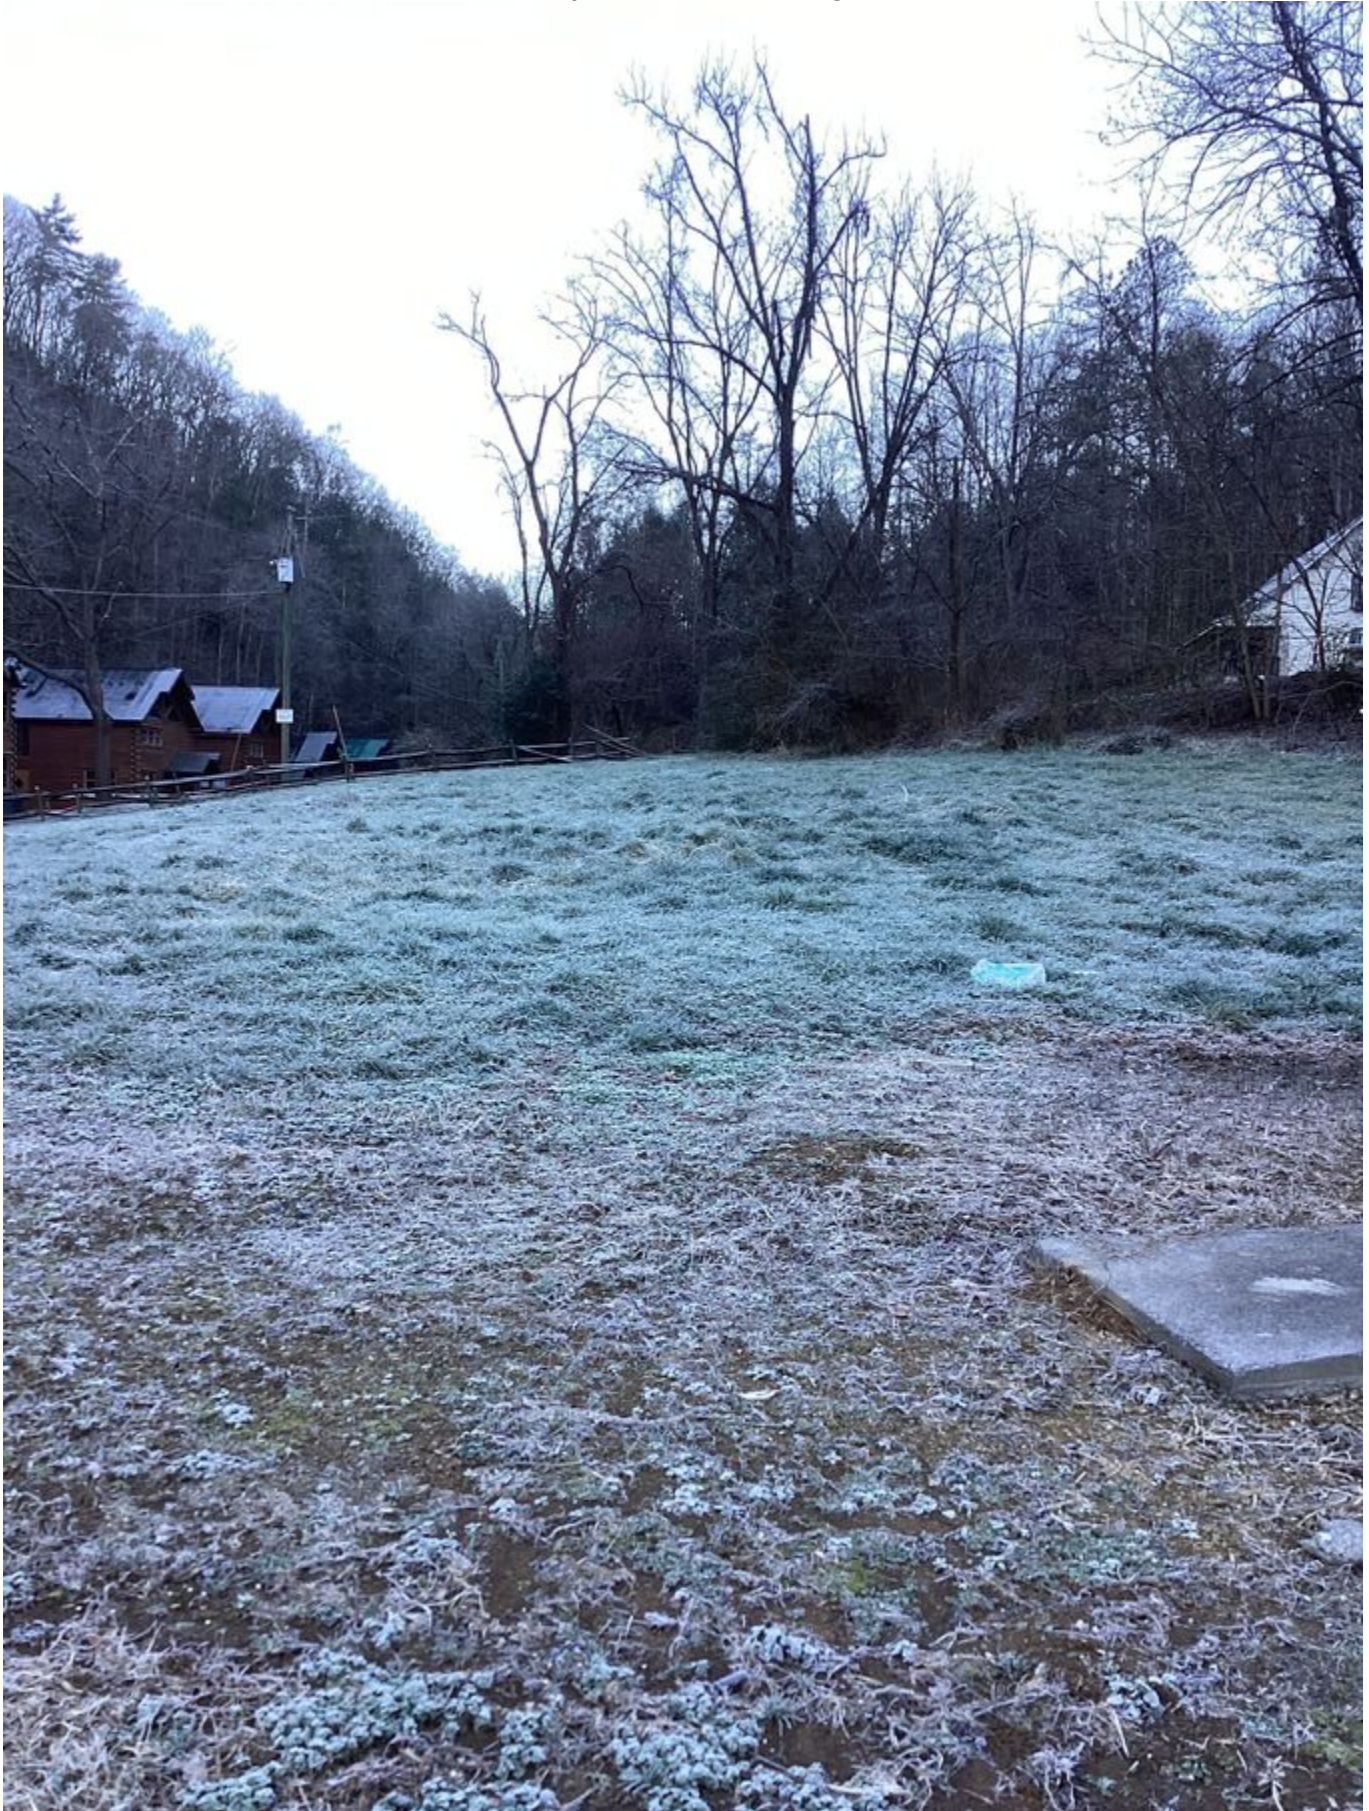
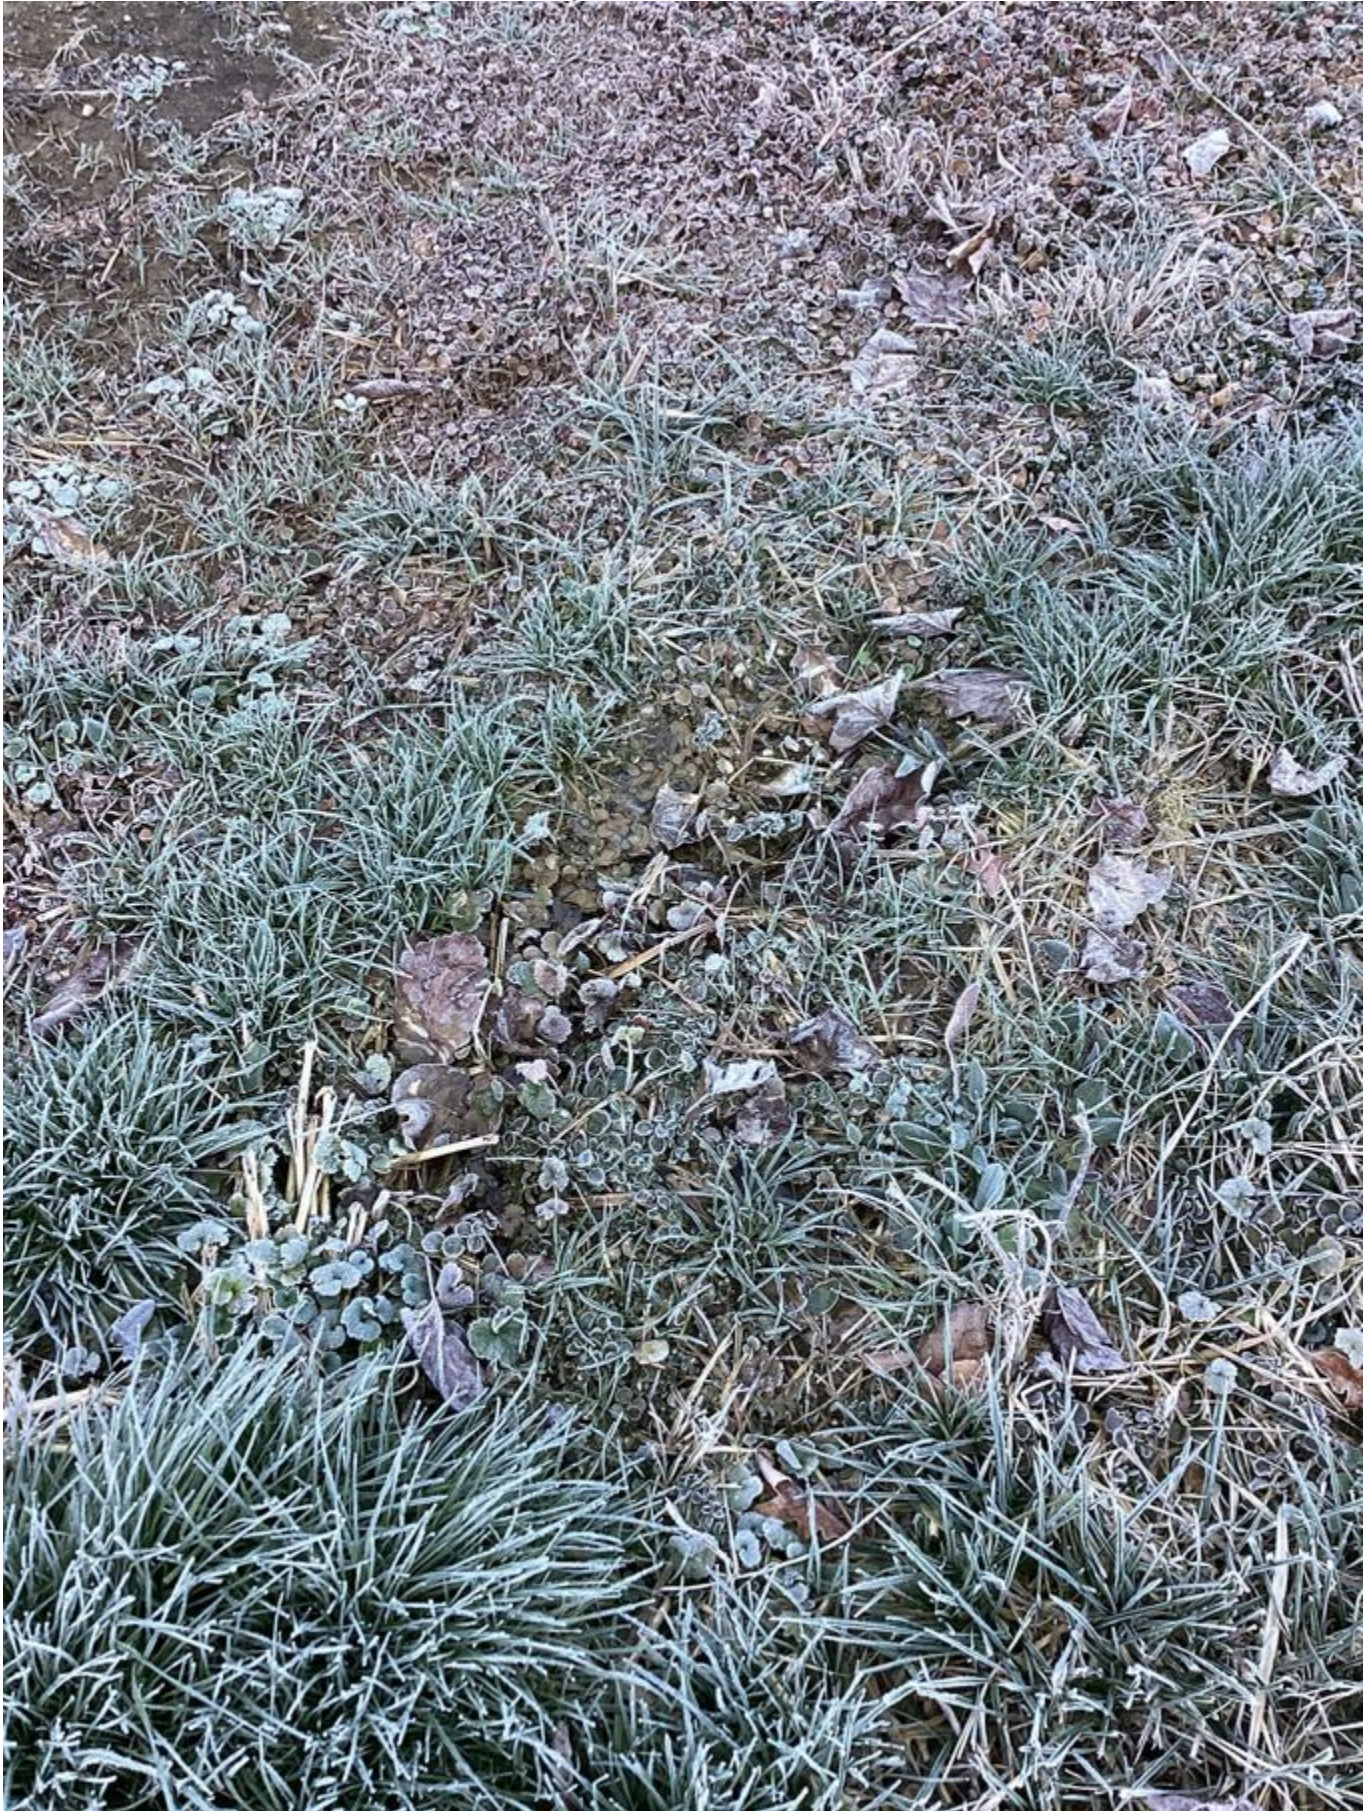
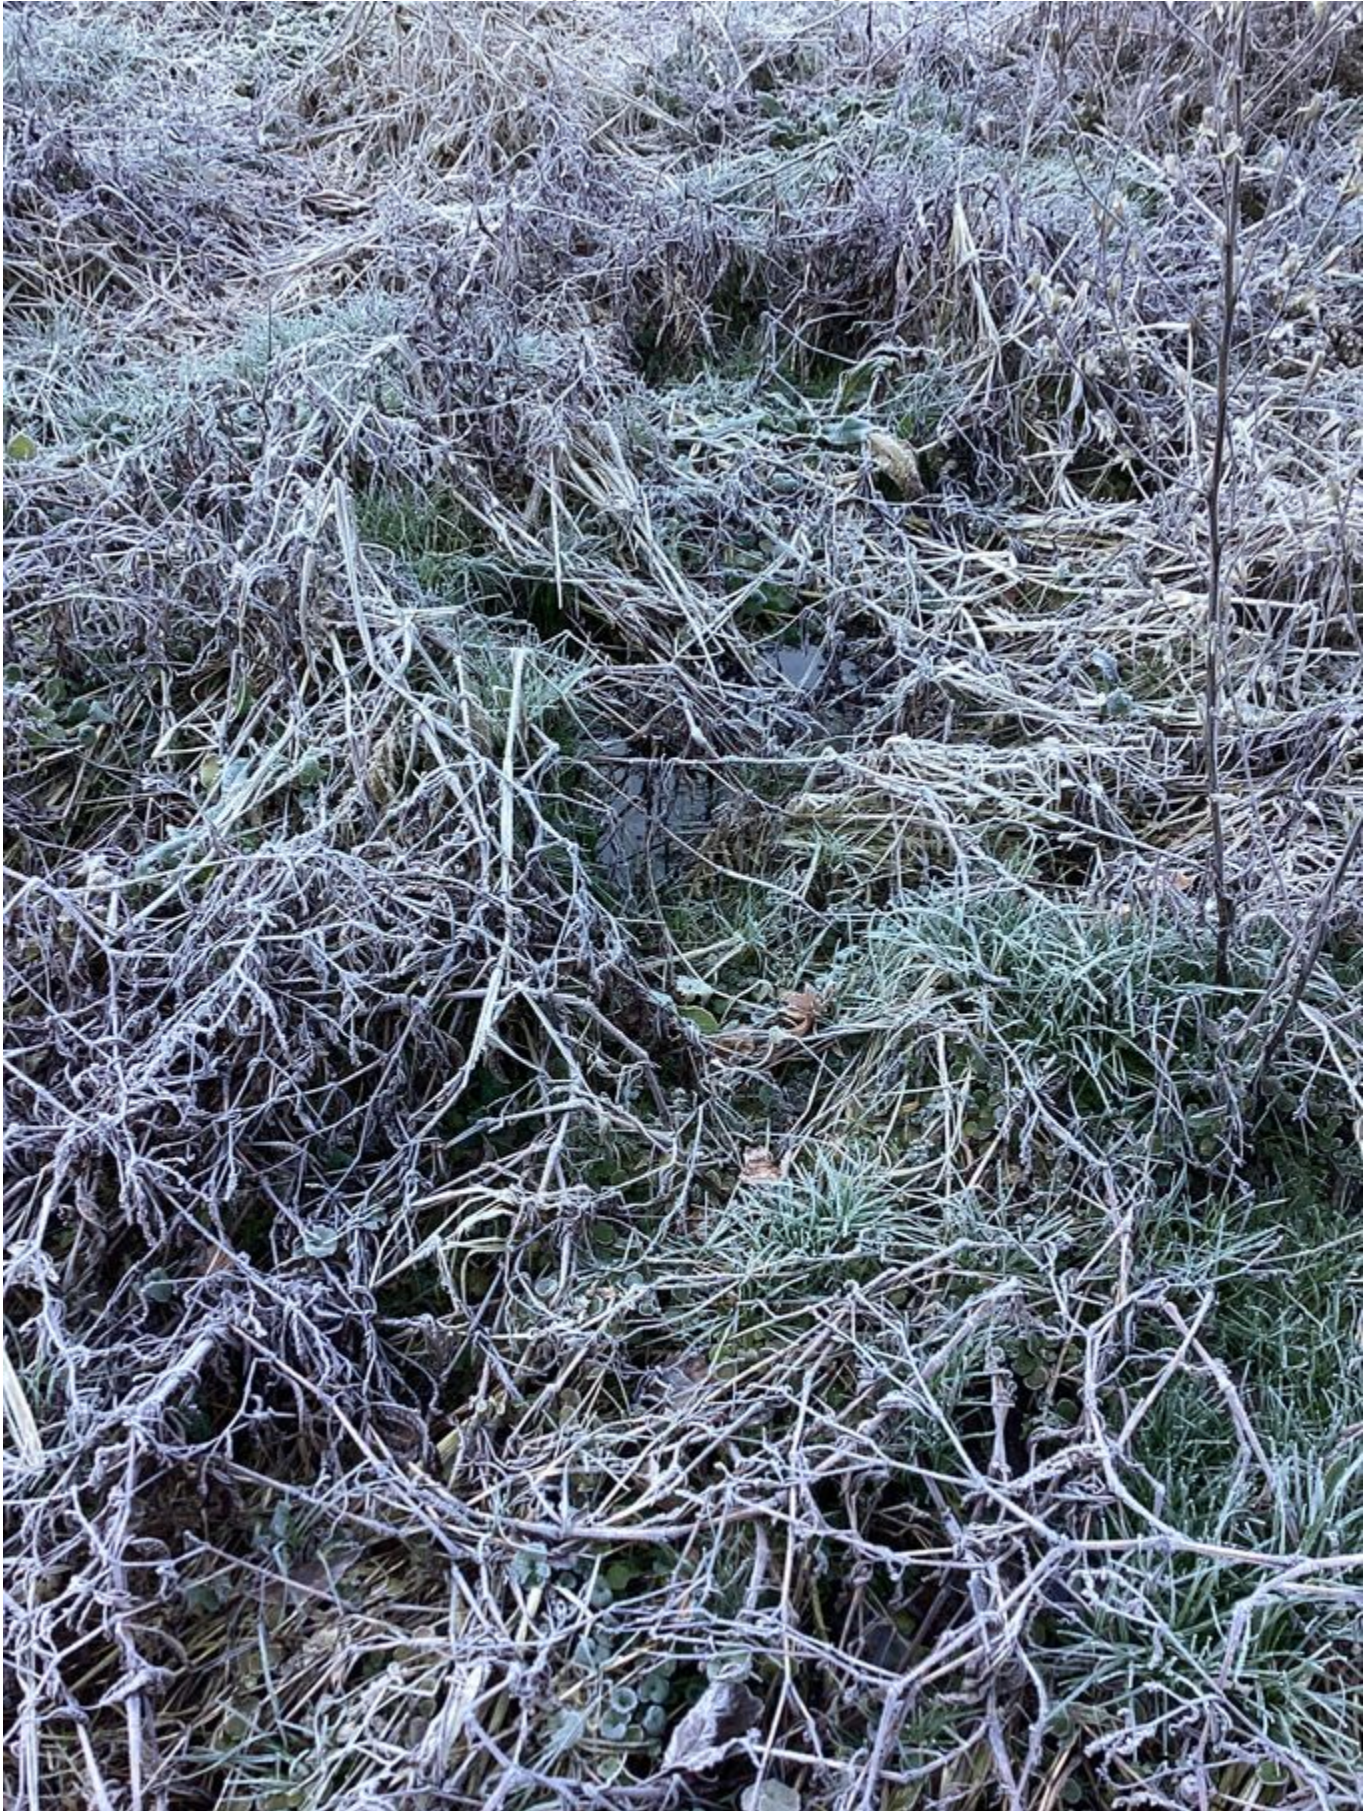
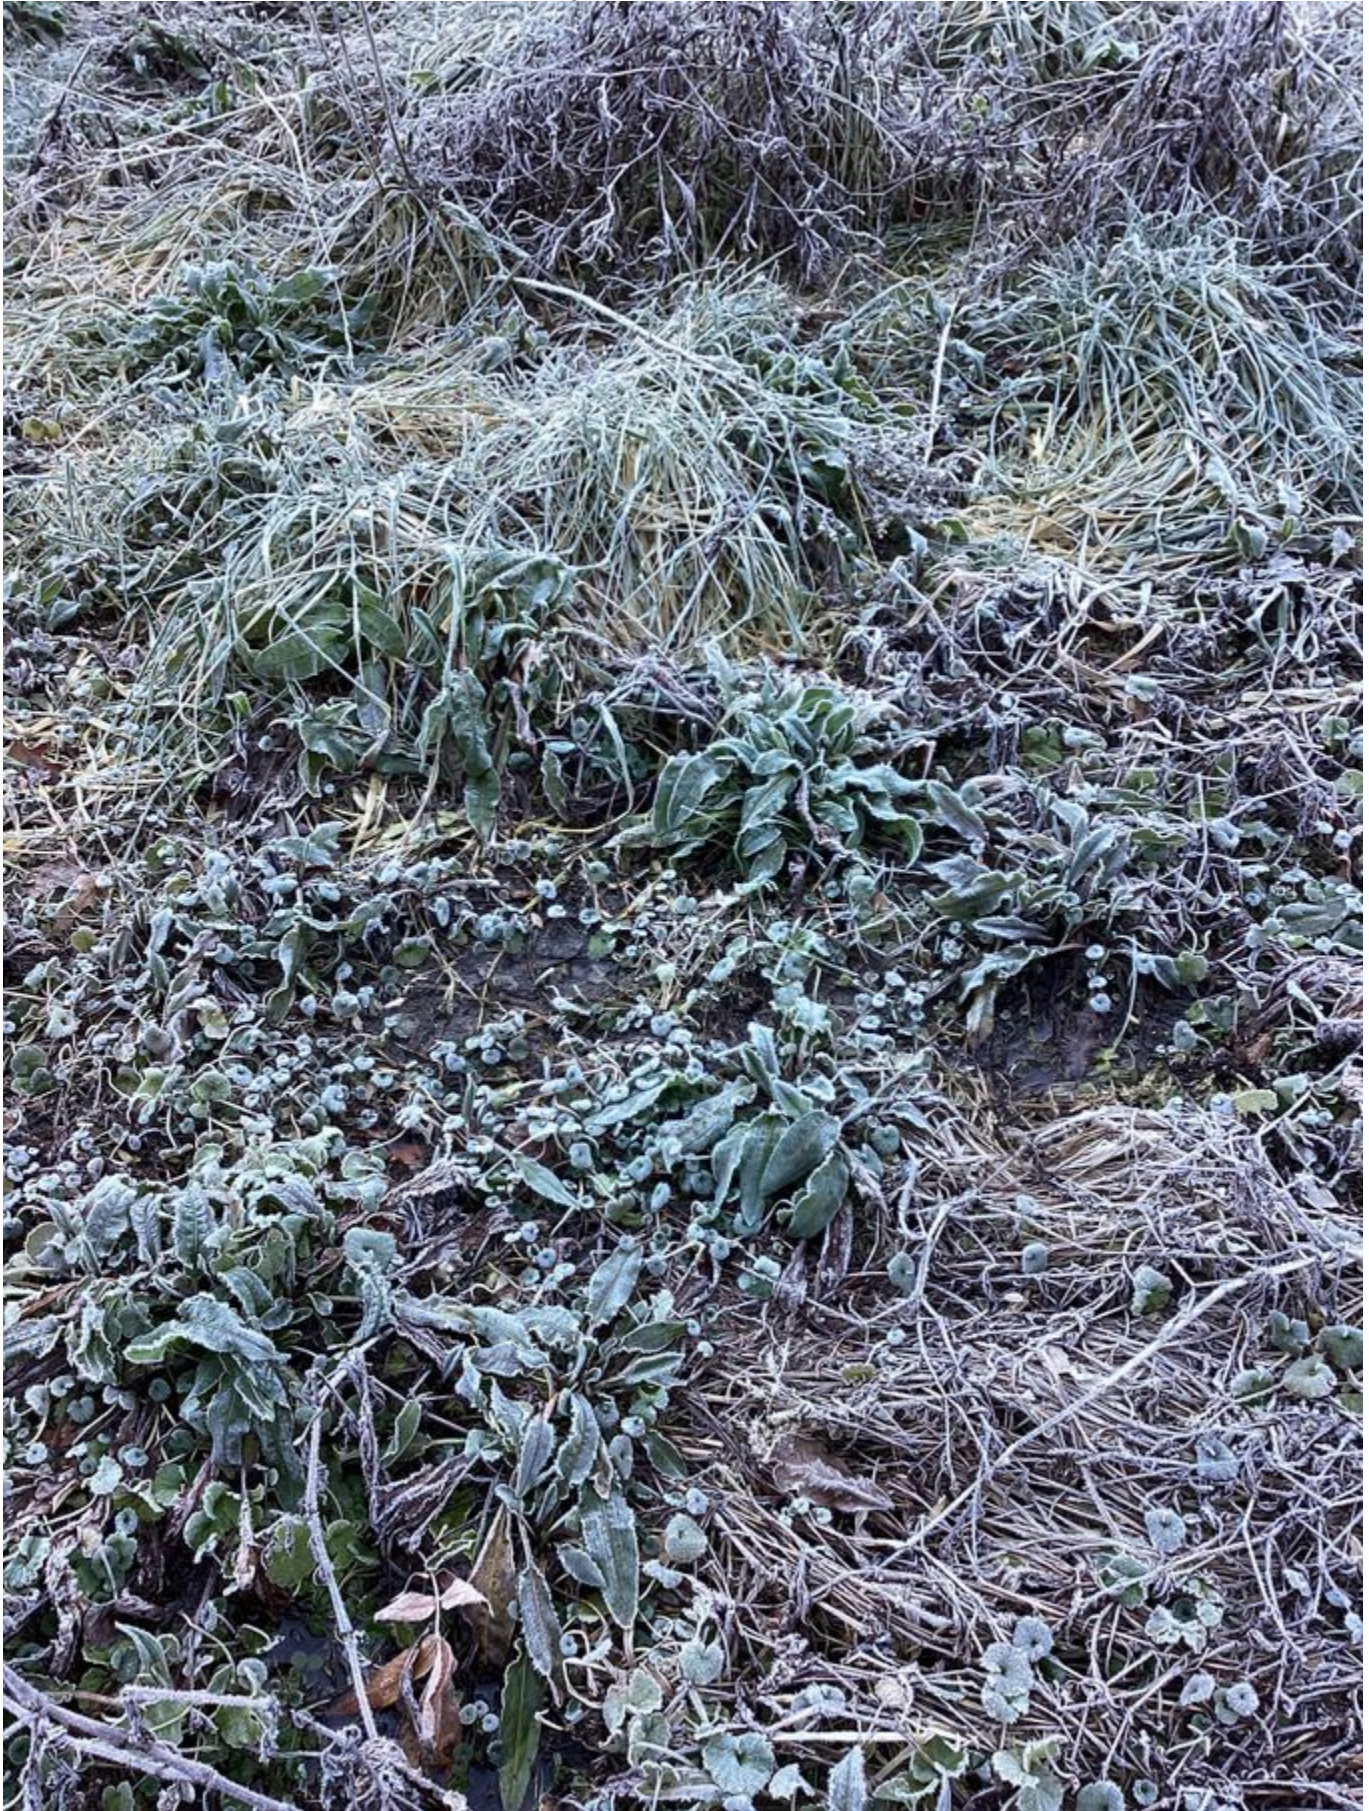
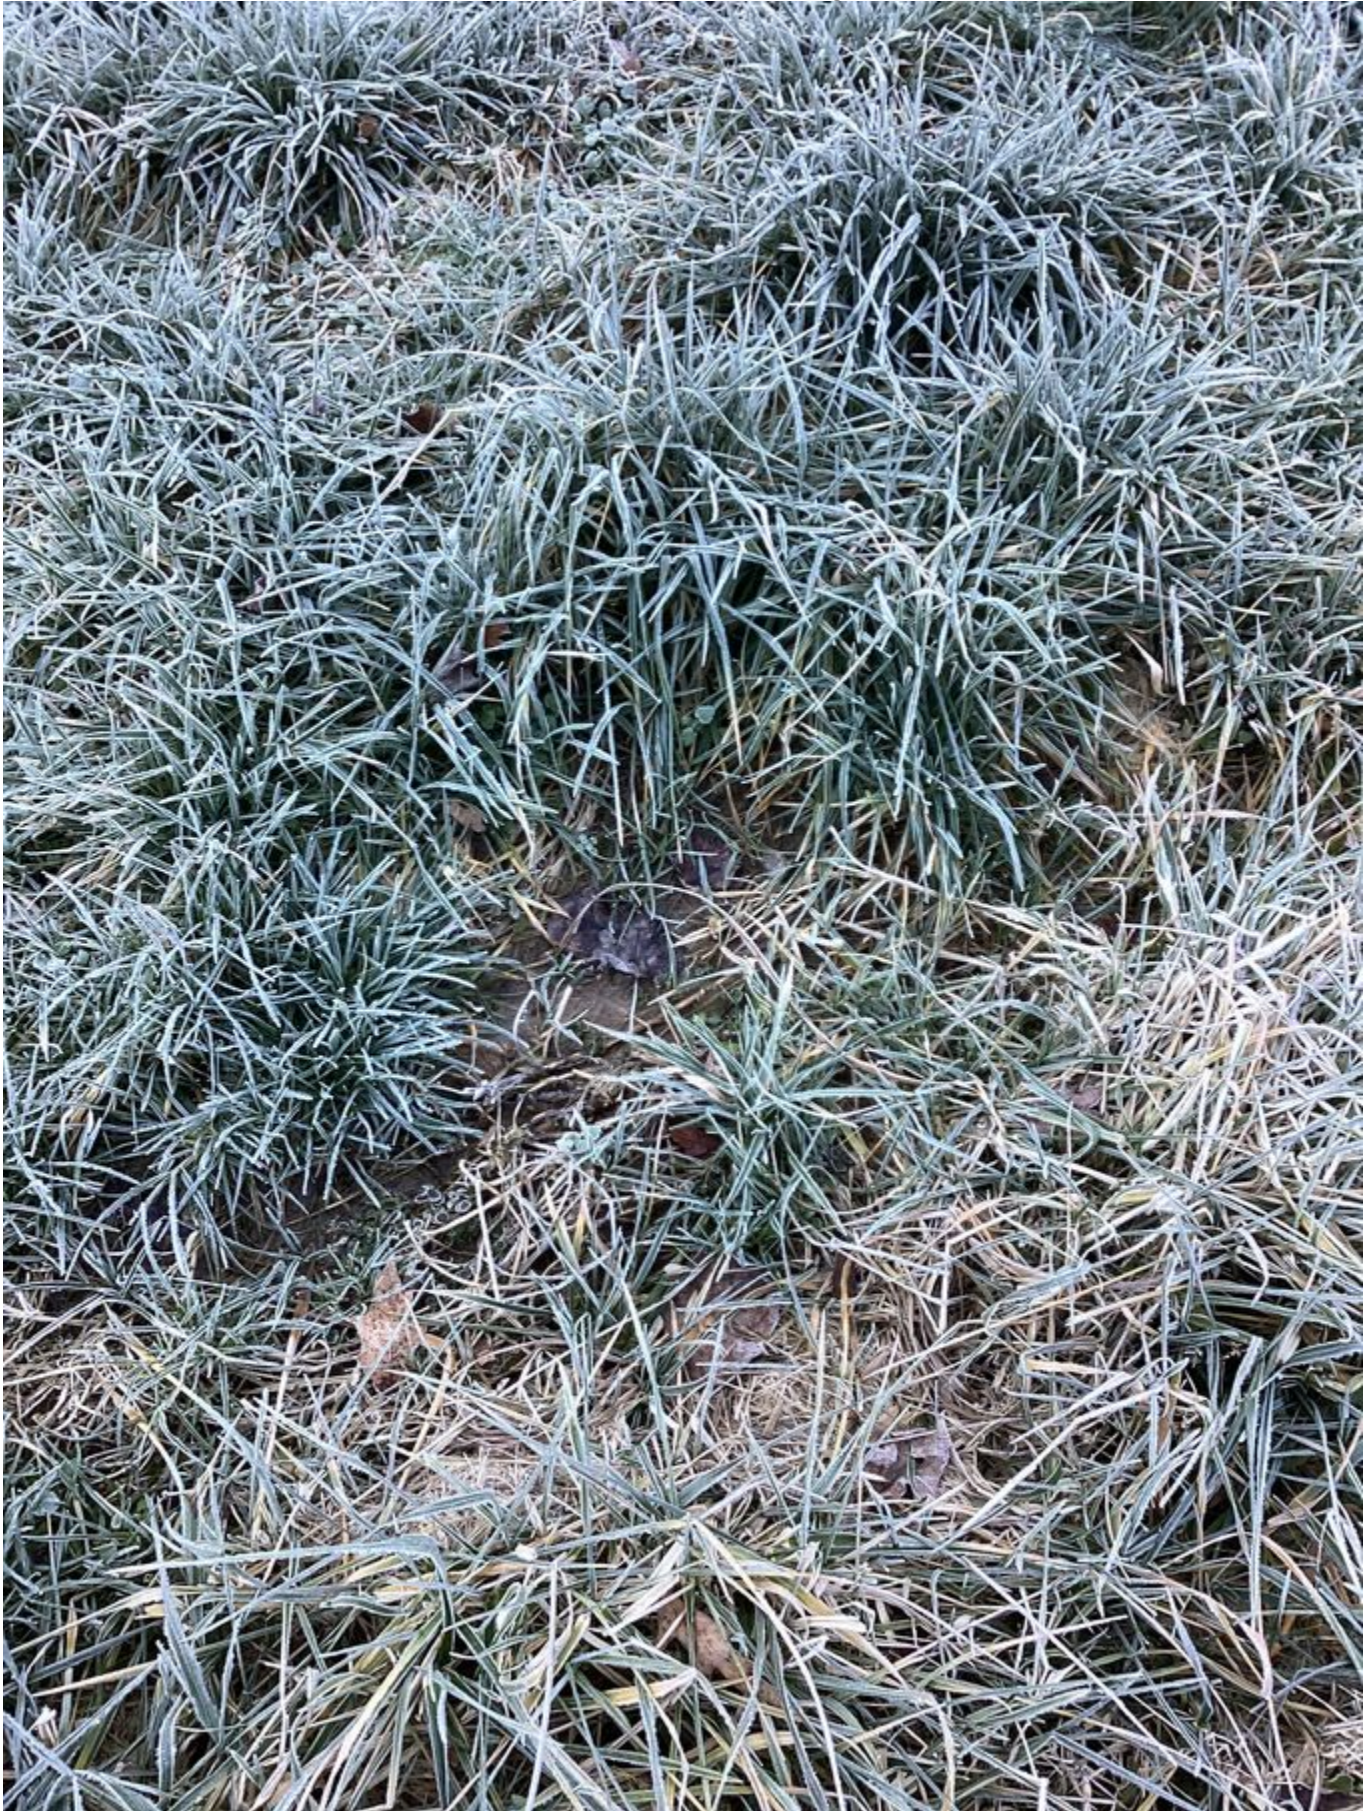
SOP-02023 - Tennessee Wastewater Systems, Inc. - Falling Waters

Ponding in multiple locations, heavily saturated soils
