**STATE OF TENNESSEE
BEFORE THE TENNESSEE PUBLIC UTILITY COMMISSION**

LIMESTONE WATER UTILITY OPERATING COMPANY

DIRECT TESTIMONY

**CONDITION OF FIVE SYSTEMS TO BE ACQUIRED; SCHEDULED CAPITAL
PROJECTS FOR GRASSLAND, SHILOH FALLS, AND CANDLEWOOD LAKES;
ACQUISITION ADJUSTMENT RECOVERY**

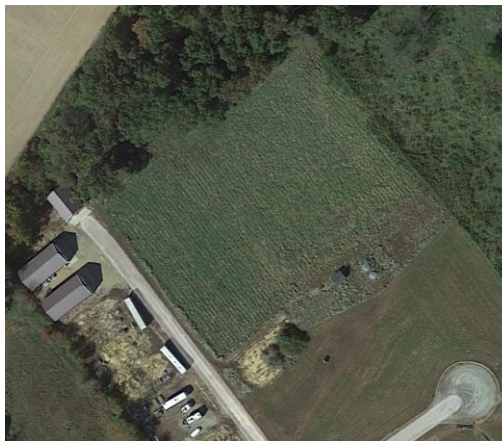
1 Genesis Village system. Based upon that engineering report, most of the Genesis Village
2 assets are in fair condition and the facility has maintained permit compliance since entering
3 operation in May of 2017.

8
9 *Aerial view of treatment units and drip irrigation field*

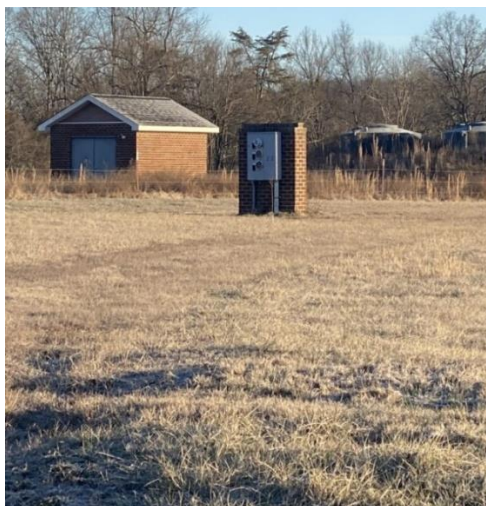
10
11 *Drip irrigation field (foreground) and structure containing treatment units and tanks (background).*

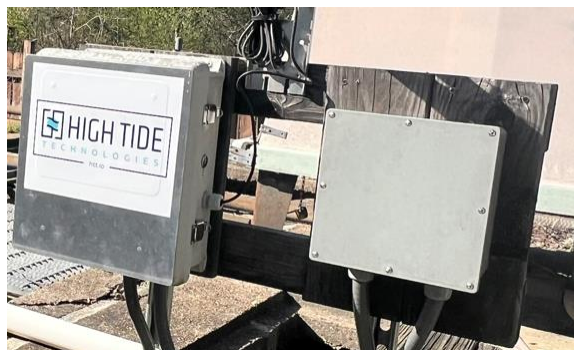
18 **A.** Yes. Below is an example of a "High Tide" remote monitoring unit.

"High Tide" remote monitoring unit.

14 A. Limestone Water installs remote monitoring equipment on all lift stations and treatment
15 plants it acquires. Remote monitoring equipment allows operations staff to remotely track
16 the status of wastewater equipment and provide notification of any abnormal operating
17 conditions. Status tracking includes live and continuously recorded data on the runtime
18 and operational performance of various system components. This provides for exceptional
19 awareness of the condition of equipment over time and allows equipment to be efficiently
20 maintained or replaced prior to equipment breakdown.

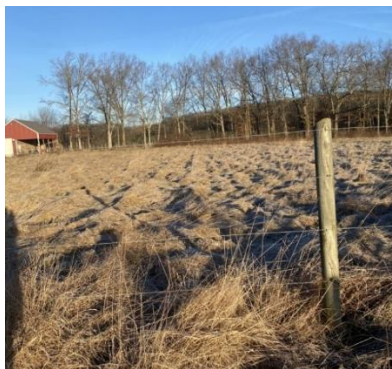
3 A. The existing fencing surrounding the drip irrigation field is in poor condition and has no
4 signage to differentiate it from nearby fencing around farmland. The facility's TDEC
5 permit requires that fencing be sufficient to impede unauthorized entry and protect the
6 facility from vandalism, so improvements to the fencing are essential to maintaining
7 compliance with TDEC requirements. Secure fencing is important for several reasons.
8 First, the Genesis Village system does not include a disinfection system in the treatment
9 process. Disinfection is not required where a drip irrigation field is fenced off and protects
10 the public from exposure to wastewater. Beyond concern with exposure to wastewater,
11 the other concern is trespassers causing damage to treatment equipment. To protect the
12 public, the third-party engineers recommend installing proper fencing with signage
13 indicating the presence of a wastewater dispersal zone.

15 A. Yes. The attached picture shows that the current fencing is little more than an indication
16 of property boundary and fails to provide any security or deterrent to unauthorized entry.

Existing barbed wire fencing.

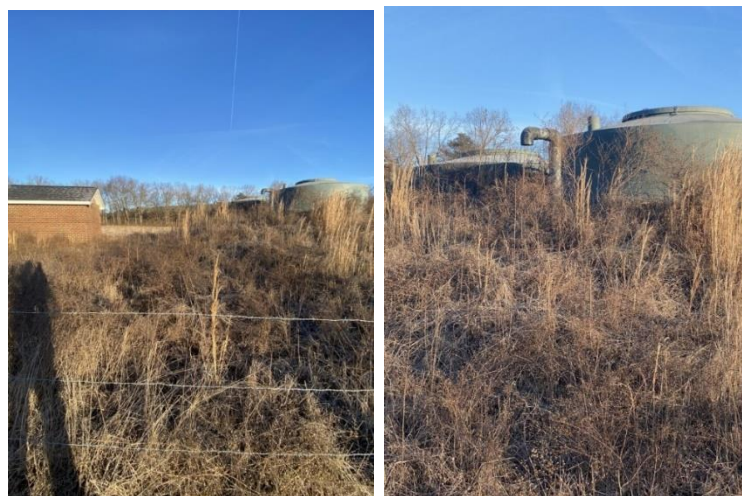
3 A. Controlling vegetation growth on the site is important to maintain proper operational
4 access to all equipment and to prevent damage to fencing and equipment. Currently, some
5 portions of the Genesis Village site are inaccessible due to uncontrolled vegetation.
6 Limestone Water will clear the site and implement a vegetation control process on the site.
7 A facility inspection conducted by TDEC in January of 2024 noted the vegetation was only
8 moderately maintained and that operations staff stated the field used to be mowed annually,
9 but they had stopped for fear of damaging irrigation piping. While they were not
10 specifically cited for the vegetation, the vegetation is more obstructive outside of winter
11 months and would likely result in violations and being evaluated as overgrown in the future
12 left unaddressed.

15 A. Yes, below are images showing treatment equipment that is completely obstructed by
16 vegetation overgrowth.

17 *Overgrown vegetation throughout the site preventing operational access to equipment.*
18

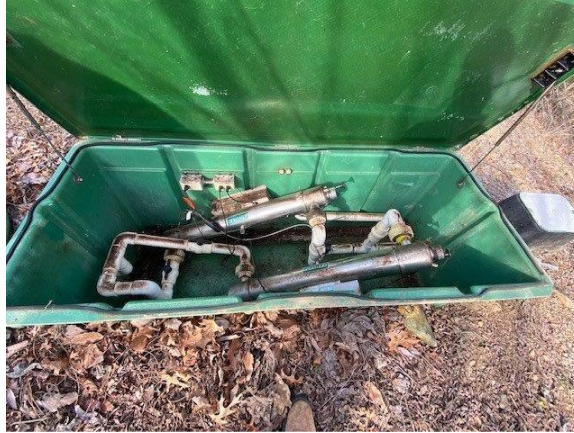
10 A. Yes. The following picture shows that the UV disinfection system was disassembled and
11 simply placed in a bin. As such, it is not operational.

Out of service UV disinfection system

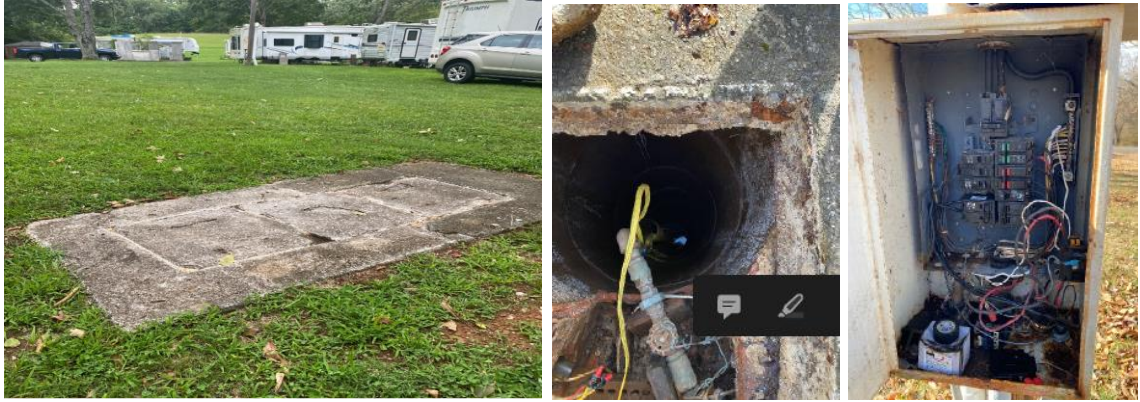
5 A. The well at the Newport Resort water system is over 50 years old and is due for renovation
6 not only to extend its useful life but also to ensure that it can provide adequate water
7 capacity. Much of the existing well equipment, including the well head and pump, are in
8 poor condition and the configuration of the system makes operational access difficult. This
9 has contributed to a lack of maintenance and incomplete testing in the past.

21 A. Yes. The below photos show the poor condition of the system assets, including a degrading
22 concrete box containing the well head, exposed wiring and poor condition of the well itself,
23 and exposed wiring in the control system.

Well box (left), well interior (center), existing well control (right)

10 The third-party engineers recommend a full well rehabilitation, including: (1) new
11 pump, (2) new well head, (3) new above-ground piping, (4) overhaul of the electrical
12 system, and (5) installation of a new flow meter. It is recommended that this be done in a
13 new well house that would contain a second room for housing disinfection equipment.
14 This is important to prevent the well equipment from being exposed to the corrosive effects
15 caused by exposure to sodium hypochlorite. Finally, it is worth noting that TDEC
16 regulations require that systems with more than 50 connections require a redundant water
17 source. This could be accomplished by either drilling an additional well or through an
18 emergency use connection to a nearby water system.

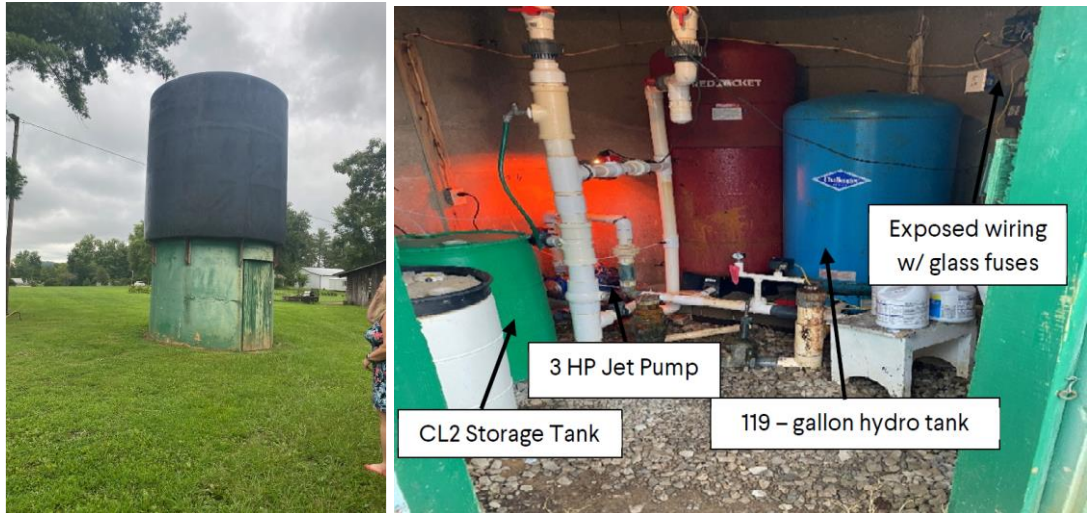
5 A. The existing Newport Resort ground storage tank has many issues. The existing tank is a
6 10,000-gallon polymer tank set atop a degrading concrete stand. The system's chlorine
7 dosing, hydropneumatic tanks, and booster pump are located under the concrete stand.

8 The above arrangement is unsafe, as the imminent collapse of the concrete stand would
9 cause the tank to collapse onto the other equipment, damaging the equipment, interrupting
10 service, and potentially harming an operator performing regular operations activities.

17 A. Yes. Below are photos showing the tank suspended on the concrete ring and the equipment
18 stored underneath.

Existing storage tank and equipment located under the concrete stand.

11 Additionally, the ground storage tank does not provide adequate water storage to provide
12 safe and reliable service to the community. For these reasons, the third-party engineers
13 recommend replacing the current tank with a new 25,000-gallon ground storage tank
14 installed on a new concrete slab on grade.

A. As reflected in the previous photo, the distribution system currently consists of two small bladder tanks and a three-horsepower jet pump. These assets are not only in poor condition, they are also poorly configured. With the installation of a new ground storage tank, the third-party engineer recommends removing the existing hydropneumatics tanks and pump from service and installing a dual booster pump skid to ensure reliable pressurization of the water system. This would necessarily include modification of the electrical system and include a quick-connect to a portable generator in the event of power failure.

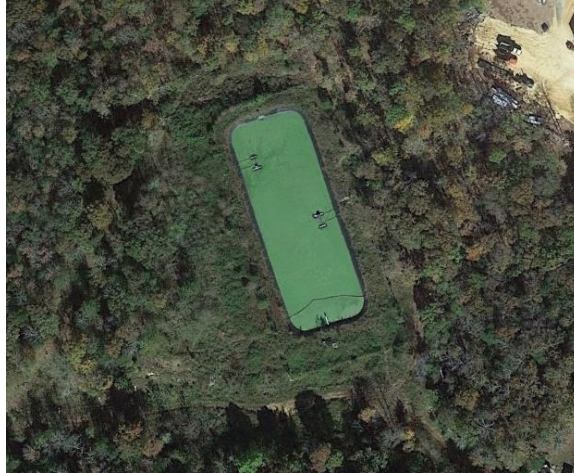
Aerial view of Riverstone Estates treatment facility.

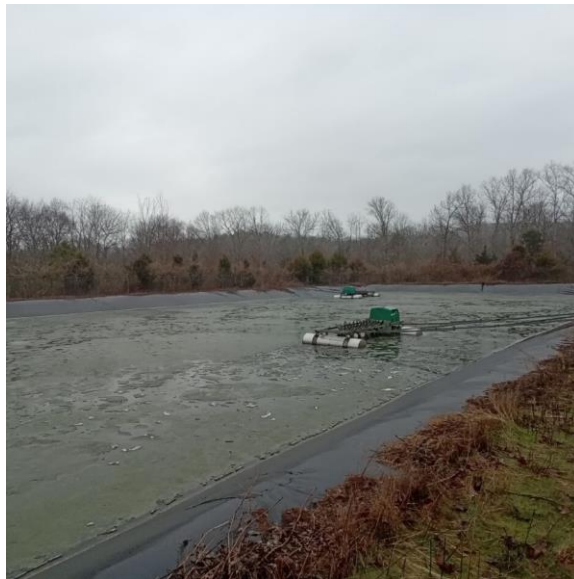
Riverstone Estates lagoon.

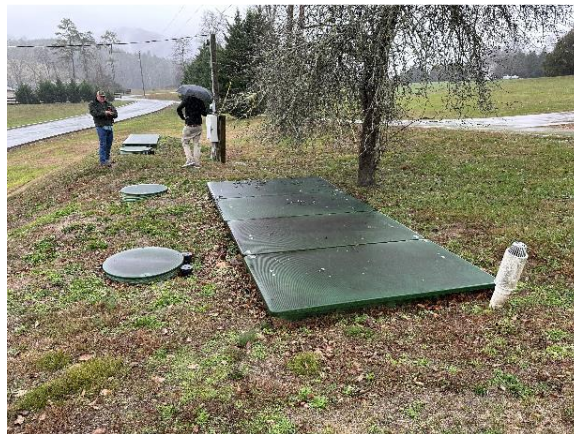
3 Based upon that engineering report, it appears that the Sunset Cove facility is in
4 good condition but has a history of compliance issues mostly, it appears, focused on
5 difficulties properly identifying the legal owners of the system, which led to a long period
6 with no valid permit.

9
10 *Sunset Cove media filter and septic tanks.*

13 **A.** As the system is mostly in good working order, improvements would prioritize maintaining
14 condition and promoting longevity of the system's assets and addressing nuisance
15 complaints. First, the Company intends to upgrade the facility's security by adding fencing,
16 installing site safety signage, and providing new locks. Second, Limestone Water will
17 install carbon caps on vents, or an equivalent odor mitigation technology, as there have
18 been persistent odor complaints from residents. Third, Limestone will repair the isolation

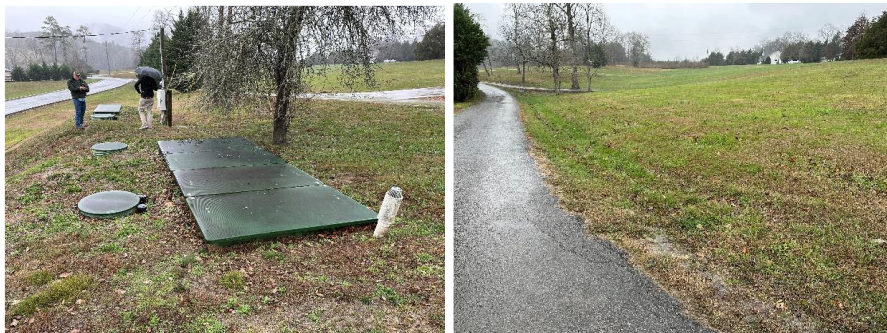
A. Yes, below are photos showing no fencing at the treatment plant and irrigation field.

No fencing present at treatment plant or drip irrigation field.

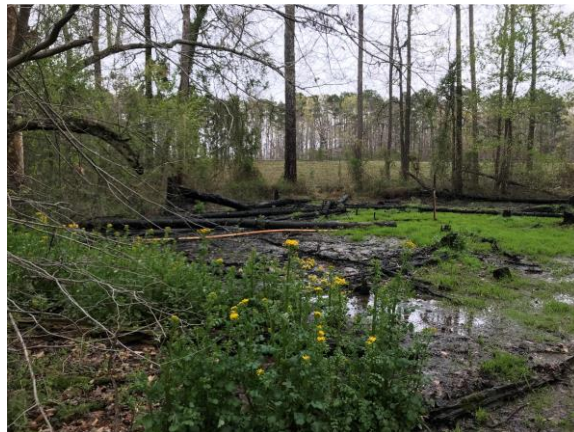
7 A. Yes. The attached picture shows the significant ponding at the Shiloh Falls spray field.
8 This clearly indicates the inadequacy of the land devoted to the spray field as well as the
9 absorption level of that land relative to the current output of the facility.

10
11 Typical overloading of existing Shiloh Falls spray field area (note, ponding and runoff).
12
