**STATE OF TENNESSEE
BEFORE THE TENNESSEE PUBLIC UTILITY COMMISSION**

LIMESTONE WATER UTILITY OPERATING COMPANY

DIRECT TESTIMONY

**OPERATION AND MAINTENANCE EXPENSE; TENNESSEE O&M PARTNER AND
STATE MANAGER; SYSTEM IMPROVEMENTS MADE BY OPERATIONS TEAM,
RECOVERY OF ACQUISITION ADJUSTMENTS**

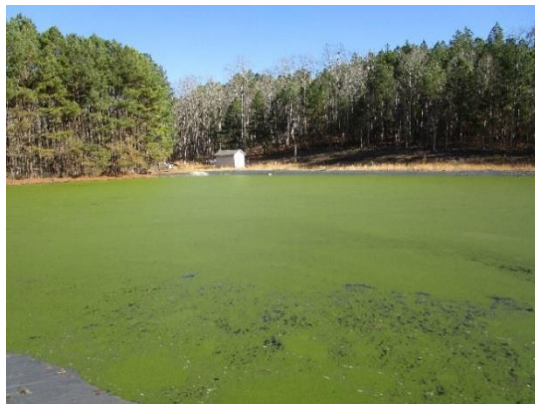
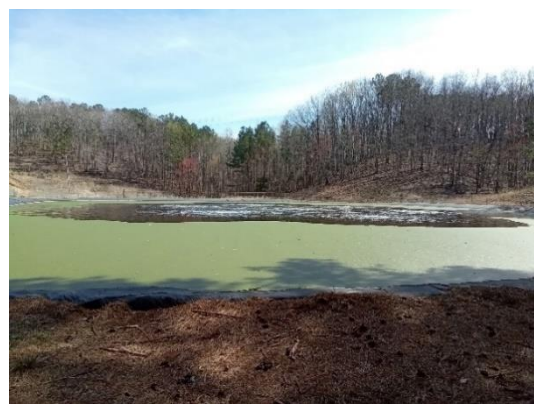
A. Yes. The following pictures show the lagoon condition at the time of acquisition given the lack of aeration (left) and the condition after the aeration system was restored following acquisition (right).

A. The most immediate improvement to the aeration system was to simply operate the system consistently as designed. In operating the system, however, an air-line leak was identified which reduced the air supplied to the lagoon and decreased the efficacy of system treatment. The air leak was repaired, and full functionality of the system was restored.

A. By not only repairing the air leaks and completing deferred maintenance on the blower and blower motor, but also ensuring the aeration system was operated as originally designed, Limestone Water has dramatically increased the efficacy of the treatment at the facility. A fully functional aeration system results in cleaner effluent distributed to the spray irrigation field resulting in improved environmental health and a reduction of health hazards. The increased aeration also aids in the long-term breakdown of sludge in the lagoon cell, reducing the frequency of sludge hauling, and reducing operating costs for the facility.

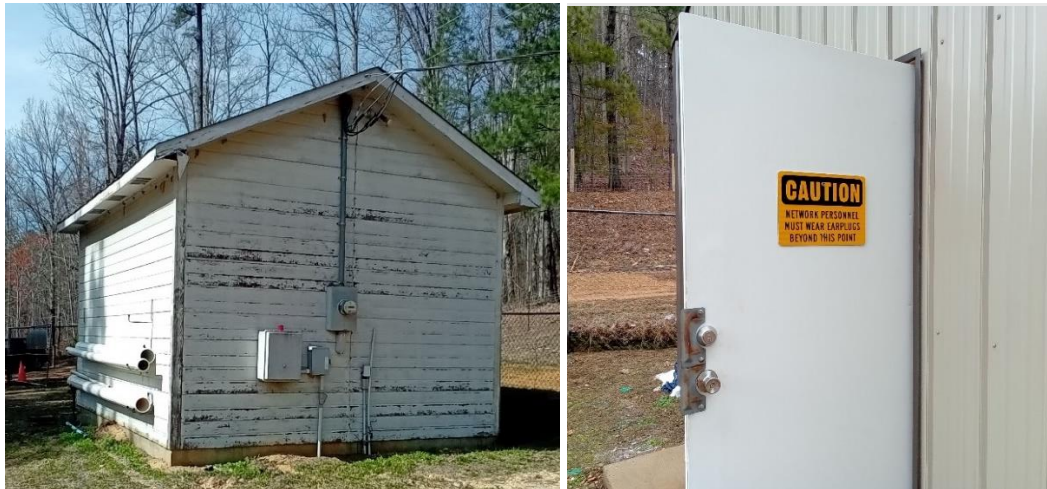
Blower building at acquisition with deteriorating roof and siding; new aluminum siding on blower building.

A. Limestone Water has replaced the storage shed, including the construction of an additional awning and pipe storage rack to protect equipment. The blower building has experienced significant improvements, including the installation of new siding and roof to protect the equipment inside and restore the useful life of the structure.

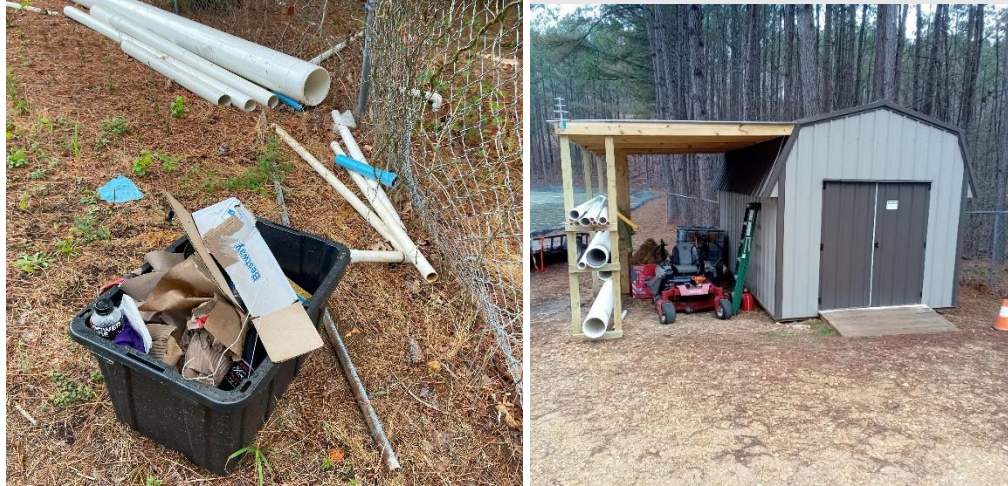
Piles of trash, pipes, and other materials at closing (left) new storage shed with awning and pipe racks (right).

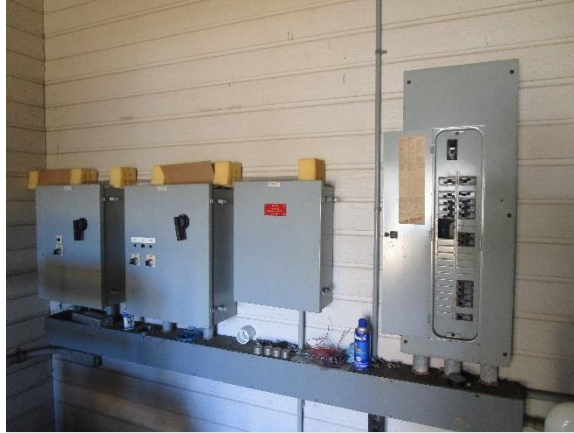
A. Yes. The following photo shows the upgraded power and control system in the blower/disinfection shed.

A. A number of electrical and control systems at the Aqua treatment plant needed repairs or improvements. This included panels and power supply boxes for the blowers, effluent pumping, and disinfection systems. Ensuring these systems are properly maintained is necessary to provide consistent and reliable treatment and ensure proper function of all facility systems. Improvements were also made to facilitate remote monitoring equipment, which will be discussed further in a later section.

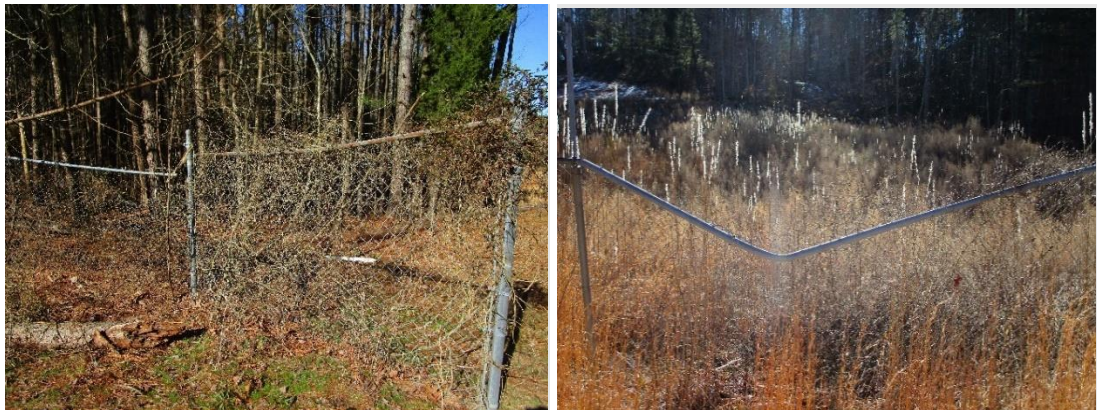
Examples of fencing damage at the Aqua facility.

- A. First, Limestone Water immediately set out to remove all of the unnecessary trash and debris allowed to accumulate at the Aqua system. Next, the nuisance vegetation and trees were cleared, and fence damage was repaired to restore site security, prevent trespassing

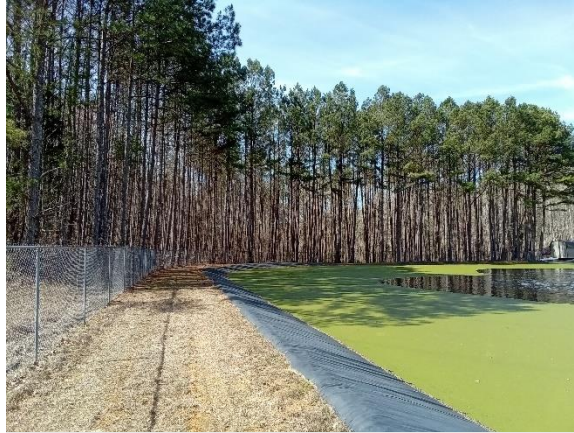
Repaired fence line.

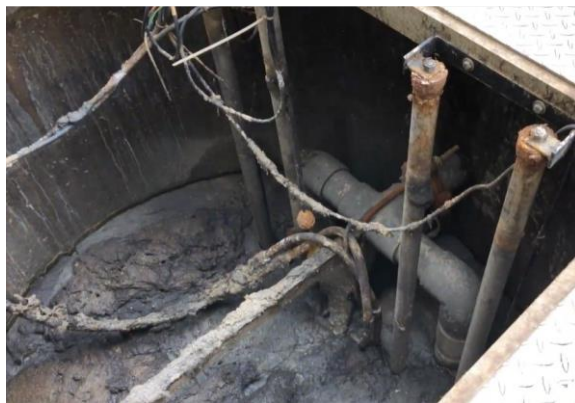
A. Yes, while a single lift station, this photo illustrates the condition of each of the 43 Aqua lift stations. Here the lift station is filled with sludge and the float that controls the on/off functioning of the pump is in poor condition. Furthermore, the wiring, power, rails and pumps are clearly approaching the end of their useful lives.

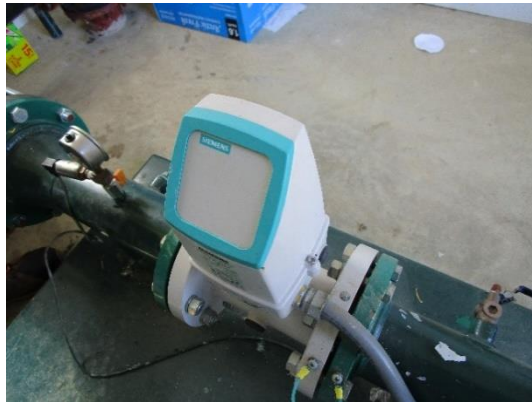
Repaired flow meter

Repaired power and control systems.

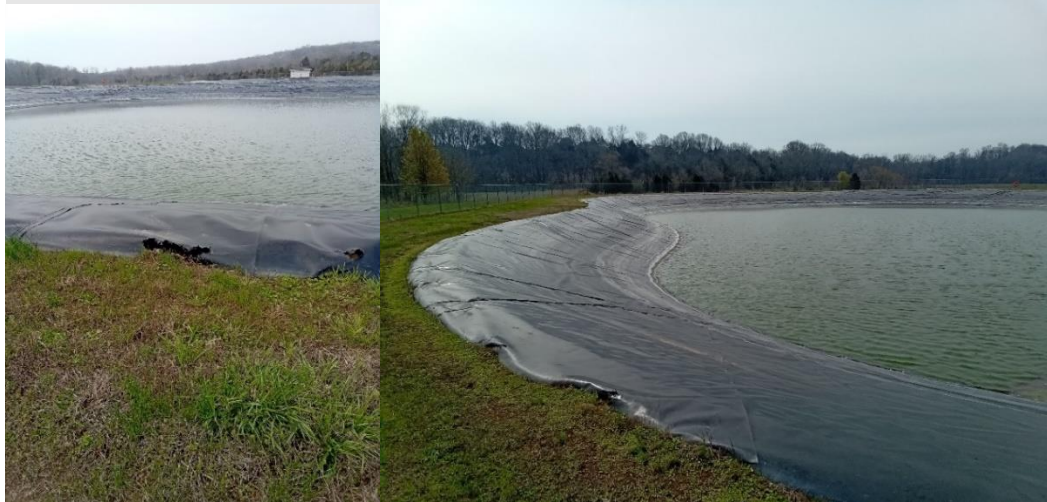
A. Yes. The first picture shows the damage that was made to the liner by animals, and the second picture shows the repaired liner with it resecured to the berm to prevent any future erosion.

Section of lagoon liner damaged by animals (left) and repairs completed and liner re-tensioned (right).

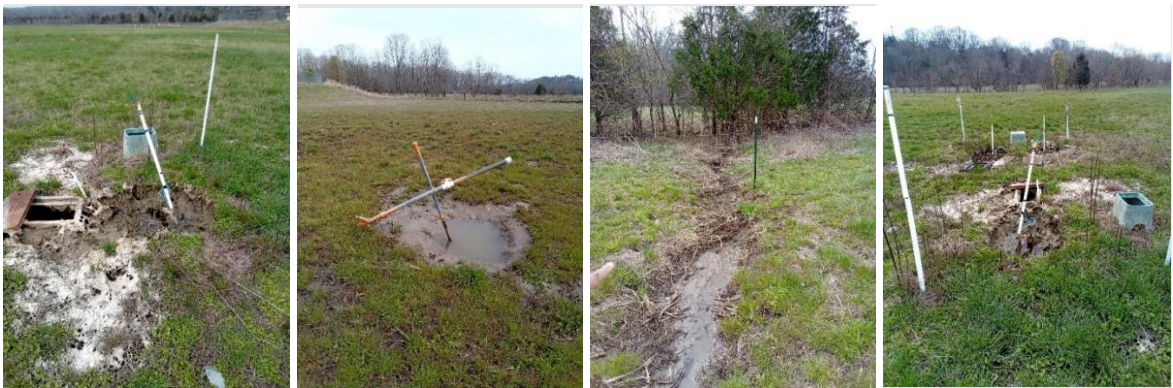
A. Yes. The first group of pictures show the damaged valving and distribution lines at the Arrington Retreat land application area that caused ponding and runoff.

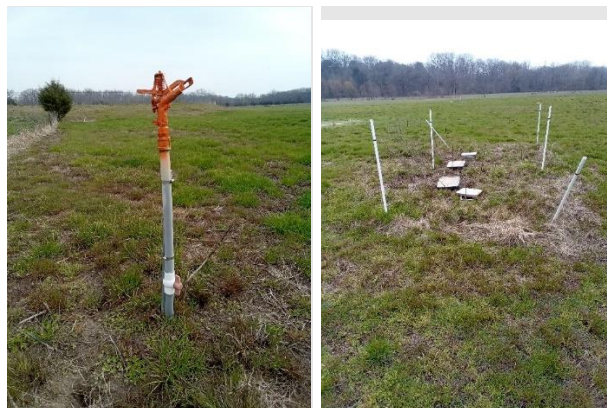
The next photos show repaired valving and spray head assemblies at the land application field.

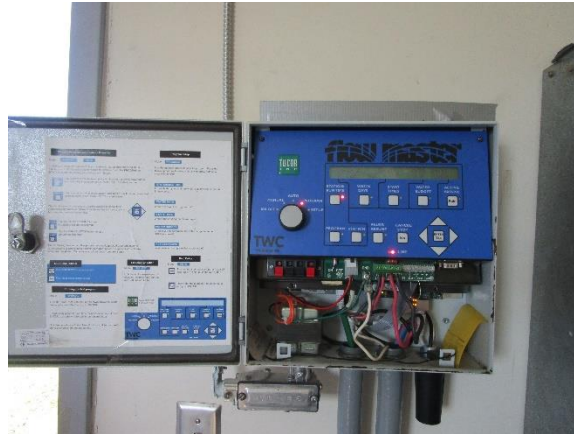
Finally, this picture show the upgraded effluent pump control system.

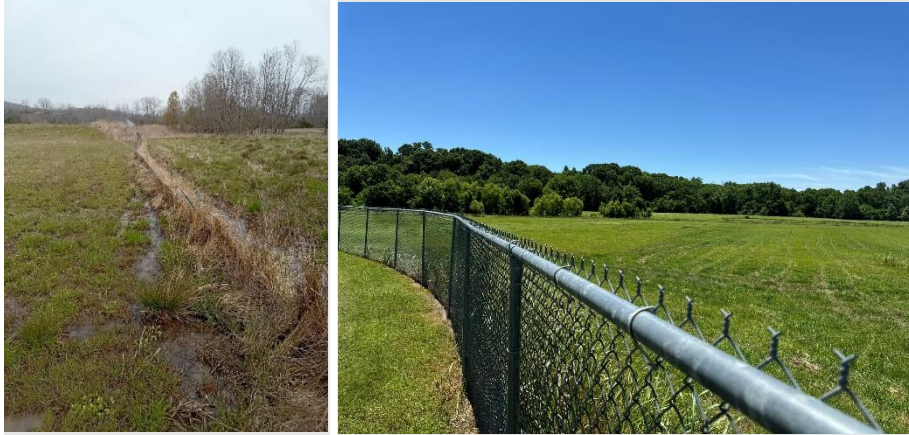
A. Yes, the following before and after pictures show the improvements made to the Arrington Retreat fencing.

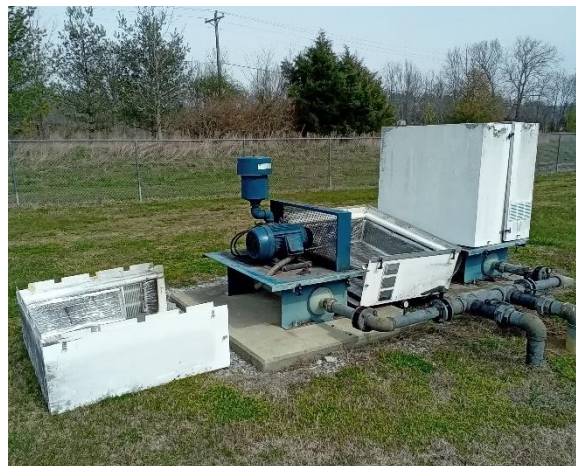
A. Yes, the following picture is of the failed aeration blower at Arrington Retreat.

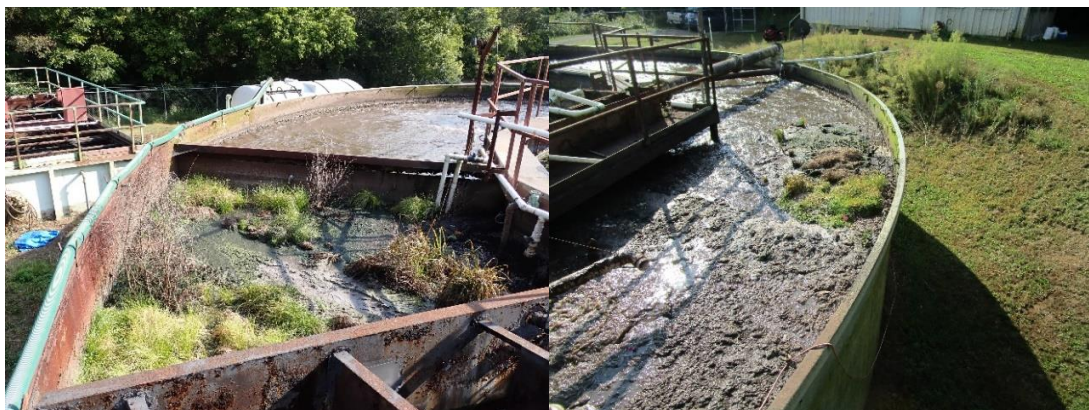
Rusting tanks, sludge accumulation, filter tanks(left).

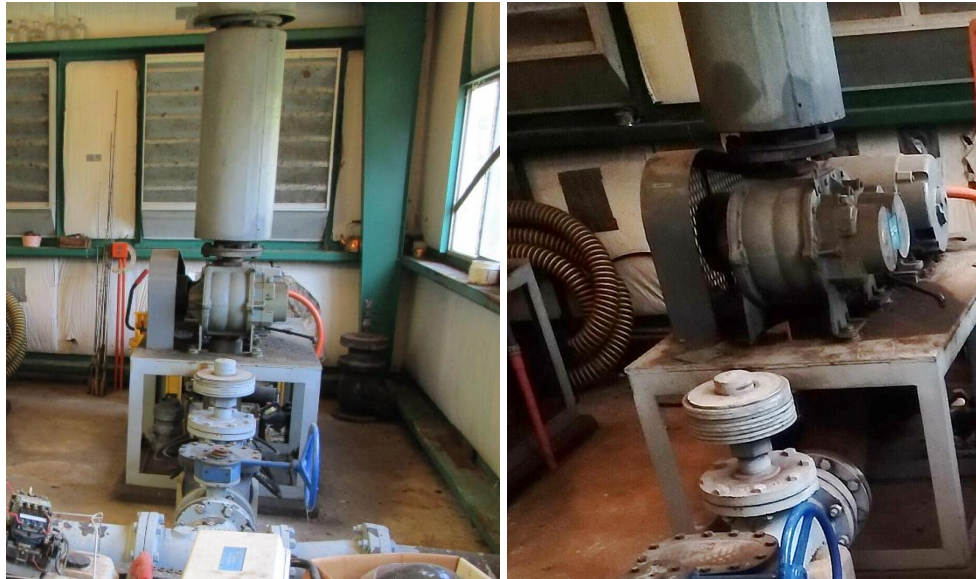
Failed blower at acquisition (left) and after motor replacement (right).

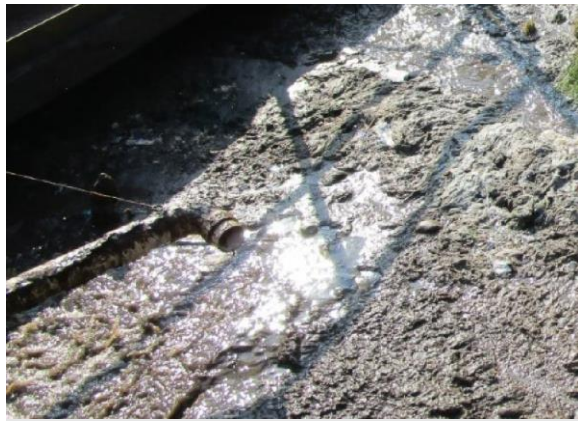
Blocked sludge return line.

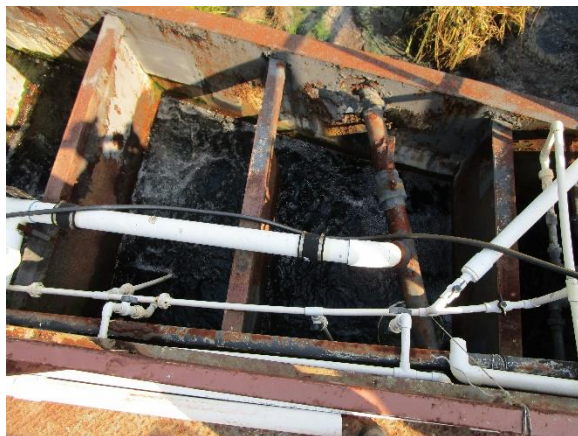
Leaking aeration lines, consisting of narrow PVC piping, throughout site.

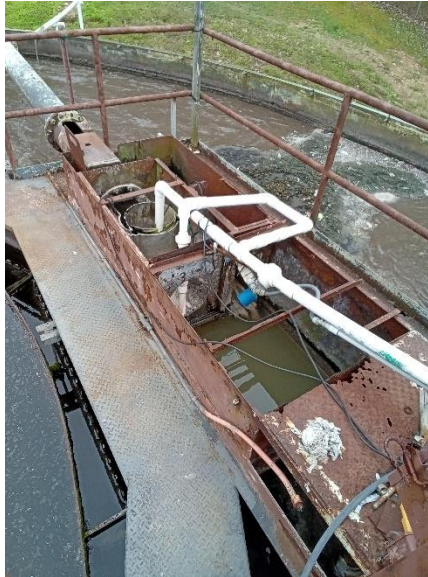
Loose wiring over treatment basins.

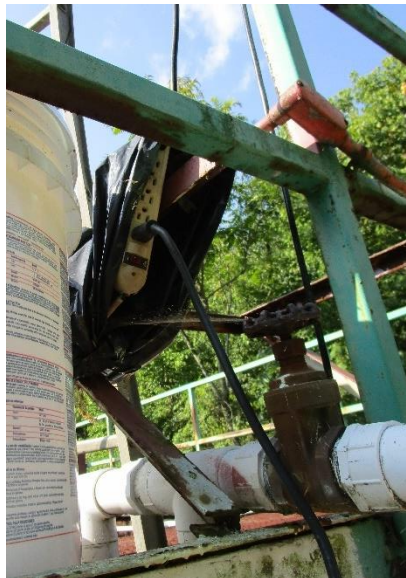
Improper power supply vulnerable to water infiltration from treatment processes and weather events.

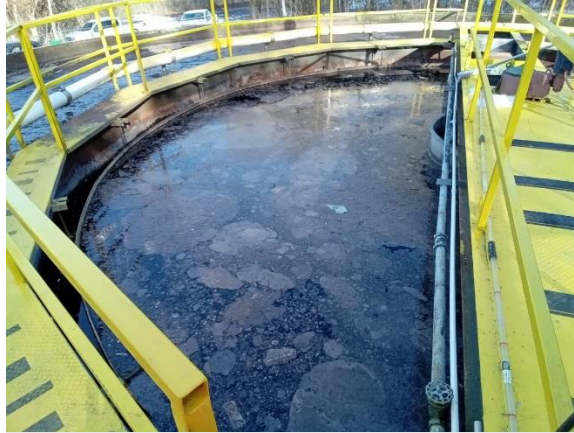
Example of new conduit installed across clarifier basin (narrow white piping above steel pipe).

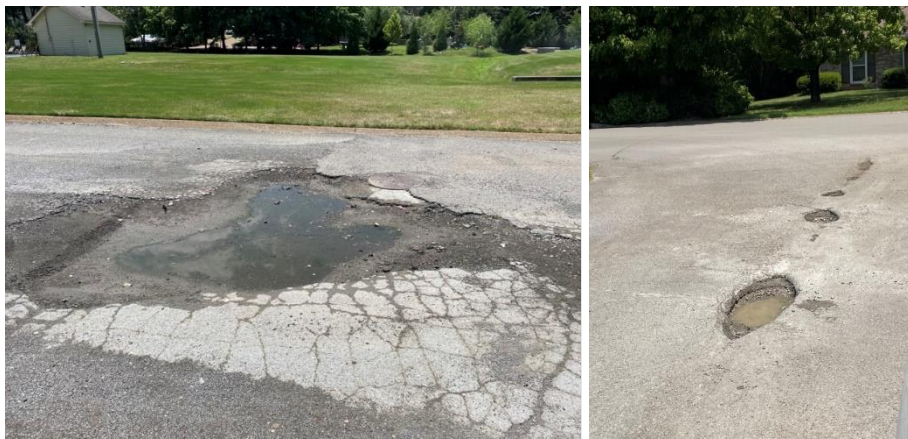
Damage on asphalt road before repairs.

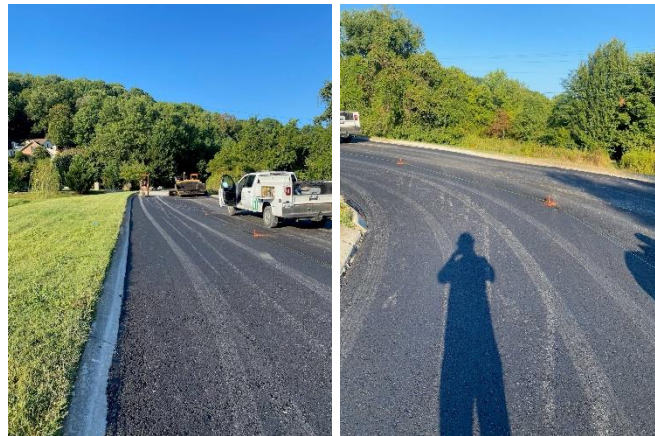
Asphalt road after repairs.

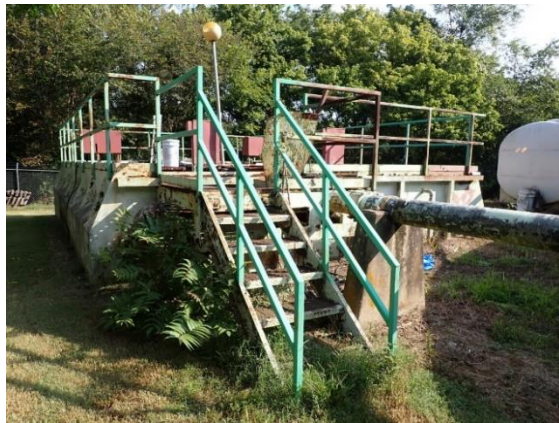
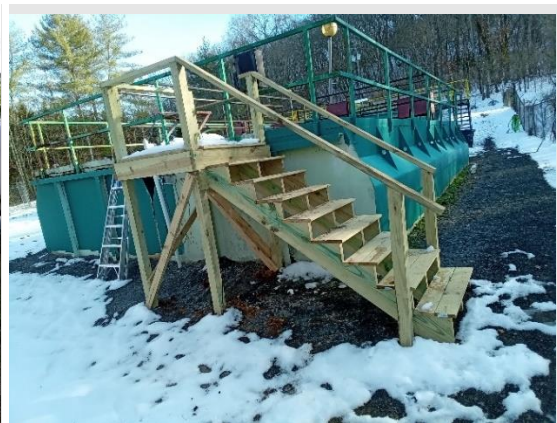
Stairs before and after replacement.

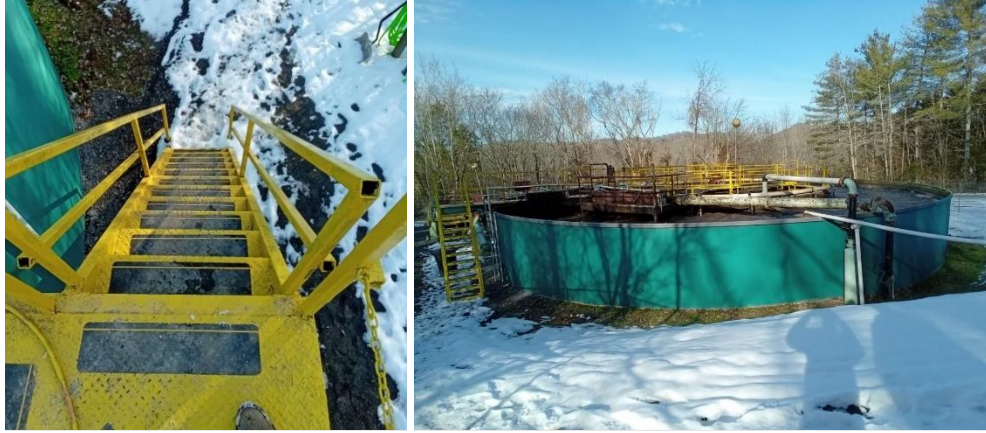
High visibility paint on all walking surfaces and stairs throughout facility.

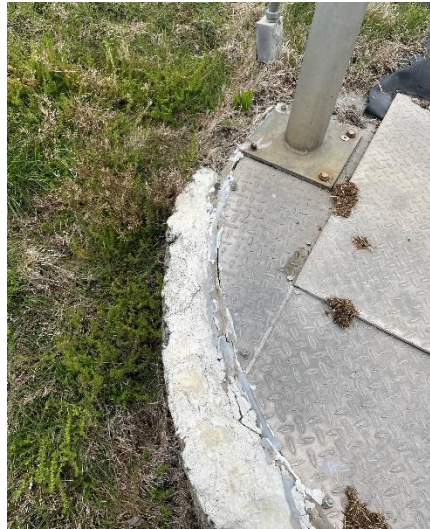
- A. Yes. The attached photo shows the repair made to the outside of the lift station ring at the Natchez lift station.

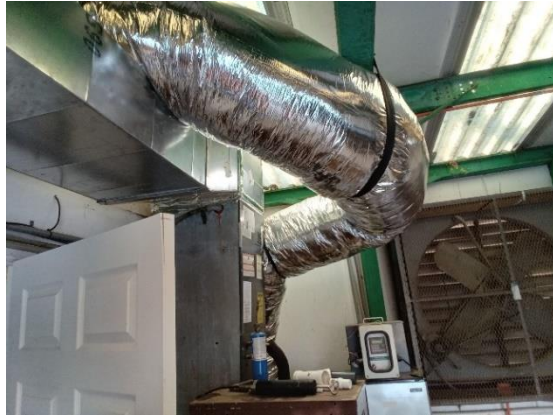
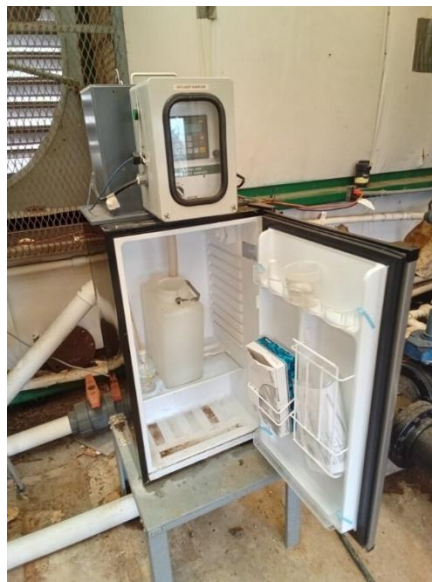
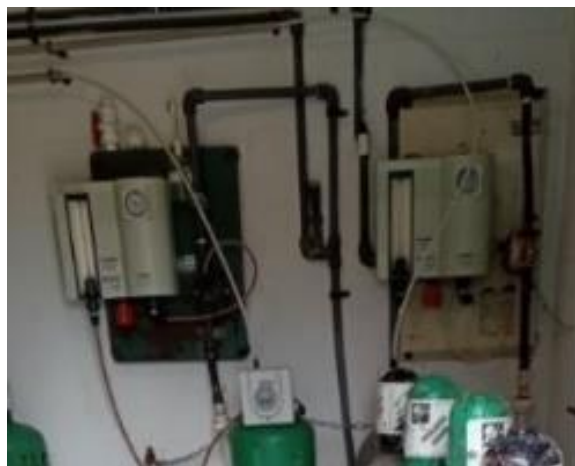
A. Yes. The attached photos show the new HVAC duct work, the new sample refrigerator for the influent autosampler, and the chlorination/dechlorination leak detection.

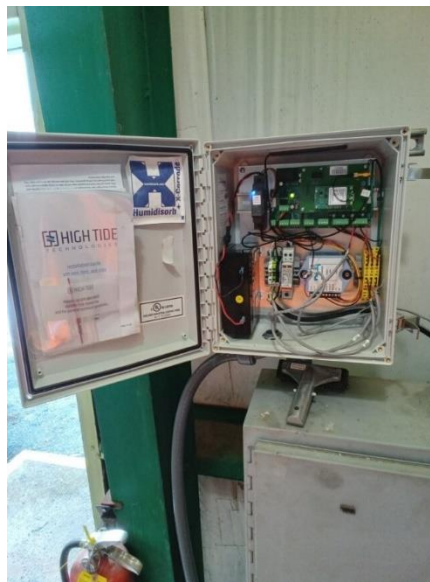
New remote monitoring unit at Grassland.

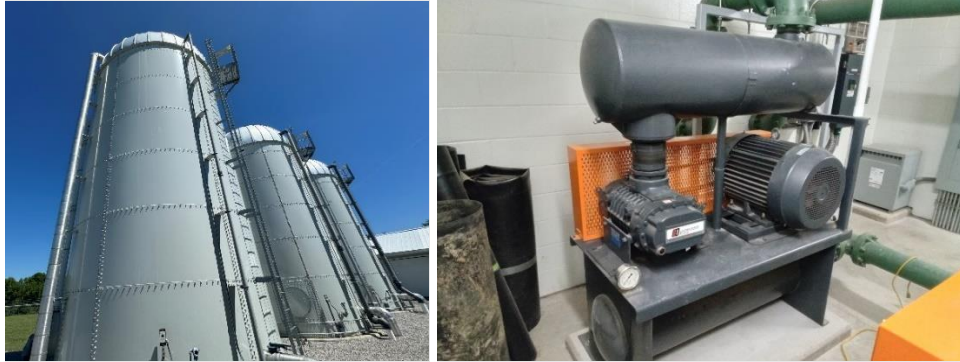
New aerobic and anaerobic Cambrian towers and part of the blower system with replaced VFD.

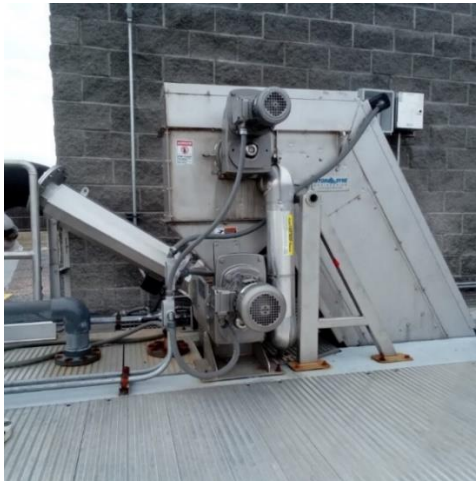
Screening system and compactor.

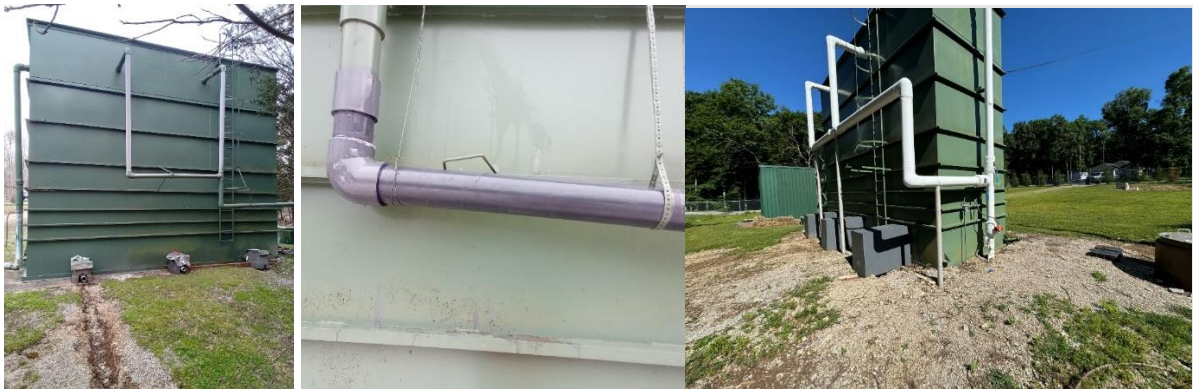
A. Yes. The first picture shows the piping that conveys wastewater from the anaerobic reactor to the nitrification tower. The second photo shows the sludge removal piping off of the anaerobic reaction which needed repair. Finally, the third photo shows the recently installed piping.

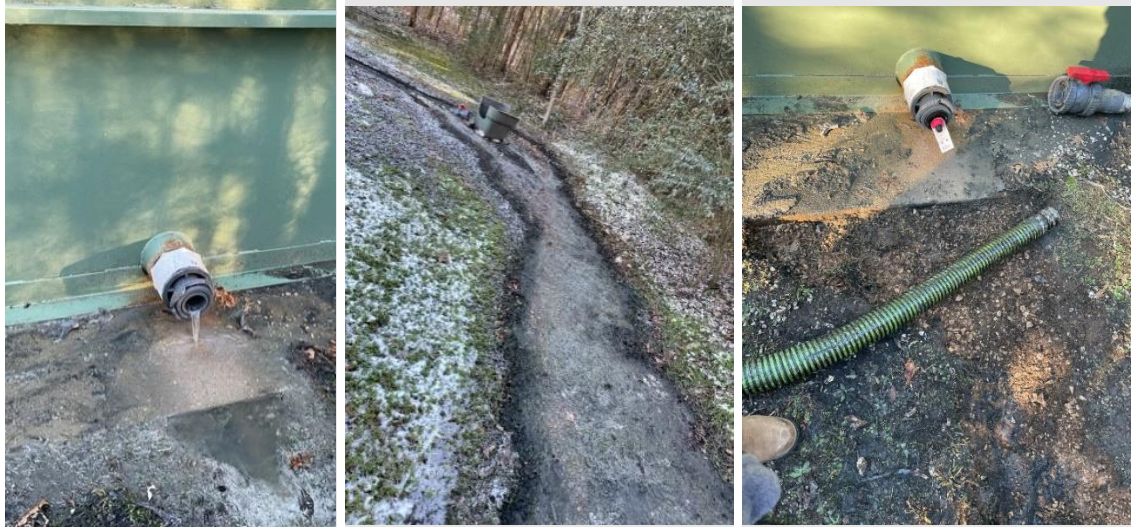
Additionally, the fourth photo shows the nonfunctional sludge removal valve. The fifth photo shows the resulting sludge overflow. The sixth photo shows the newly installed sludge removal valve.

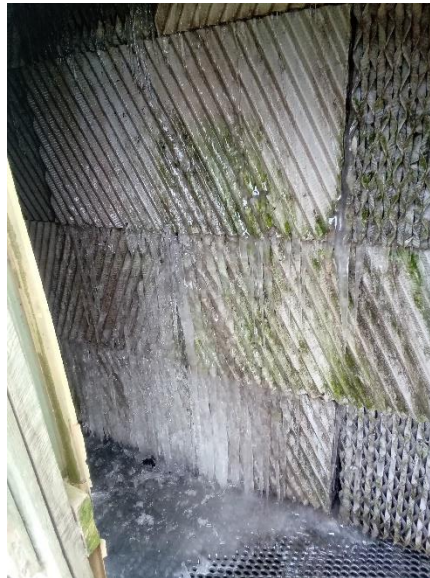
Finally, this photo shows portion of the nitrification media that had become overloaded due to lack of valving control over the nitrification media caused by faulty valving.

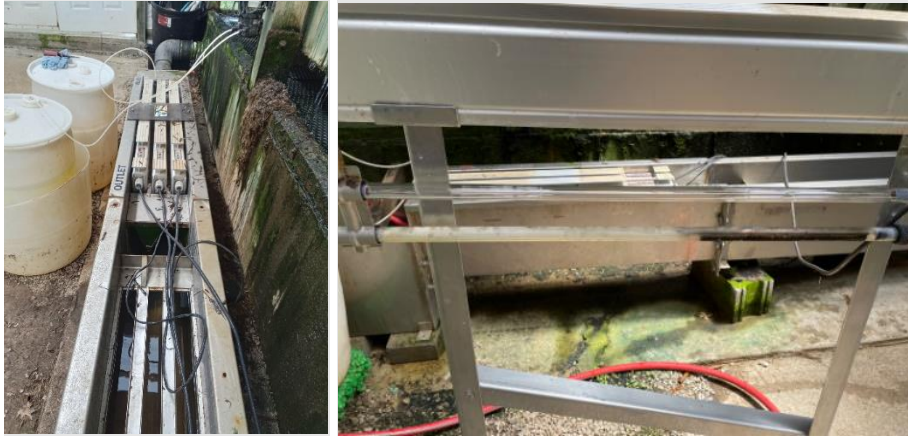
- A. The first photos show the Chapel Woods UV disinfection system. The first photo shows the replaced bulbs and quartz sleeves. The second photo shows the quartz sleeves as they are being replaced with the new sleeve on the top and the stained sleeve below.

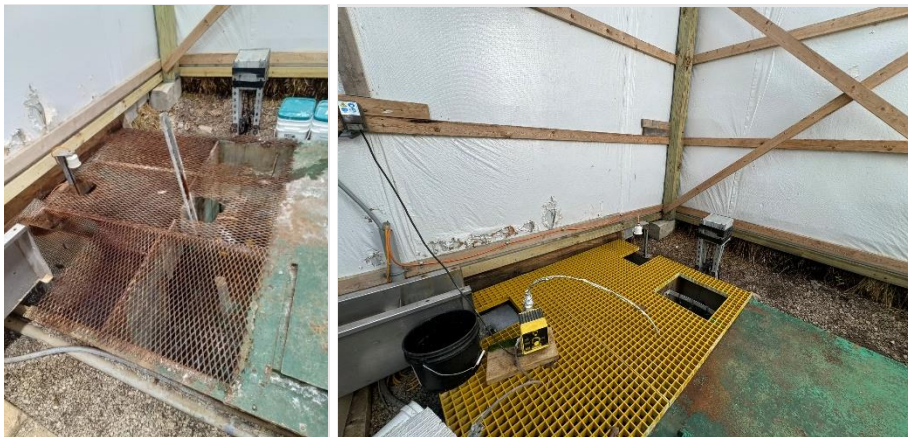
The following pictures are before and after pictures of the replacement of the rusted grating over the chloring contact chamber.

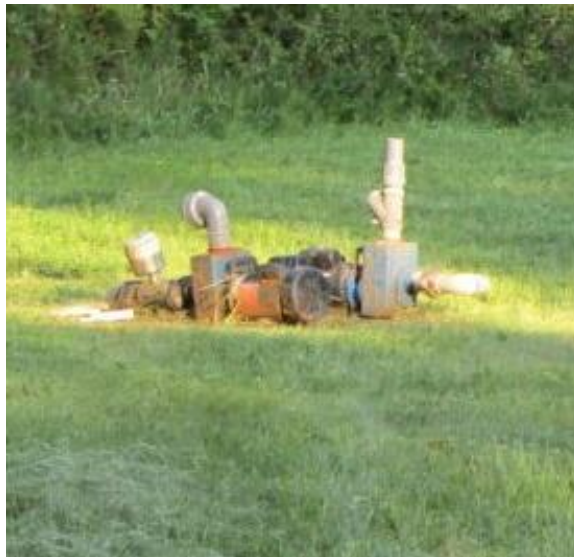
Trash left at the site including several broken pumps.

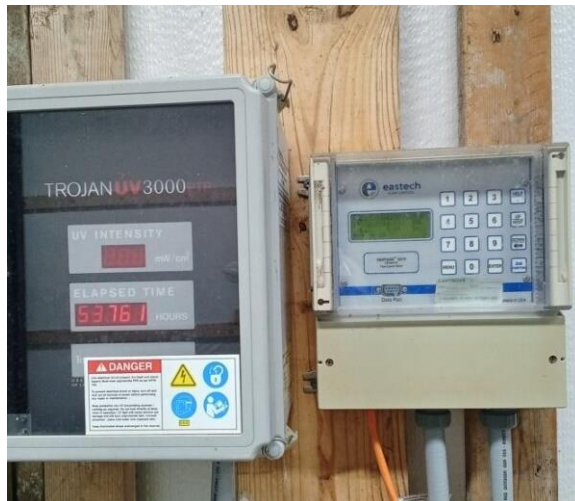
Recalibrated flow meter and UV intensity meter.

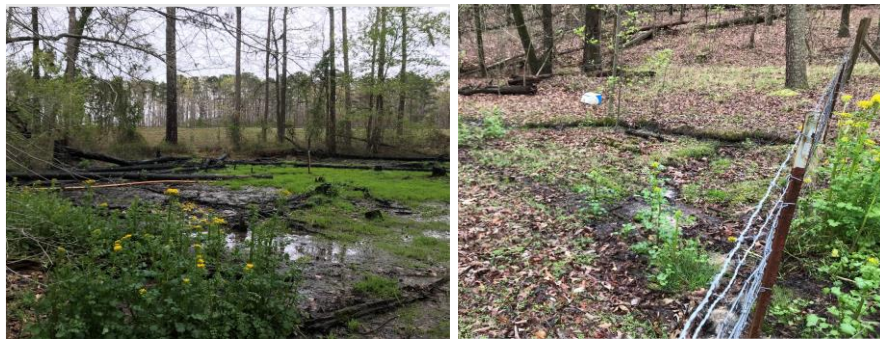
Overloaded spray field area due to inadequate size (left); runoff from spray field due to overloading (right).

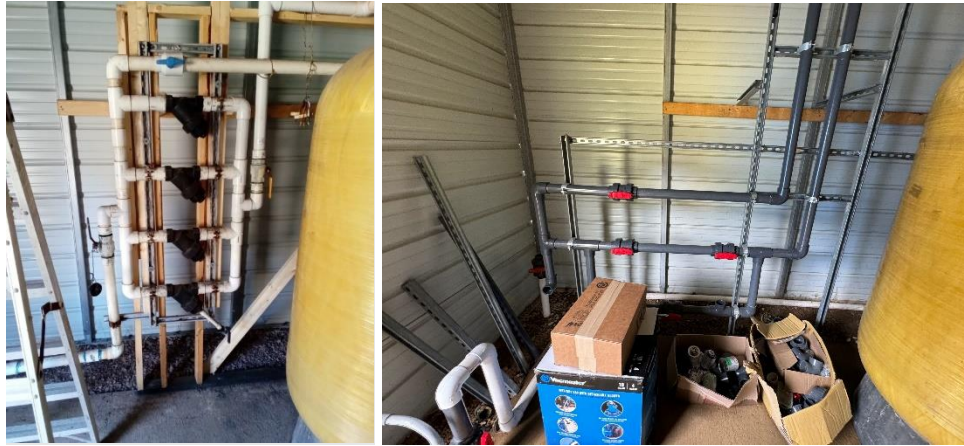
Strainer intended to capture larger solids before flow enters the sand filter before (left) and during replacement (right).

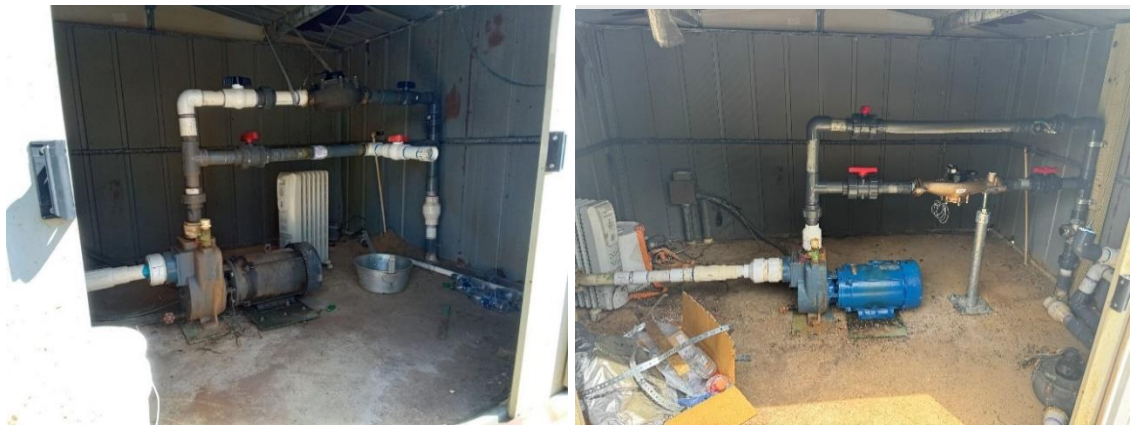
Discharge pump and motor before (left) and after (right) repair.

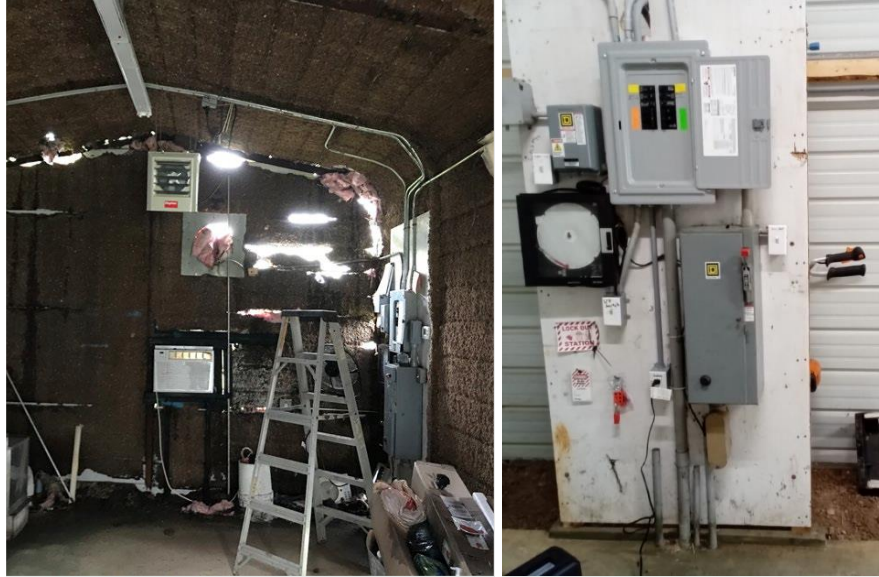
Poorly mounted power and control systems (left), remounted with rehabilitation of filter/disinfection shed (right).

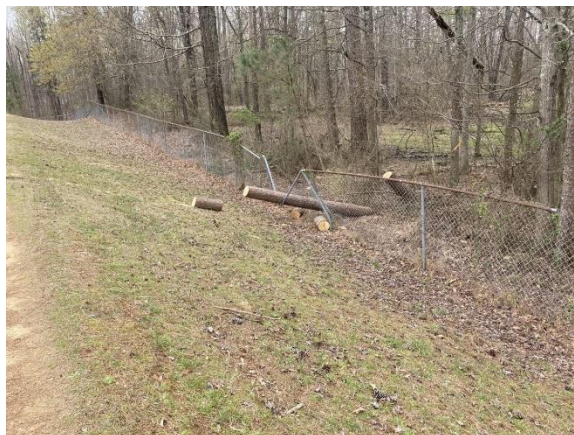
Example of damaged fencing before repairs.

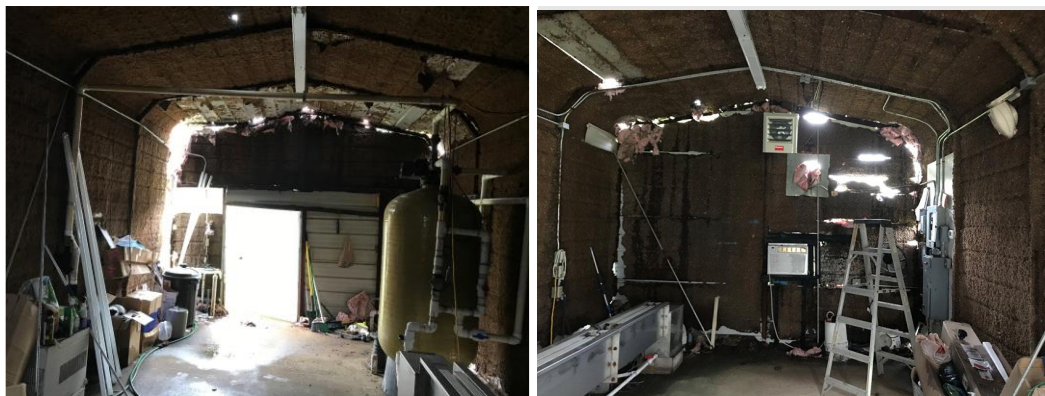
Severely deteriorated interior of filter and disinfection building.

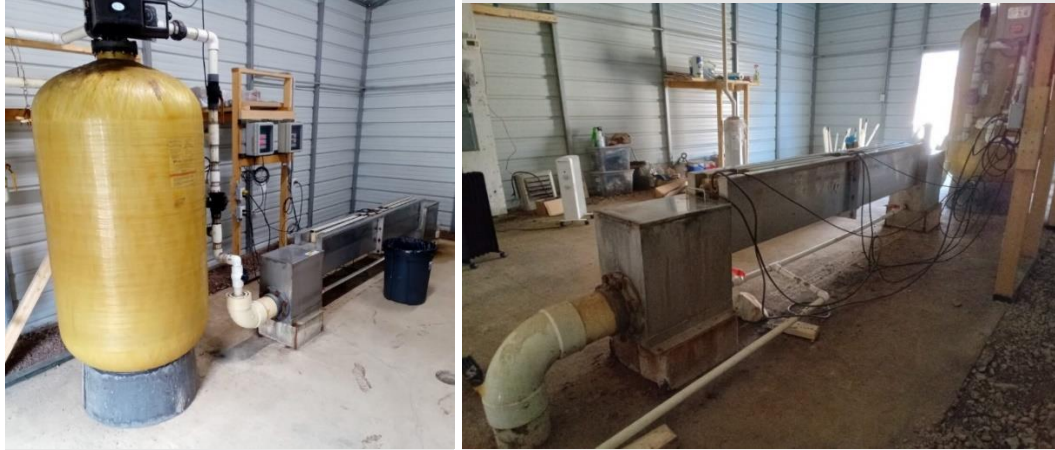
Filter and disinfection building interior after replacement.

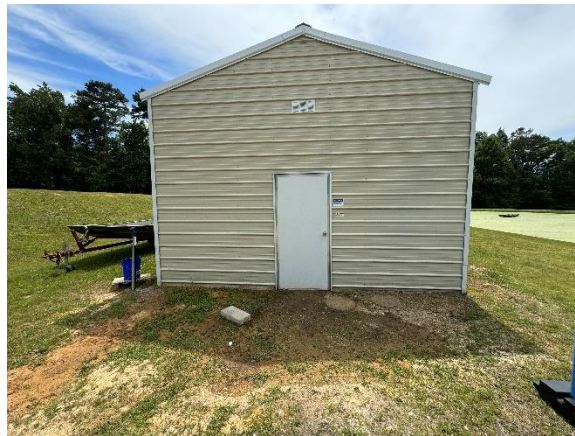
New filter and disinfection building exterior.

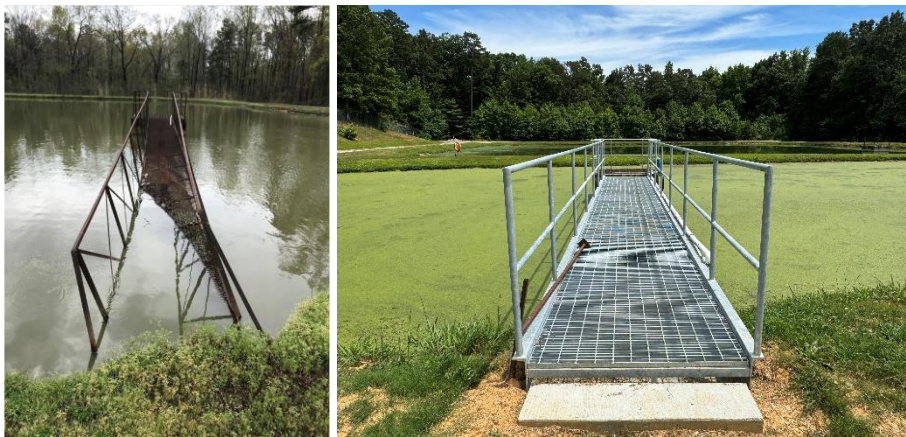
Failing catwalk structure before replacement (left) and after replacement (right).

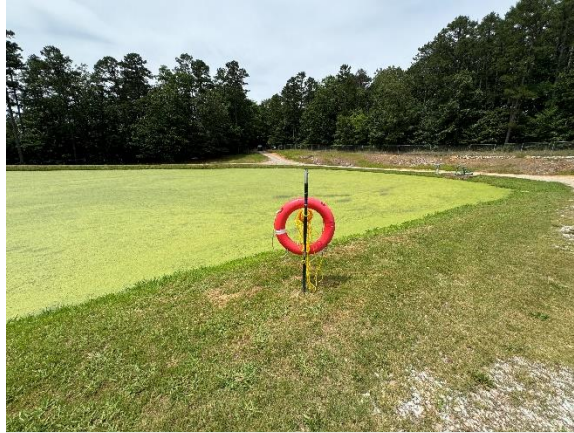
Life rings installed around the lagoon for emergency rescue.

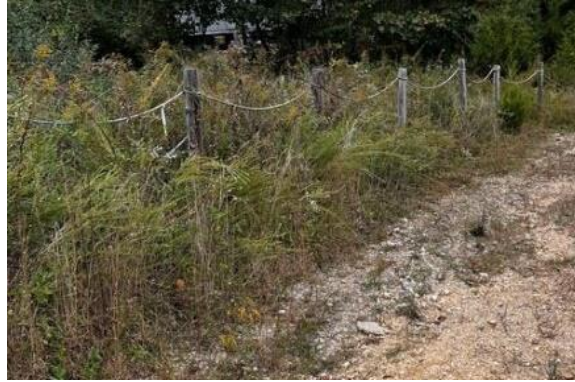
Example of inadequate fencing around drain field.

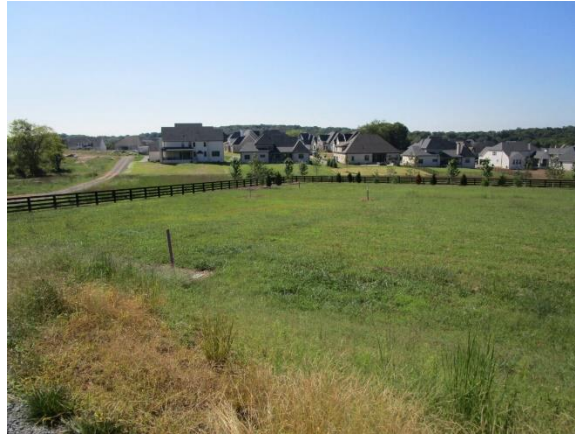
Restored drain field area.

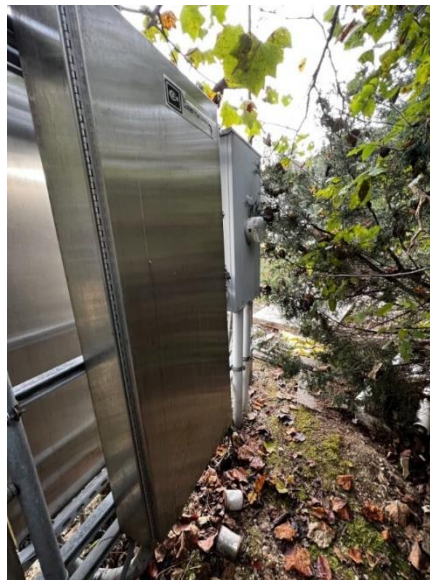
Vegetation blocking access to power and control panels.

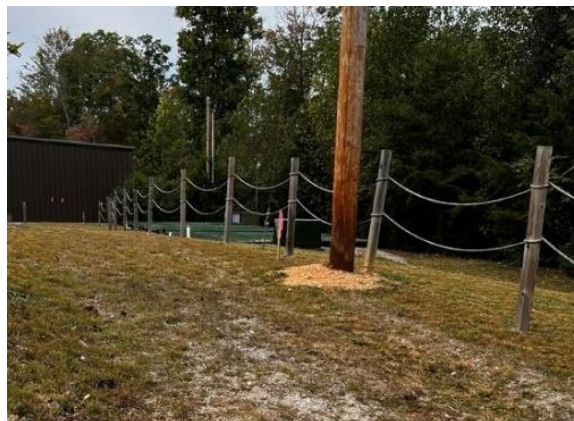
Inadequate fencing at treatment plant.

facility were wood posts with ropes strung between them. This offers no actual security for the site. As with the drain field, a contractor has been retained to install fencing around the treatment plant with a gate, which will have a lock on it to bar public access to the facility. Finally, vegetation overgrowth was an issue throughout the site, reducing operational access to equipment and treatment components, and potentially causing damage to equipment. The vegetation has been cleared and processes put in place to control the vegetation growth on the site moving forward.¹⁶

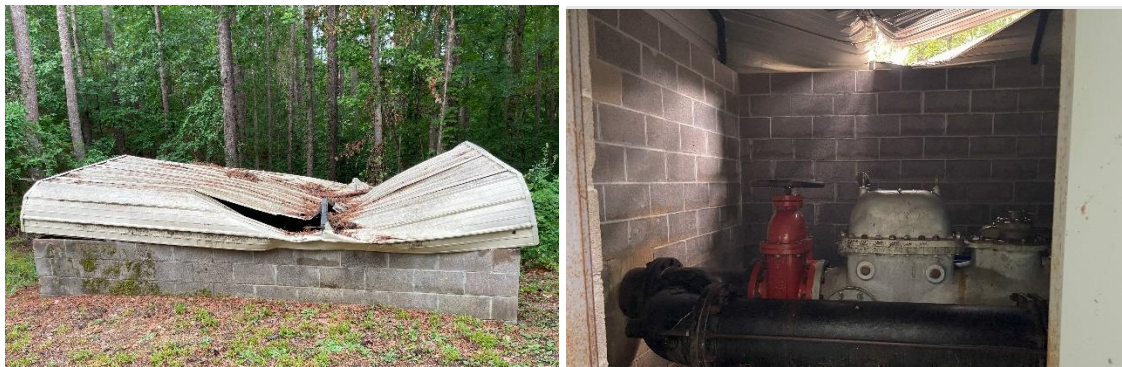
View of roof damage from the exterior (left) and interior (right).

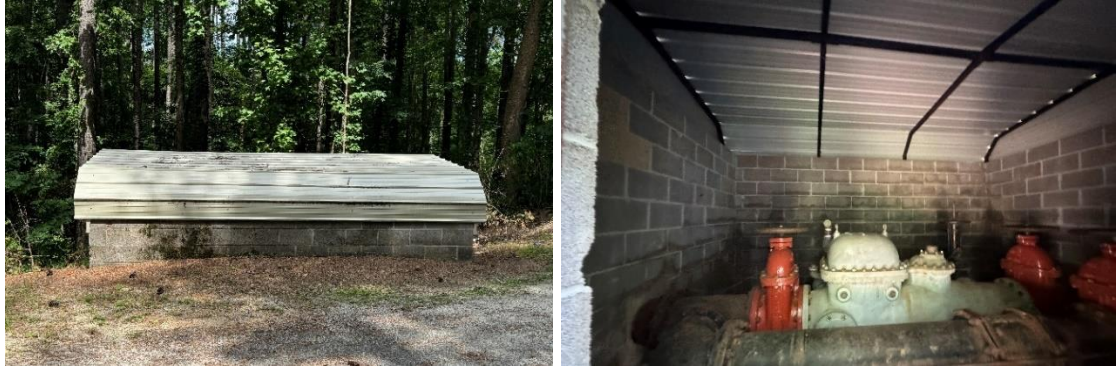
Roof following completion of repairs.

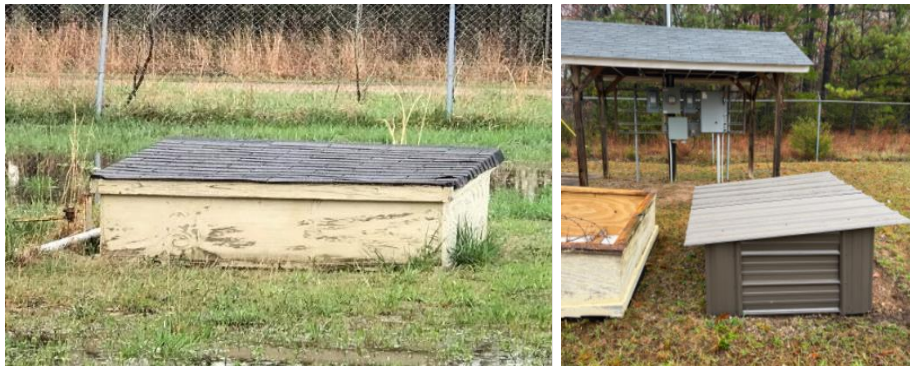
Old deteriorating well housing (left) and new well housing (right).

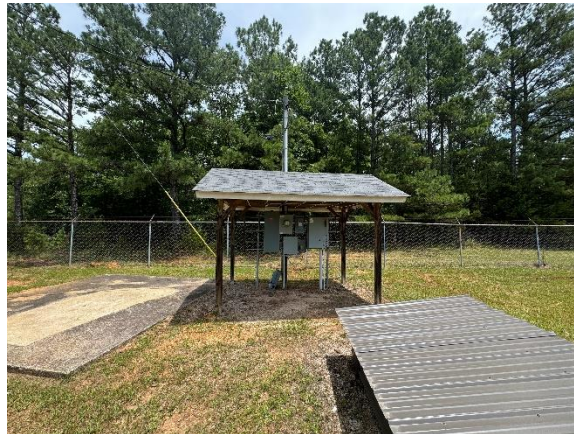
Concrete pad to the left of the power panels for future backup generator installation.
