BEFORE THE TENNESSEE REGULATORY AUTHORITY NASHVILLE, TENNESSEE

IN RE:)		
)		
PETITION OF BERRY'S CHAPEL)		
UTILITY, INC. TO RECOVER COSTS)		
TO REPAIR FLOOD DAMAGE AND TO)		
REFUND CUSTOMER SERVICE FEES)	DOCKET NO.	11-00180

PETITION TO RECOVER COSTS TO REPAIR FLOOD DAMAGE AND TO REFUND CUSTOMER SERVICE FEES

Flood Damage Inspection GAM Project No. 10-054

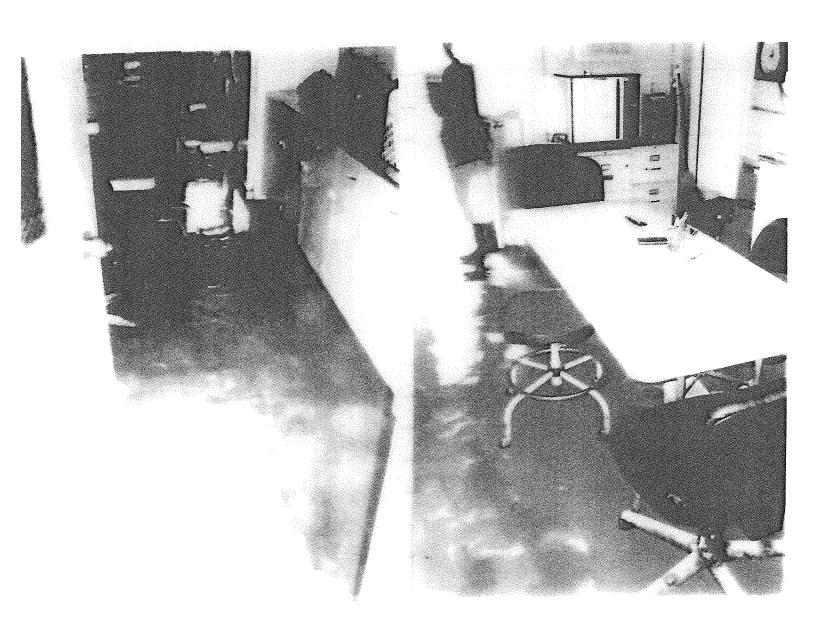
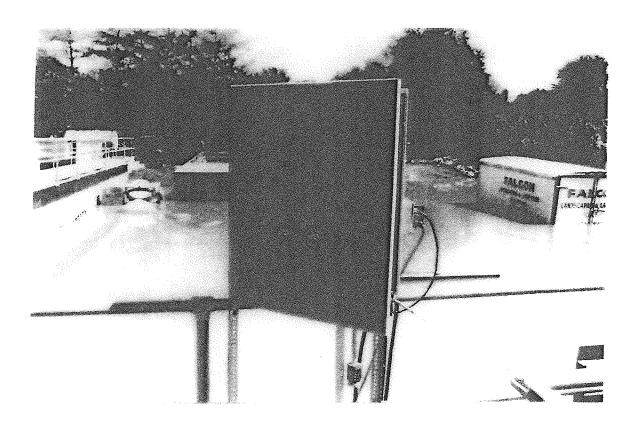
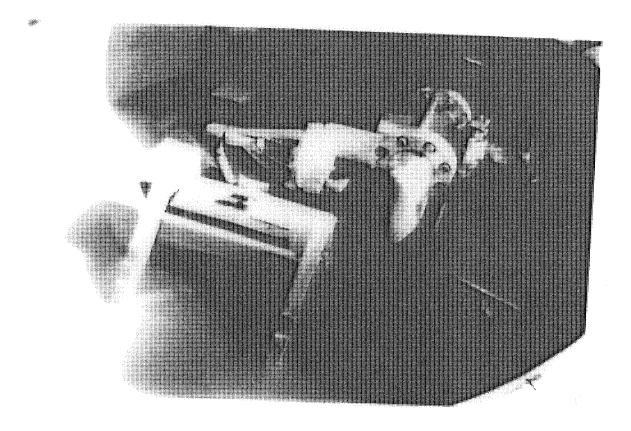
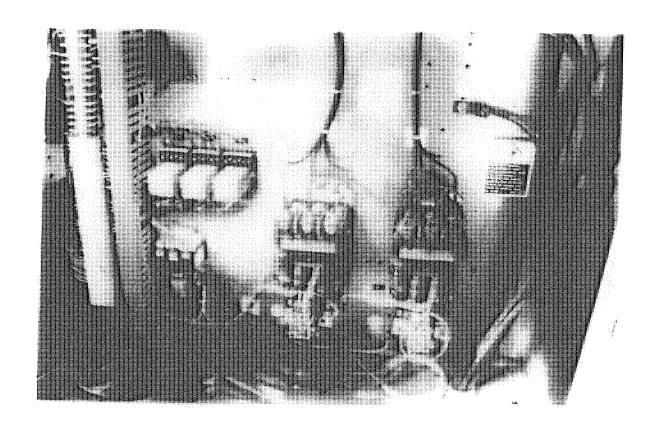
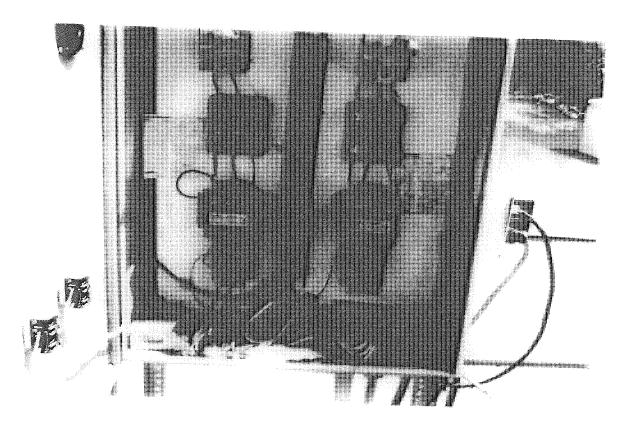
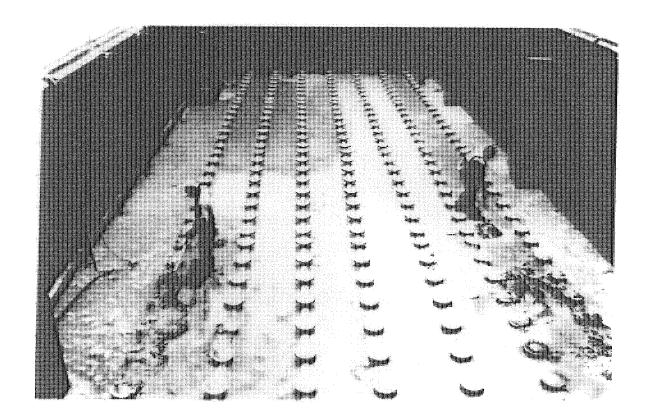
There are also photographs of the flood damage shown in Schedule FD-1 (attached). The cost of repairs, less the amount of insurance money collected, is \$190,237. These expenses are itemized in Schedule FD-1. Berry's Chapel proposes to recover the cost of repairs over three
