**BEFORE THE TENNESSEE REGULATORY AUTHORITY
NASHVILLE, TENNESSEE**

**FORMAL NOTICE OF VIOLATIONS,
KNOXVILLE UTILITIES BOARD INCIDENT,
12/09/09, REPORT OF NATURAL GAS SAFETY
INSPECTION #11-211**

**DOCKET NO.
12-00111**

**ORDER ACCEPTING PROPOSED CIVIL PENALTY
AND CORRECTIVE ACTIONS**

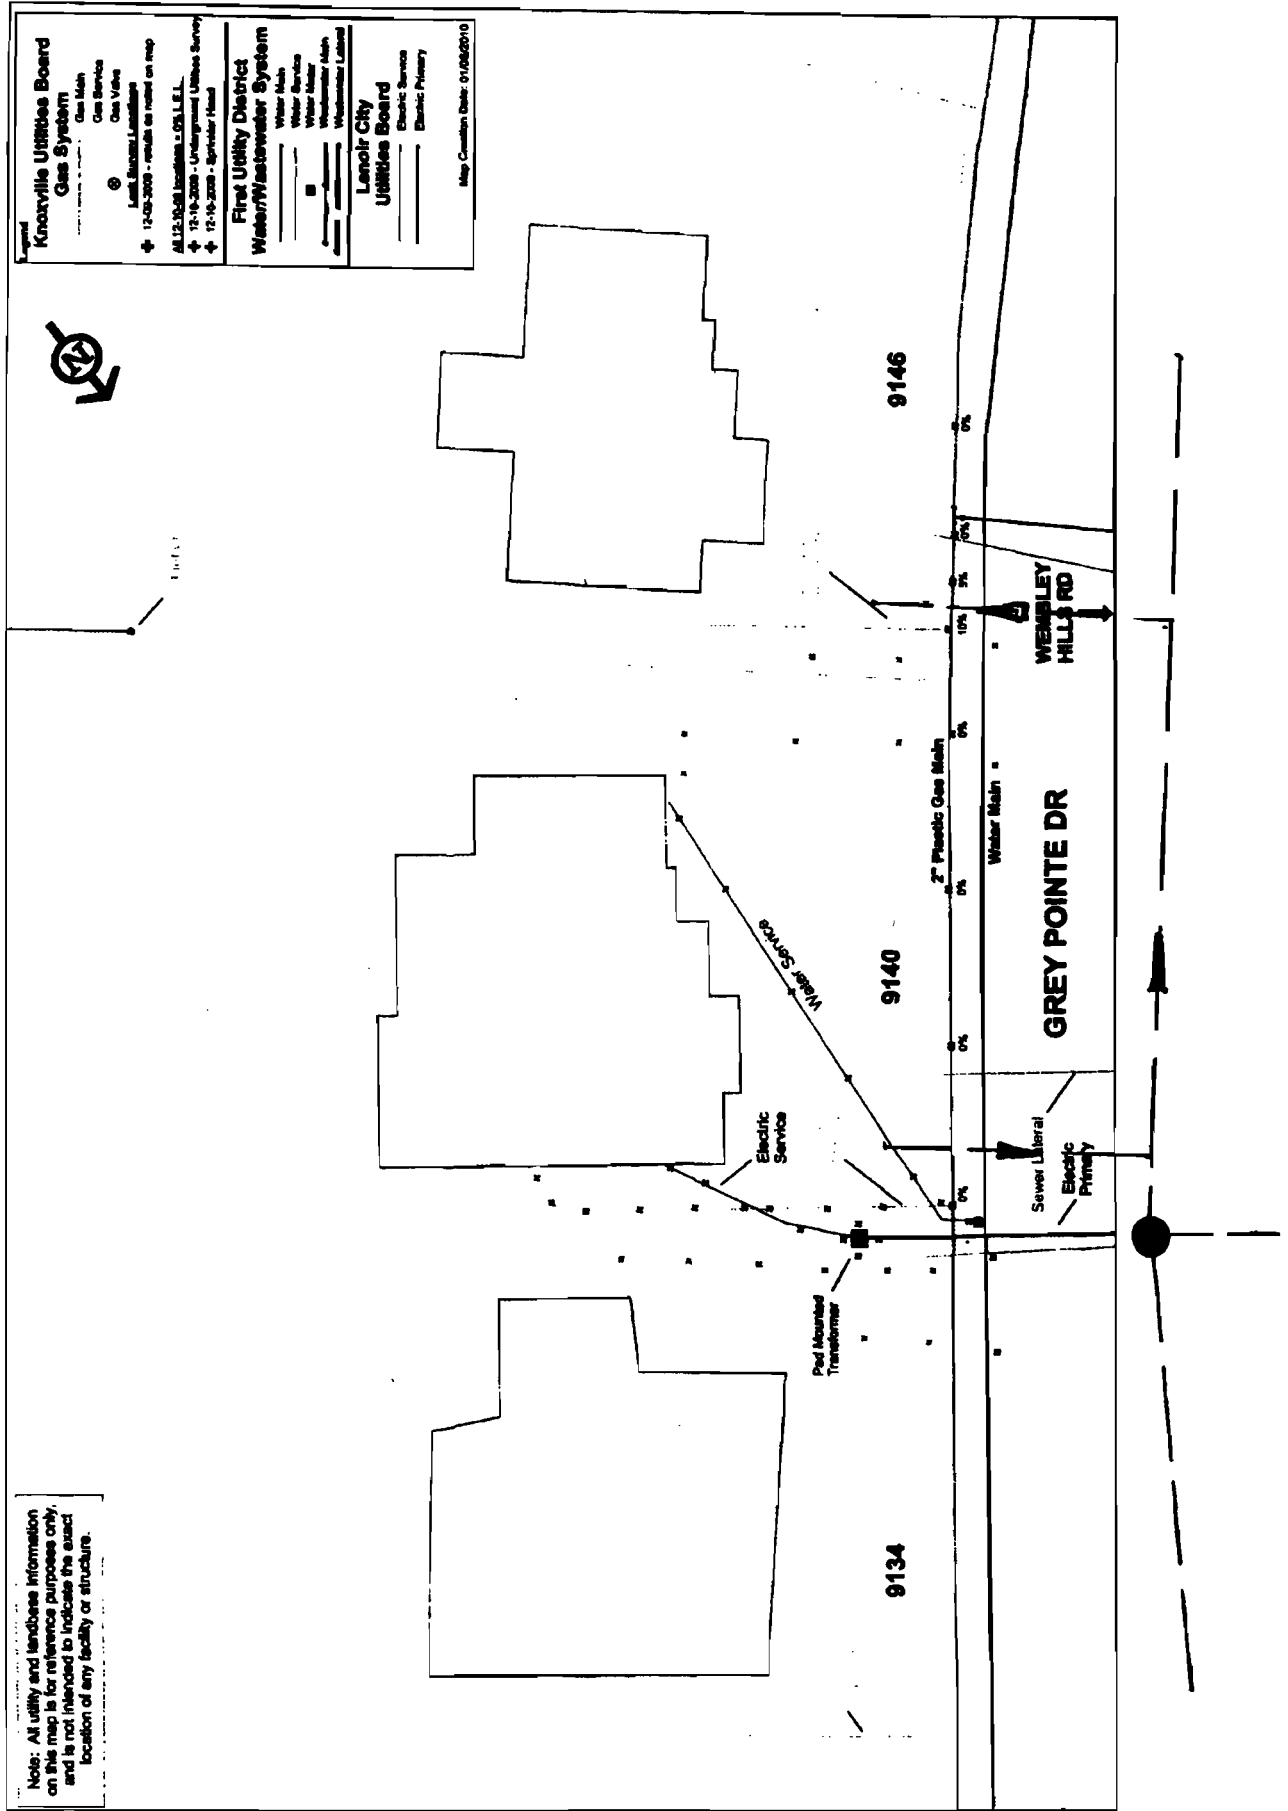
Sketch 1

INVESTIGATIVE ACTIONS TAKEN: At 7:00 am on Thursday, December 10, 2009, KUB met with Knox County Sheriff's Department (KCSD) to begin the collection of information and evidence at the explosion site. Bar hole testing by KUB's leak survey contractor began as soon as access to the explosion site was available. All bar hole readings were 0% of the LEL at the water, natural gas, and electric service lines to 9140 Grey Pointe Drive. See enclosed sketch for bar hole test locations and readings.
