Docket  
14-0000000000

Monthly Update  
31-Aug-15

August 19, 2015

RE: Compliance Inspections 7/20/2015  
 SOP-05033 Smoky Village Subdivision, Sevier County  
 SOP-00019 Starr Crest Resort, Sevier County  
 SOP-01033 Starr Crest II Resorts, Sevier County  
 SOP-98033 Swan Harbour Subdivision, Roane County  
 SOP-99024 Tall Oak Subdivision, Blount County  
 SOP-99016 Townsend Town Square, Blount County

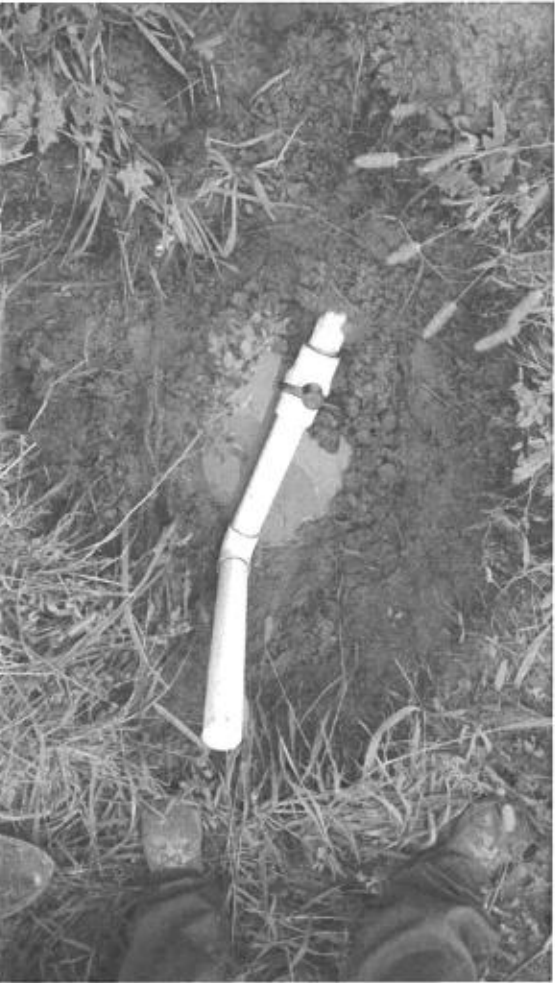
Photo #8

*An area of ponding was observed on the lower portion of the drip field located at 35°48'18.4/-83°50'00.00". Ponding was previously observed on the February 28, 2014 inspection conducted by KFFO staff and & August 15, 2014 as well.*

The several areas of ponding that were noted on last year's inspection were addressed by making repairs to leaking drip tubing. While we do not believe this ponding is due to last year's leak, but rather due to a new leak, this new ponding was evaluated and the broken drip tubing that was contributing to it was repaired on August 4, 2015 (see photo #8).
