Re: Petition of Cartwright Creek, LLC to Increase Tap Fees to Address
Environmental Issues Raised by the Tennessee Department of Environment and
Conservation
Docket No. 19- 00034

Cartwright Creek, Collections System Review Inflo Design Group

Collections System Review

JUNE, 2018

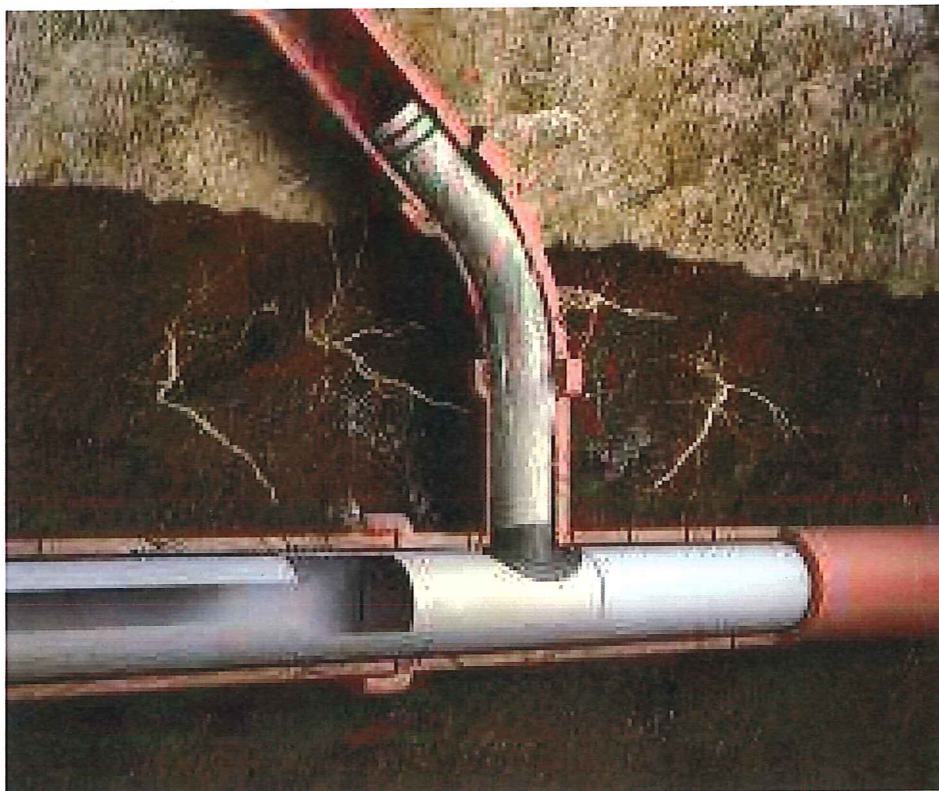
Based on our opinion, option #4 would be both an economical and effective lateral rehabilitation method for Cartwright Creek. A “full-wrap” lateral seal extending approximately 4-feet into the service line will effectively seal the majority of leaks in service lines. A leader in the industry, BLD Contracting, has installed several thousand of these lateral connection seals throughout Middle Tennessee, shown graphically below:
