**RE: Limestone Water UOC – Grassland STP  
Permit No. – TN0027278  
Franklin, Williamson County, TN**

This letter is submitted in response to the Sanitary Sewer Overflow (SSO) violation reported by the Division of Water Resources on Thursday, July 24, 2025, and will outline the corrective actions taken by Limestone along with the additional measures required to remediate this incident.

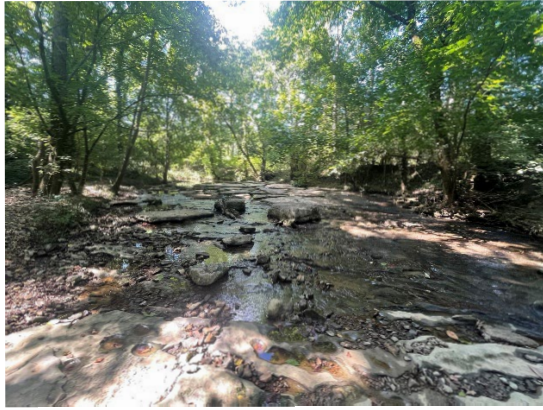
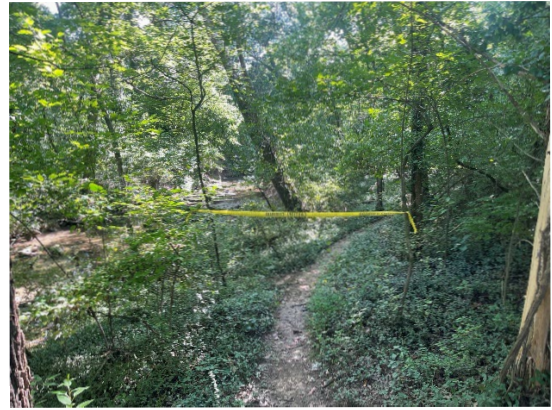
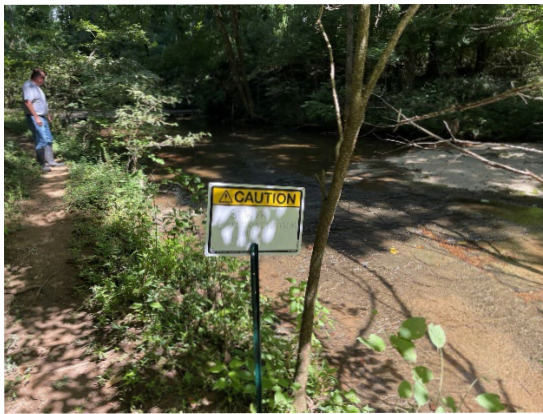
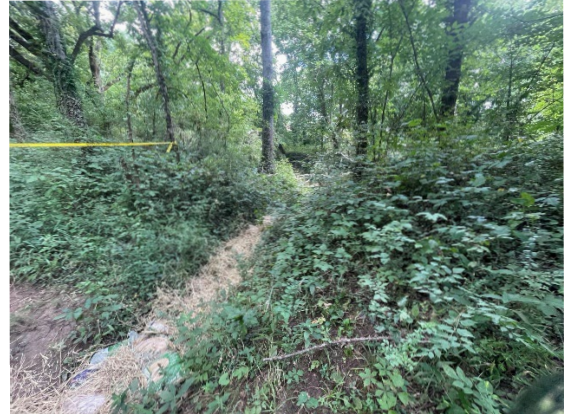
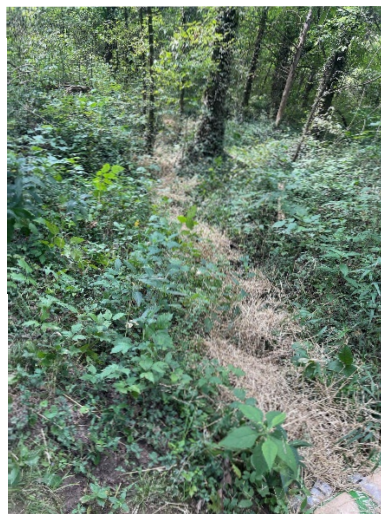
Due to the contaminated area being available for public access, the Division advised that the area be corded off with caution tape and that informative warning signage be placed to ensure public safety. Limestone's team complied with the Division's request on the morning of July 25, 2025, as can be seen in the attachments below. The Division representative also required an *E. coli* analysis to be conducted within the impacted area of the receiving stream (along with an upstream control) once per day until normal conditions are restored. Daily testing of the site is continuing.

- Commencing on July 25, 2025, operations crews used pumps and hoses to agitate waterways and extracted the debris and concentrated spillage. Debris has been placed into containment bins and disposed of as a Class I solid waste as per **TN Rule 0400-11-01-.04(2)**. Those activities are ongoing.
- Commencing on July 25, 2025, all contaminated areas in the woods, where overflow reached the creek, have been shoveled, treated with lime, and covered with straw to prevent the lime from dispersing. Crews will remove any straw visible from the walking trails by August 8. However, straw at the primary overflow site will remain in place through at least August 15 to help with lime stabilization and bacterial neutralization. This area will be cleaned and restored afterward, with a berm installed around the manhole.

After the line was returned to operational on July 25, 2025, remediation began. Those efforts are documented as follows,
