**RE: *Limestone Water Utility Operating Company, LLC's Application to Expand its Certificate of Convenience and Necessity to Serve the Nash Ridge Subdivision, Williamson County, Tennessee, TPUC Docket No. 23-00036***

**RE: Limestone Water UOC – Grassland STP  
Permit No. – TN0027278  
Franklin, Williamson County, TN**

This letter is submitted in response to the Sanitary Sewer Overflow (SSO) violation reported by the Division of Water Resources on Thursday, July 24, 2025, and will outline the corrective actions taken by Limestone along with the additional measures required to remediate this incident.

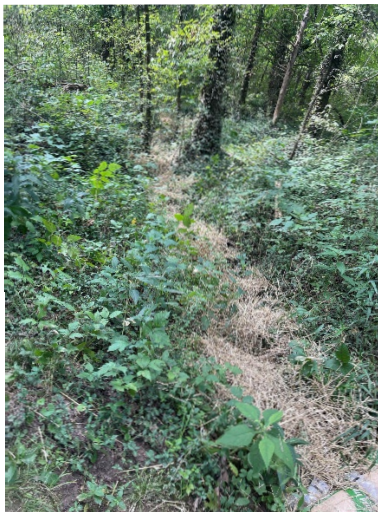
Once notified by the Division, the Clearwater Solutions team responded immediately. In fact, when Limestone contacted Clearwater Solutions its technicians were already enroute to the site in response to a call received from one of Limestone's customers. Once onsite, Clearwater Solutions discovered a line blockage caused by grease deposits and an accumulation of disposable wipes. The line was cleared on July 25, 2025, to ensure proper flow was returned to the system

Due to the contaminated area being available for public access, the Division advised that the area be corded off with caution tape and that informative warning signage be placed to ensure public safety. Limestone's team complied with the Division's request on the morning of July 25, 2025, as can be seen in the attachments below. The Division representative also required an *E. coli* analysis to be conducted within the impacted area of the receiving stream (along with an upstream control) once per day until normal conditions are restored. Daily testing of the site is continuing.

After the line was returned to operational on July 25, 2025, remediation began. Those efforts are documented as follows,

- Commencing on July 25, 2025, operations crews used pumps and hoses to agitate waterways and extracted the debris and concentrated spillage. Debris has been placed into containment bins and disposed of as a Class I solid waste as per **TN Rule 0400-11-01-.04(2)**. Those activities are ongoing.
- Commencing on July 25, 2025, all contaminated areas in the woods, where overflow reached the creek, have been shoveled, treated with lime, and covered with straw to prevent the lime from dispersing. Crews will remove any straw visible from the walking trails by August 8. However, straw at the primary overflow site will remain in place through at least August 15 to help with lime stabilization and bacterial neutralization. This area will be cleaned and restored afterward, with a berm installed around the manhole.

After an inspection by Limestone, it has been determined that the efforts made have restored the area to a safe and aesthetic condition. This inspection revealed that there are no longer any detectable odors or visible signs of discharge present.
